**Report: TAB Report**  
**Function: Test, Adjust, & Balance**  
**Date: 01/07/2026**  
**Completed By: National TAB**

**PROJECT**  
**12-29-25 CHIPOTLE #5135 SCHERTZ, TX**

Project: 12-29-25 CHIPOTLE #5135 SCHERTZ, TX

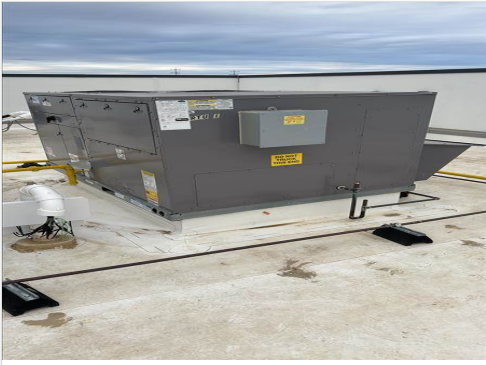
## Unit Data - PHOTO LOG

Asset: RTU1

AREA: KITCHEN

Unit Data		
	Design	Actual
MFG	CARRIER	CARRIER
Serial Num	-	0524P63468
Model Num	48FEFN12	48FCFN12D3M5A6W4F0
Type	RTU	RTU
Configuration	VERTICAL	VERTICAL
Num OA Filters 1	-	1
OA Filter Size 1	-	36X21
Num Final Filter 1	-	4
Final Filter Size 1	-	20X20X2

Test Data		
	Design	Actual
SF CFM	4000	3777
SF RPM	-	DIRECT DRIVE
RA CFM	3500	3263
OA CFM	500	514
RL Voltage	208	213/212/213
RL Amperage	12.6	7.5/7.5/7.2
SF Rotation	-	CCW
SF System SetPt	-	SETTING C 50%
RA Damper Position	-	90% OPEN
Min OA Damper Position	-	3.00 VOLTS
Min OA Damper Type	-	OPOSED BLADE
OA Enthalpy Setpt	-	ES5

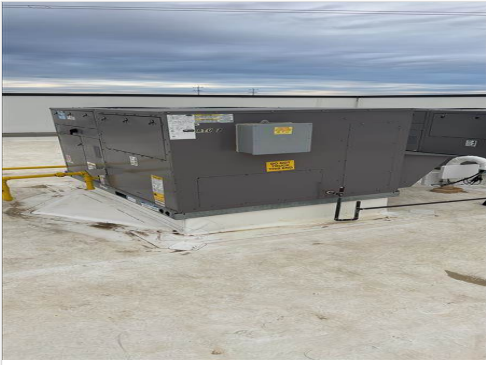
## Unit Data - PHOTO LOG

Asset: RTU2

AREA:DINING

Unit Data		
	Design	Actual
MFG	CARRIER	CARRIER
Serial Num	-	0424P63062
Model Num	48FEFN12	48FCFN12D3M5A6W4F0
Type	RTU	RTU
Configuration	VERTICAL	VERTICAL
Num OA Filters 1	-	1
OA Filter Size 1	-	36X21
Num Final Filter 1	-	4
Final Filter Size 1	-	20X20X2

Test Data		
	Design	Actual
SF CFM	4000	4066
SF RPM	-	DIRECT DRIVE
RA CFM	3000	3003
OA CFM	1000	1063
RL Voltage	208	213/213/212
RL Amperage	12.6	6.7/6.8/6.5
SF Rotation	-	CCW
SF System SetPt	-	SETTING C 45%
RA Damper Position	-	80% OPEN
Min OA Damper Position	-	4.50 VOLTS
Min OA Damper Type	-	OPOSED BLADE
OA Enthalpy Setpt	-	ES5

DIFFUSER #8 SERVES A RESTROOM. DIFFUSER IS SHOWN ON REFLECTED CEILING DRAWINGS, BUT NOT ON MECHANICAL DRAWINGS. DIFFUSER WAS BALANCED TO 50 CFM TO KEEP RESTROOM NEGATIVE, THIS CFM WAS TAKEN FROM THE 5 SR1 DIFFUSERS IN THE DINING ROOM. THESE 5 SR1 DIFFUSERS WILL NOW BE BALANCED TO 630 CFM PER INSTEAD OF 640 CFM PER.

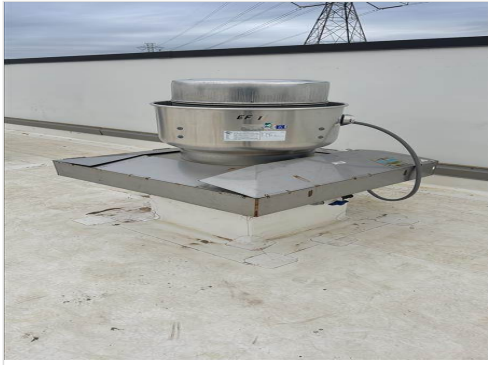
## Unit Data - PHOTO LOG

Asset: EF1

AREA:HOOD

Unit Data		
	Design	Actual
<b>MFG</b>	ACCUREX	ACCUREX
<b>Model Num</b>	XCUE-160-VG	XCUE-160-20-1-26-G
<b>Serial Num</b>	-	26931069
<b>Type</b>	UPBLAST	UPBLAST
<b>Configuration</b>	VERTICAL	VERTICAL

Test Data		
	Design	Actual
<b>CFM</b>	2550	2596
<b>Fan RPM</b>	1330	DIRECT DRIVE
<b>Fan Rotation</b>	-	CCW
<b>Motor RPM</b>	-	DIRECT DRIVE
<b>System SetPt</b>	-	6.7 VDC
<b>RL Voltage</b>	230	213
<b>RL Amperage</b>	4.8	3.3
<b>Total ESP</b>	1.2"	0.27
<b>Fan Inlet SP</b>	-	-0.27
<b>Fan Discharge SP</b>	-	ATM

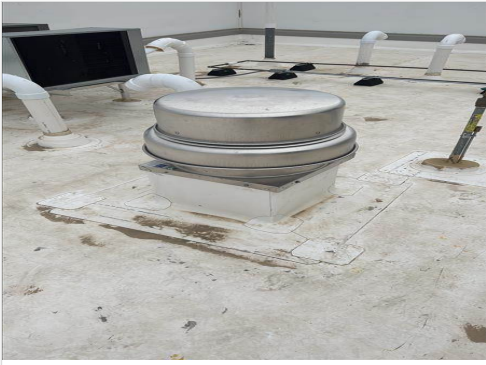
**Unit Data - PHOTO LOG**

Asset: EF2

AREA:RESTROOM

Unit Data		
	Design	Actual
MFG	ACCUREX	ACCUREX
Model Num	XRED-097-VG	XRED-097-4-VG-1-19-X
Serial Num	-	26901061
Type	DOWNBLAST	DOWBLAST
Configuration	VERTICAL	VERTICAL

Test Data		
	Design	Actual
CFM	150	160
Fan RPM	1330	DIRECT DRIVE
Fan Rotation	-	CCW
Motor RPM	-	DIRECT DRIVE
System SetPt	-	6.5
RL Voltage	115	121
RL Amperage	2.85	0.8
Total ESP	0.6"	0.24
Fan Inlet SP	-	-0.24
Fan Discharge SP	-	ATM

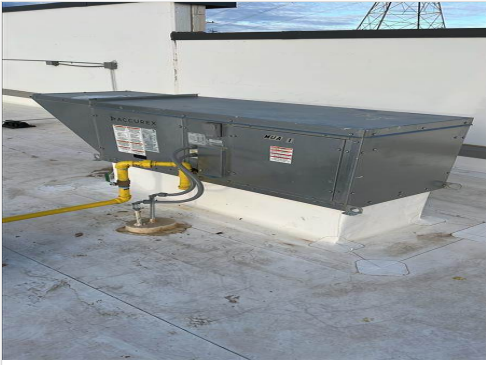
## Unit Data - PHOTO LOG

Asset: MAU1

AREA:HOOD

Unit Data		
	Design	Actual
MFG	ACCUREX	ACCUREX
Model Num	XDGX-P115-P115-H05-VG	XDGX-P115-H05-VG
Serial Num	-	26912748
Type	MAU	MAU
Configuration	VERTICAL	VERTICAL

Test Data		
	Design	Actual
CFM	1300	1370
SF RPM	-	DIRECT DRIVE
Motor RPM	-	DIRECT DRIVE
SF System SetPt	-	4.5
RL Voltage	-	122
RL Amperage	-	2.0
Total ESP	-	[1]
Fan Discharge SP	-	[1]

[1] UNABLE TO OBTAIN DISCHARGE STATIC PRESSURE DUE TO CEILING TILE LAY OUT AND LIMITED ACCESS TO SUPPLY DUCT DROP.

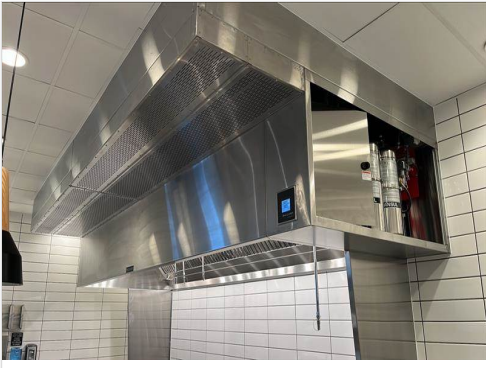
**Unit Data - PHOTO LOG**

Asset: HD1

AREA:COOKLINE

Unit Data		
	Design	Actual
MFG	ACCUREX	ACCUREX
Model Num	XXEW-153-S	XXEW-153.00-S
Job / Serial Num	-	9549024/190
Type	TYPE I CANOPY	TYPE I CANOPY
Hood length	153"	153"
Hood Width	54"	54"
Supply Plenum Type	-	PSP
Supply Plenum Width	14"	14"
Supply Plenum Length	165"	165"

Test Data Exhaust		
	Design	Actual
Filter Type	XTRACTOR	XTRACTOR
Filter Size 1	16X20	20X16
Filter Size 2	20X20	20X20
Filter Qty 1	2	2
Filter Qty 2	6	6
Filter AK factor size 1	2	2.00
Filters AK factor size 2	3	3.00
Filter Total AK Area	22	22.00
Filter1 FPM	-	113
Filter2 FPM	-	111
Filter3 FPM	-	121
Filter4 FPM	-	133
Filter5 FPM	-	143
Filter6 FPM	-	118
Filter7 FPM	-	106
Filter8 FPM	-	106
Filter Ave FPM(corr)	-	118
CFM	2550	2596

Test Data Supply		
	Design	Actual
Total Area	16.04	16.04
Kv factor (Vel)	0.89	0.89
Num of Readings	-	14
Reading1 FPM	-	143
Reading2 FPM	-	105
Reading3 FPM	-	106
Reading4 FPM	-	157
Reading5 FPM	-	133
Reading6 FPM	-	97
Reading7 FPM	-	112
Reading8 FPM	-	66
Reading9 FPM	-	58
Reading10 FPM	-	100
Reading11 FPM	-	60
Reading12 FPM	-	64
Reading13 FPM	-	71
Reading14 FPM	-	75
Ave FPM(corr)	-	96
CFM	1300	1370
