MECHANICAL PLAN SCALE: 1/8"=1'-0" NORTH

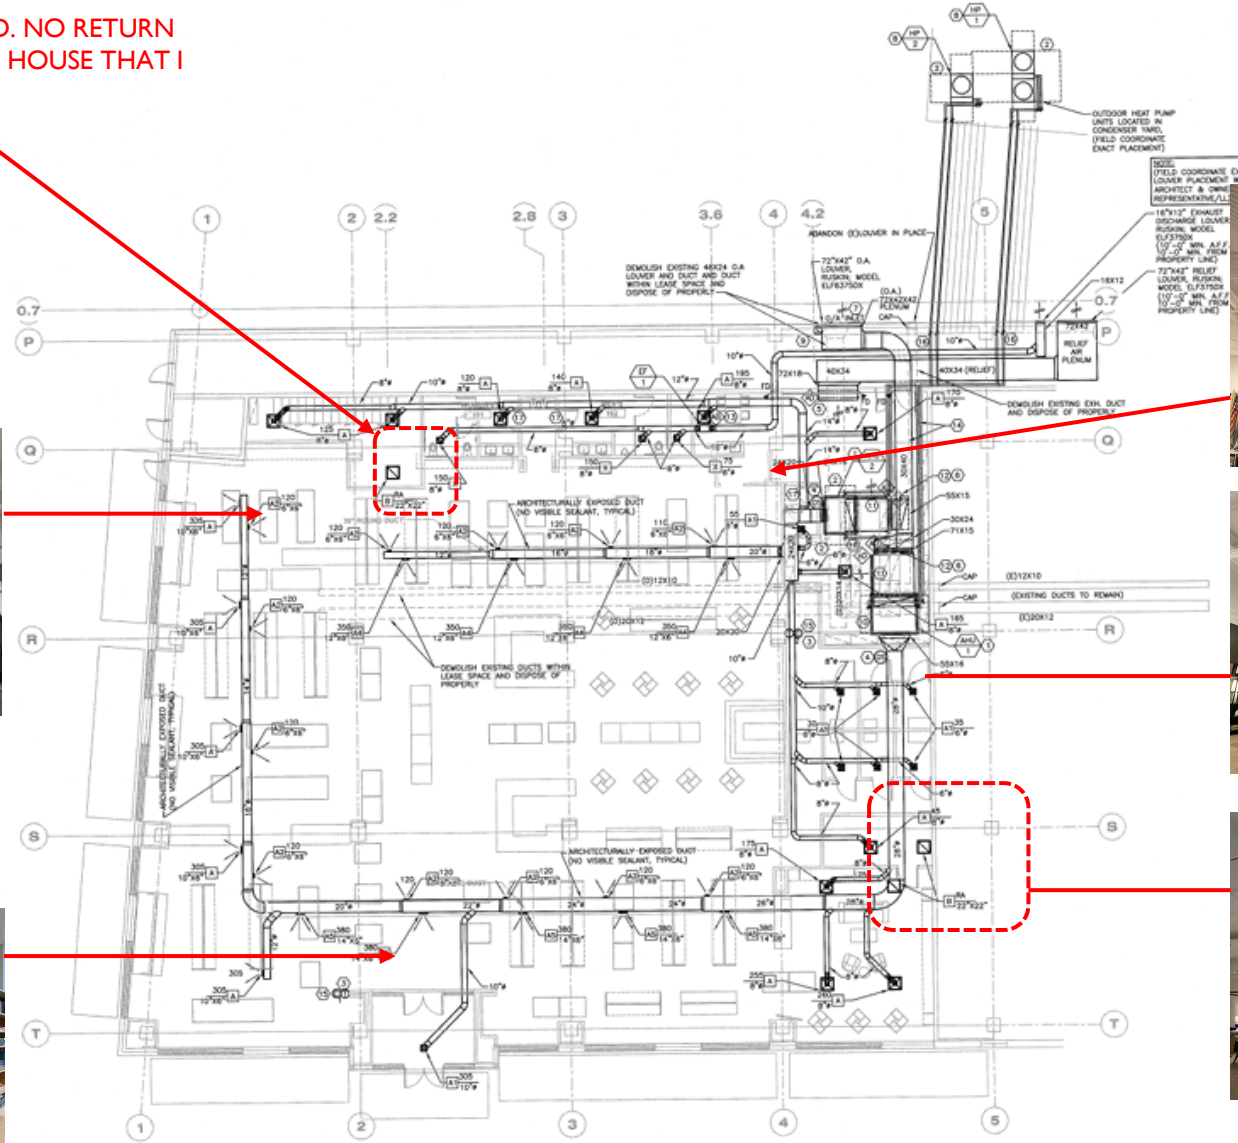
RETURN AIR REMOVED. NO RETURN AIR IN THE FRONT OF HOUSE THAT I COULD SEE

ONE THERMOSTAT POSITIVE AIR IN FRONT OF HOUSE,

DUCTLESS VENTS ABOVE BACK OF HOUSE DOOR. DOOR NEEDS TO REMAIN OPEN OTHERWISE SHOWROOM IS POSITIVE AND CREATES LOUD WISTLE AT FRONT DOOR. ALSO, NEGATIVE IN BACK OF HOUSE

VERY LOUD UNIT WITH STRONG AIR FLOW
