Report: Inspection Report
Function: Test, Adjust, & Balance
Date: 02/06/2026
Completed By: National TAB

PROJECT
02-02-26 CULVERS - CHARLOTTE, NC

Project: 02-02-26 CULVERS - CHARLOTTE, NC

Project Summary

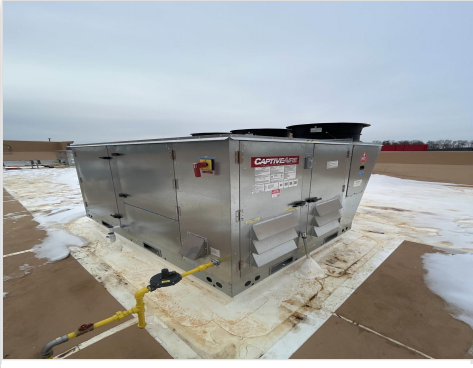
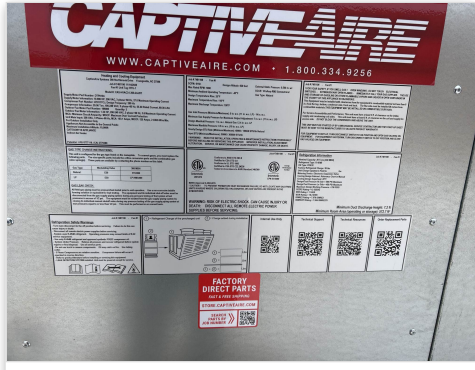
Unit Data - PHOTO LOG

Asset: RTU1

AREA:DINING

Test Data		
	Design	Actual
SF CFM	6150	6231
SF RPM	-	DD/ 55.4
RA CFM	4400	4416
OA CFM	1750	1815
RL Voltage	-	213/213/213
RL Amperage	-	23.4/23.3/23.1
SF Rotation	-	CCW
SF System SetPt	-	55.4
RA Damper Position	-	5.7
Min OA Damper Position	-	4.3
Min OA Damper Type	-	ECON
