**Report: Inspection Report**  
**Function: Test, Adjust, & Balance**  
**Date: 02/06/2026**  
**Completed By: National TAB**

**PROJECT**  
**02-02-26 CULVERS - CHARLOTTE, NC**

3416 W ARROWOOD RD  
CHARLOTTE, NC 28273

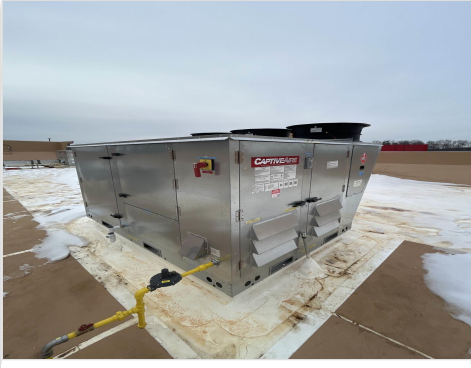
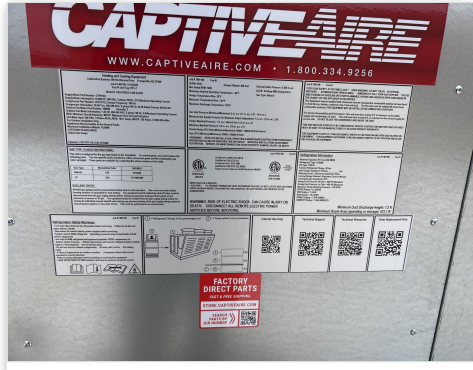
Asset: RTU1

Test Data		
	Design	Actual
SF CFM	6150	6231
SF RPM	-	DD/ 55.4
RA CFM	4400	4416
OA CFM	1750	1815
RL Voltage	-	213/213/213
RL Amperage	-	23.4/23.3/23.1
SF Rotation	-	CCW
SF System SetPt	-	55.4
RA Damper Position	-	5.7
Min OA Damper Position	-	4.3
Min OA Damper Type	-	ECON

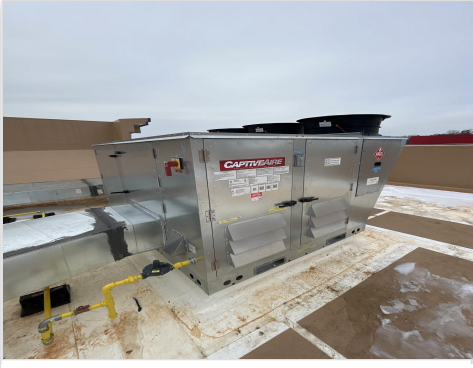
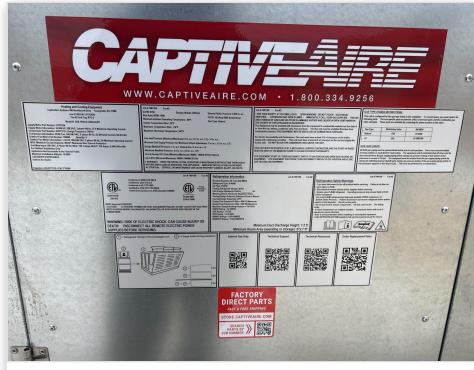
Asset: RTU2

Test Data		
	Design	Actual
SF CFM	6025	5638
SF RPM	-	DD/ 59.5HZ
RA CFM	4450	3897
OA CFM	1700	1741
RL Voltage	-	213/213/213
RL Amperage	-	24.7/25.1/25.0
SF Rotation	-	CCW
SF System SetPt	-	59.5HZ
RA Damper Position	-	5.8
Min OA Damper Position	-	4.2
Min OA Damper Type	-	ECON

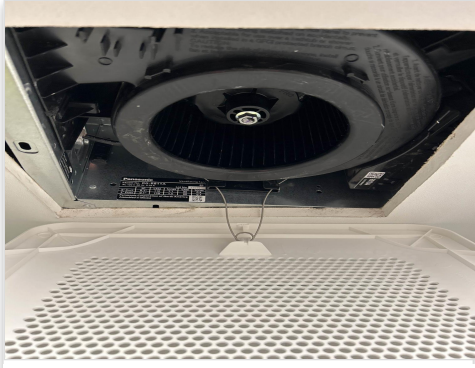
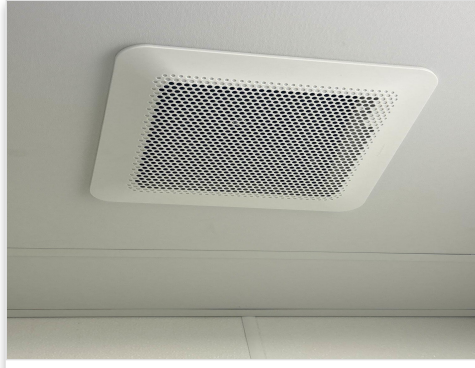
Asset: EF1

Test Data		
	Design	Actual
CFM	75	71
Fan RPM	881	DD
Fan Rotation	-	CCW
Motor RPM	-	DD
System SetPt	-	MAX
Total ESP	0.125"	0.10"
Fan Inlet SP	-	-0.10"
Fan Discharge SP	-	ATMO

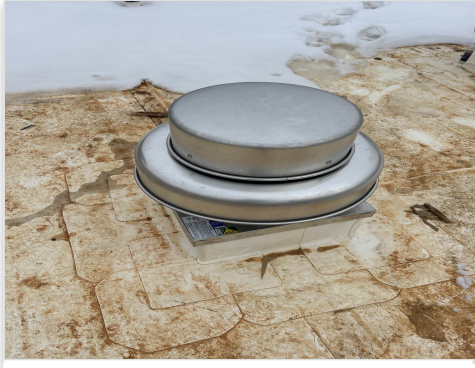
Asset: PRV1

Test Data		
	Design	Actual
<b>CFM</b>	375	375
<b>Fan RPM</b>	1466	DD
<b>Fan Rotation</b>	-	CCW
<b>Motor RPM</b>	-	DD
<b>System SetPt</b>	-	9.5 ON DAIL
<b>RL Voltage</b>	-	NA
<b>RL Amperage</b>	-	NA
<b>Total ESP</b>	0.5"	0.46"
<b>Fan Inlet SP</b>	-	-0.46"
<b>Fan Discharge SP</b>	-	ATMO

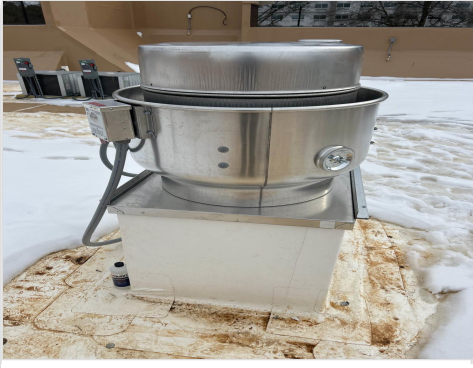
Asset: PRV2

Test Data		
	Design	Actual
<b>CFM</b>	1500	1530
<b>Fan RPM</b>	1725	DD/ 6.6 VDC
<b>Fan Rotation</b>	-	CCW
<b>Motor RPM</b>	-	DD/ 6.6 VDC
<b>System SetPt</b>	-	6.6 VDC
<b>RL Voltage</b>	-	NA
<b>RL Amperage</b>	-	NA
<b>Total ESP</b>	1.801"	0.46"
<b>Fan Inlet SP</b>	-	-0.46"
<b>Fan Discharge SP</b>	-	ATMO

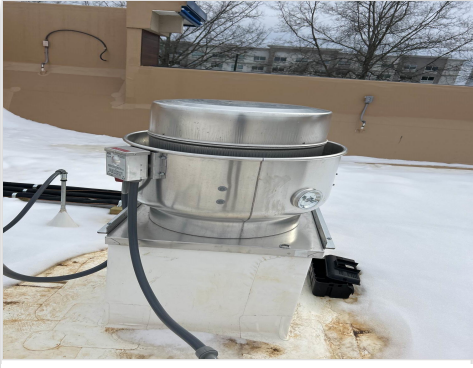
Asset: PRV3

Test Data		
	Design	Actual
<b>CFM</b>	1500	1606
<b>Fan RPM</b>	1365	DD/ 6.5 VDC
<b>Fan Rotation</b>	-	CCW
<b>Motor RPM</b>	-	DD/ 6.5 VDC
<b>System SetPt</b>	-	6.5 VDC
<b>RL Voltage</b>	-	NA
<b>RL Amperage</b>	-	NA
<b>Total ESP</b>	1"	0.47"
<b>Fan Inlet SP</b>	-	-0.47"
<b>Fan Discharge SP</b>	-	ATMO

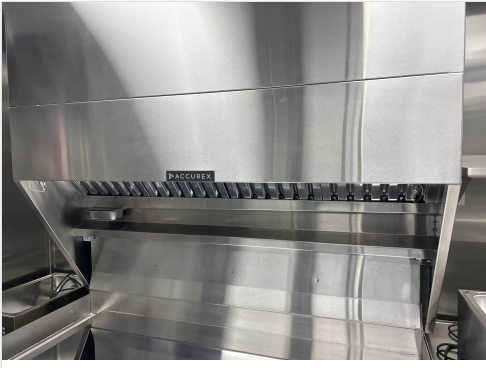
Asset: HD1

Test Data Exhaust		
	Design	Actual
Filter Type	XTRACTOR	XTRACTOR
Filter Size 1	16X16	16X16
Filter Qty 1	4	4
Filter AK factor size 1	1.53	1.53
Filter Total AK Area	6.12	6.12
Filter1 FPM	-	257
Filter2 FPM	-	239
Filter3 FPM	-	239
Filter4 FPM	-	267
Filter Ave FPM(corr)	-	250
CFM	1500	1530

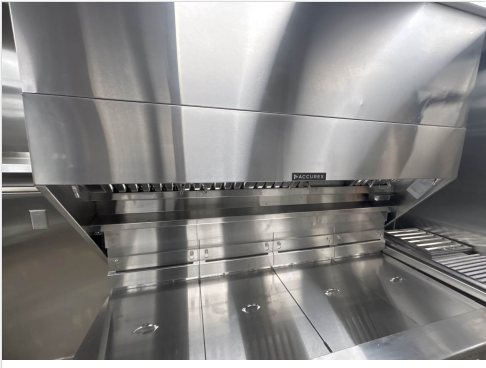
Asset: HD2

Test Data Exhaust		
	Design	Actual
Filter Type	XTRACTOR	XTRACTOR
Filter Size 1	16X16	16X16
Filter Qty 1	5	5
Filter AK factor size 1	1.53	1.53
Filter Total AK Area	7.65	7.65
Filter1 FPM	-	228
Filter2 FPM	-	192
Filter3 FPM	-	211
Filter4 FPM	-	206
Filter5 FPM	-	217
Filter Ave FPM(corr)	-	210
CFM	1500	1606
