Report: Inspection Report
Function: Test, Adjust, & Balance
Date: 02/06/2026
Completed By: National TAB

PROJECT
02-02-26 CULVERS - CHARLOTTE, NC

Project: 02-02-26 CULVERS - CHARLOTTE, NC

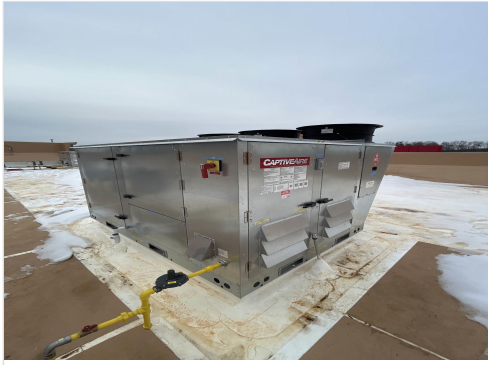
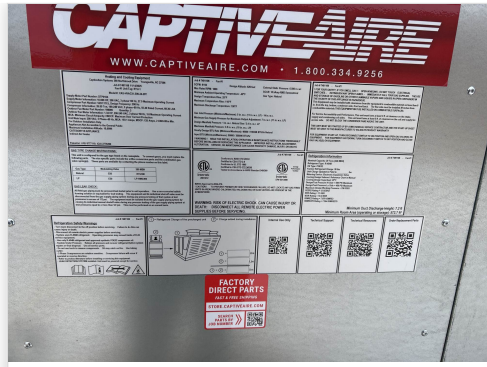
Asset: RTU1

Unit Data		
	Design	Actual
MFG	CAPTIVEAIRE/LENNOX	CAPTIVEAIRE/LENNOX
Serial Num	-	7481106
Model Num	UNKNOWN	CAS-HVAC3-I.300-24-2OT
Type	RTU	RTU
Configuration	VERTICAL	VERTICAL
Num OA Filters 1	-	1
OA Filter Size 1	-	31.5X45X5
Num Final Filter 1	-	4
Final Filter Size 1	-	20X25X2

Notes:
See issue/notes about abnormal balance reading.

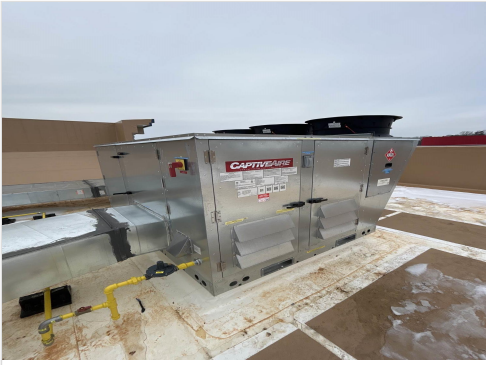
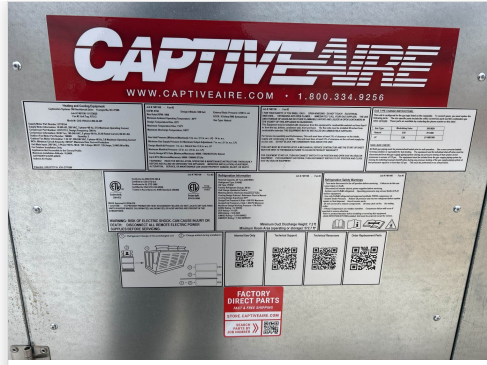
Asset: RTU2

Unit Data		
	Design	Actual
MFG	CAPTIVEAIRE/LENNOX	CAPTIVEAIRE/LENNOX
Serial Num	-	7481106
Model Num	UNKNOWN	CAS-HVAC3-I.300-24-20T
Type	RTU	RTU
Configuration	VERTICAL	VERTICAL
Num OA Filters 1	-	1
OA Filter Size 1	-	31.5X45.5
Num Final Filter 1	-	4
Final Filter Size 1	-	20X25X2

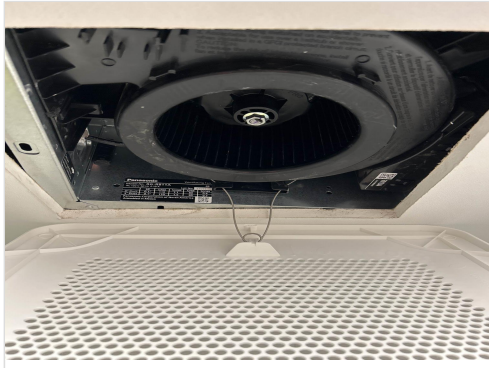
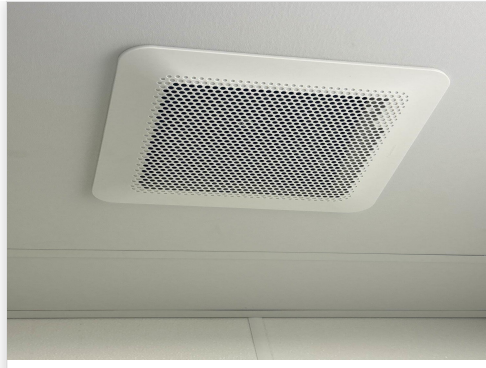
Asset: EF1

Unit Data		
	Design	Actual
MFG	ACCUREX	ACCUREX
Model Num	XCR-B80	XCR-B80
Type	CEILING	CEILING
Configuration	VERTICAL	VERTICAL

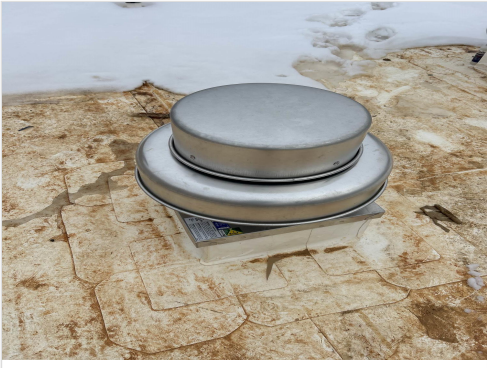
Asset: PRV1

Unit Data		
	Design	Actual
MFG	ACCUREX	ACCUREX
Model Num	XRED-090-VG	XRED-090-VG
Type	DOWNBLAST	DOWNBLAST
Configuration	VERTICAL	VERTICAL

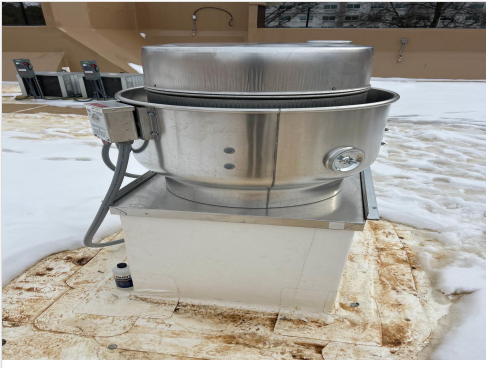
Asset: PRV2

Unit Data		
	Design	Actual
MFG	ACCUREX	ACCUREX
Model Num	XCUE-140-VG	XCUE-140-VG
Serial Num	-	28353912
Type	UPBLAST	UPBLAST
Configuration	VERTICAL	VERTICAL

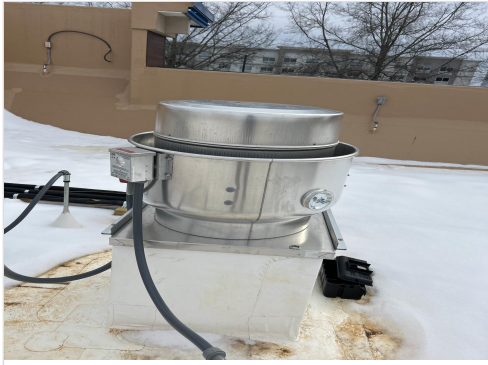
Asset: PRV3

Unit Data		
	Design	Actual
MFG	ACCUREX	ACCUREX
Model Num	XCUE-140-VG	XCUE-140-VG
Serial Num	-	28021051
Type	UPBLAST	UPBLAST
Configuration	VERTICAL	VERTICAL
