**Report: TAB Report**  
**Function: Test, Adjust, & Balance**  
**Date: 10/23/2025**  
**Completed By: National TAB**

**PROJECT**  
**10-06-25 QT #1121 EASLEY, SC**

QUIKTRIP  
4705 SOUTH 129TH EAST AVENUE  
TULSA, OK 74134

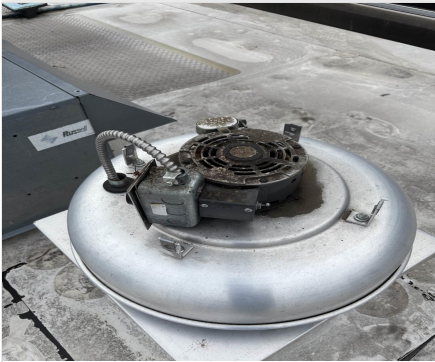
**Issue Name :** EF-1 not working  
**Description :** When attempting to turn on the fan the motor began to smoke.  
**Created By :** National TAB                      **Assigned To :** National TAB - Brianna Biggs  
**Status :** Open  
**Priority :** High                                      **Asset Tag :** EF1  
**Originated Date :** 10/08/2025 - Christian Moller - National TAB

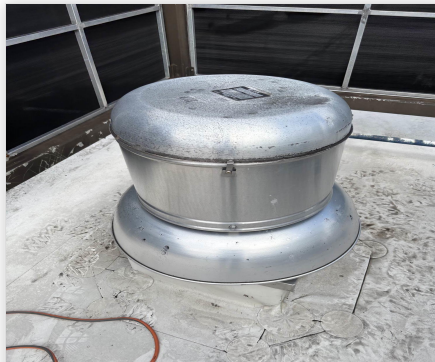
**Issue Name :** EF-2 no speed controller  
**Description :** EF-2 does not have a speed controller, airflow is less than design. Left low.  
**Created By :** National TAB                      **Assigned To :** National TAB - Brianna Biggs  
**Status :** Open  
**Priority :** High                                      **Asset Tag :** EF2  
**Originated Date :** 10/08/2025 - Christian Moller - National TAB

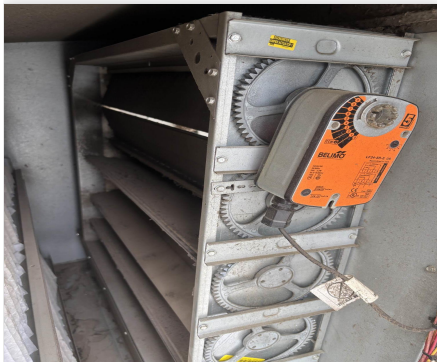
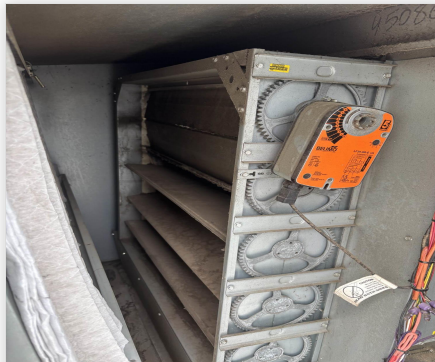
**Issue Name :** RTU 2 & 3 economizers don't work  
**Description :** RTU 2&3 economizers do not work. When using the dial on the economizer itself as well as the Emerson board the flaps do not open.  
**Created By :** National TAB                      **Assigned To :** National TAB - Brianna Biggs  
**Status :** Open  
**Priority :** High                                      **Asset Tag :**  
**Originated Date :** 10/08/2025 - Christian Moller - National TAB

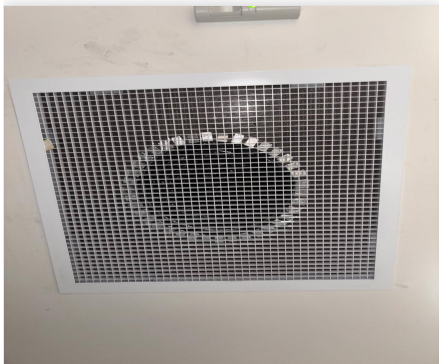
**Issue Name :** RTU-3 wrong diffusers  
**Description :** The new diffusers for RTU-3 are not the correct ones. The correct ones are Titus 300F's with deflection blades. Unit was still balanced to design.  
**Created By :** National TAB                      **Assigned To :** National TAB - Brianna Biggs  
**Status :** Open  
**Priority :** Medium                                      **Asset Tag :** RT-3  
**Originated Date :** 10/08/2025 - Christian Moller - National TAB

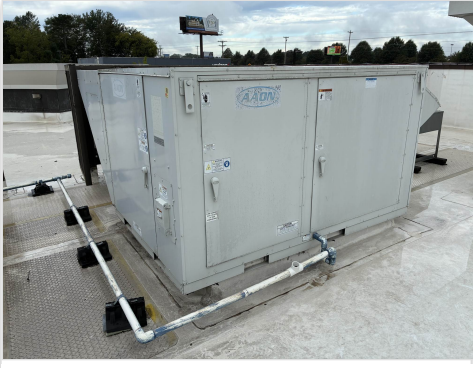
Asset: RT-2

Notes:  
ECONOMIZER does not work.

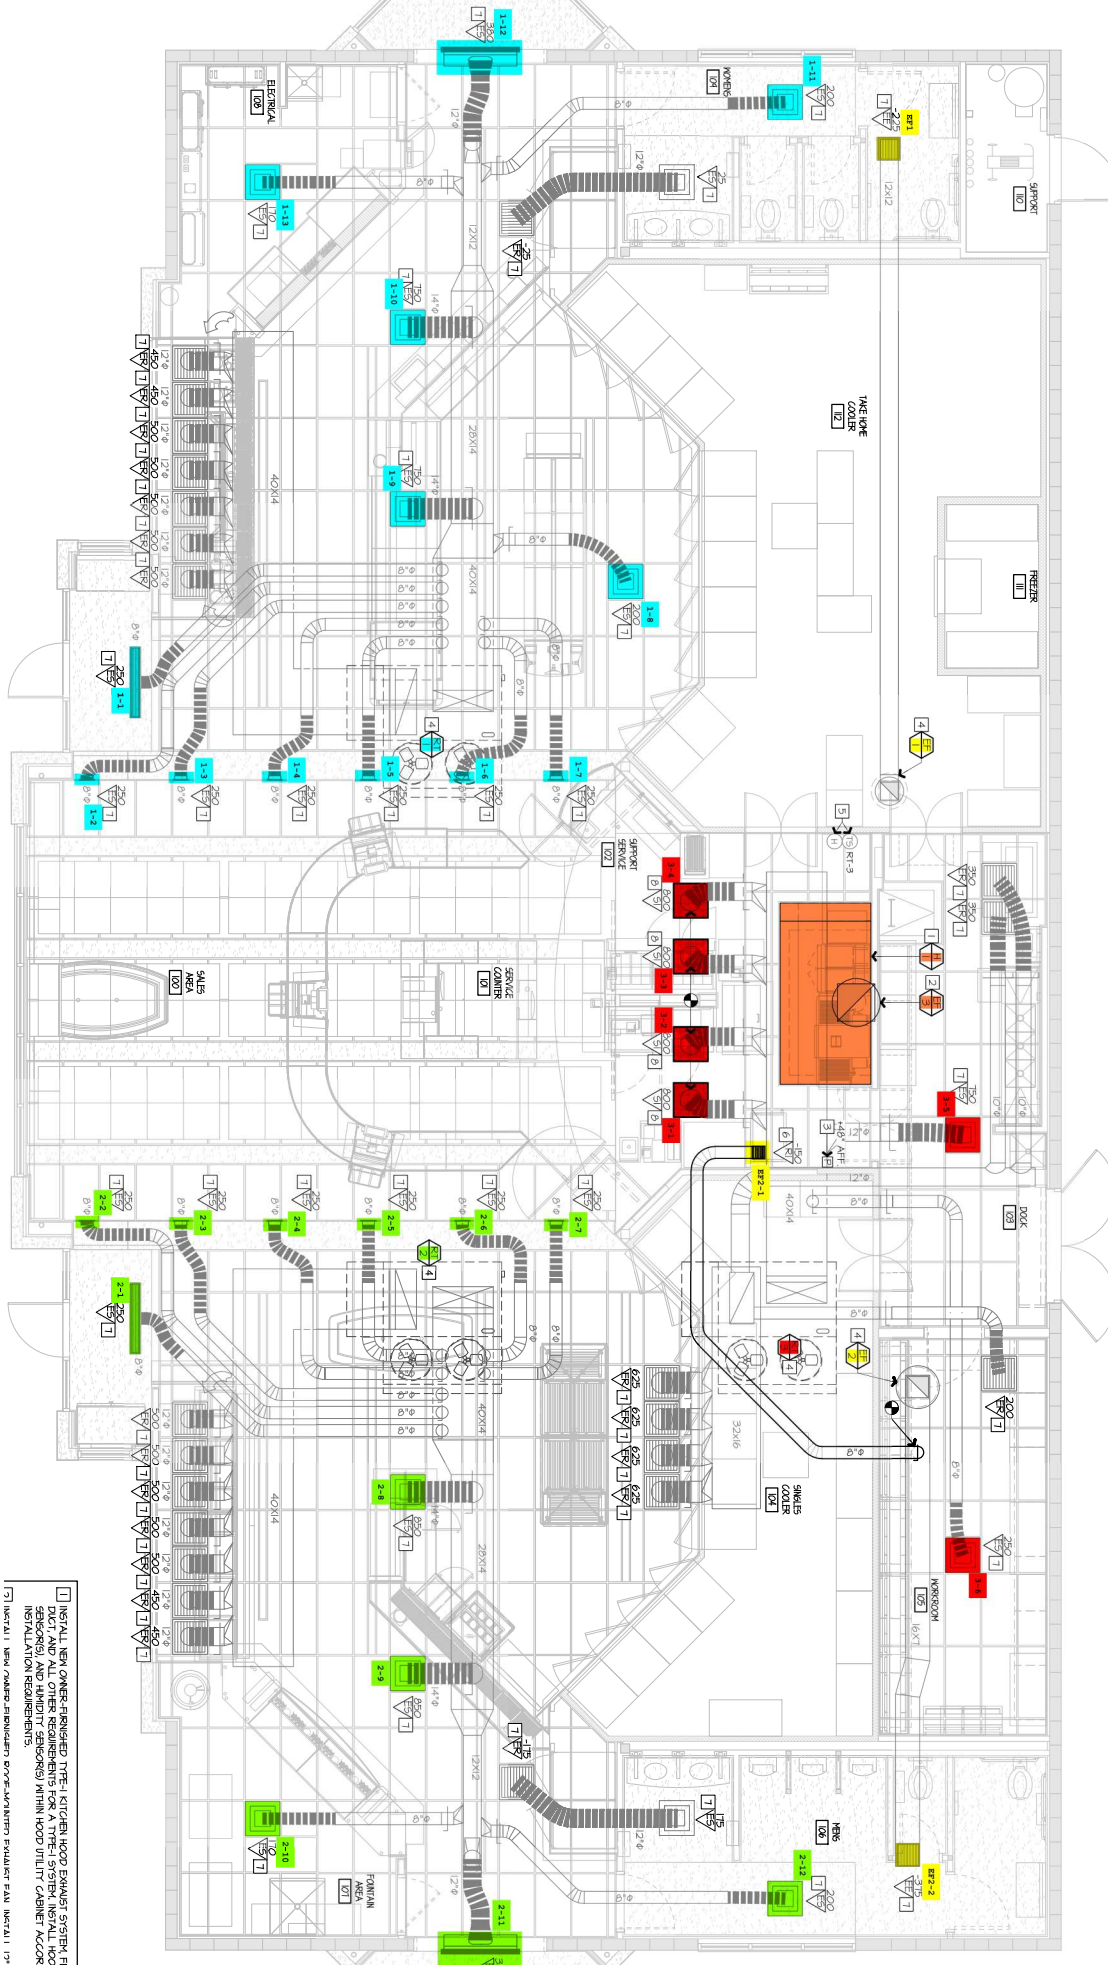
- 1 INSTALL NEW OWNER-FINISHED TYPE-I KITCHEN HOOD EXHAUST SYSTEM FIRE SUPPRESSIBLE DUCT, AND ALL OTHER REQUIREMENTS FOR A TYPE-I SYSTEM. INSTALL HOOD CONTROL PANEL (SENSORS) AND HUMIDITY (SENSORS) WITHIN HOOD UTILITY CABINET ACCORDING TO MANUFACTURER'S INSTALLATION REQUIREMENTS.
- 2 INSTALL NEW OWNER-FINISHED OWNER-MOUNTED EXHAUST FAN IN ACCORDANCE WITH THE FOLLOWING:
