**Report: TAB Report**  
**Function: Test, Adjust, & Balance**  
**Date: 10/23/2025**  
**Completed By: National TAB**

**PROJECT**  
**10-06-25 QT #1121 EASLEY, SC**

QUIKTRIP  
4705 SOUTH 129TH EAST AVENUE  
TULSA, OK 74134

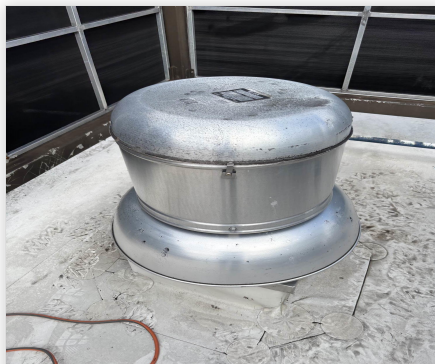
**Issue Name :** EF-2 no speed controller  
**Description :** EF-2 does not have a speed controller, airflow is less than design. Left low.  
**Created By :** National TAB                      **Assigned To :** National TAB - Brianna Biggs  
**Status :** Open  
**Priority :** High                                      **Asset Tag :** EF2  
**Originated Date :** 10/08/2025 - Christian Moller - National TAB
