Report: TAB Report
Function: Test, Adjust, & Balance
Date: 10/23/2025
Completed By: National TAB

PROJECT
10-06-25 QT #1121 EASLEY, SC

Project: 10-06-25 QT #1121 EASLEY, SC

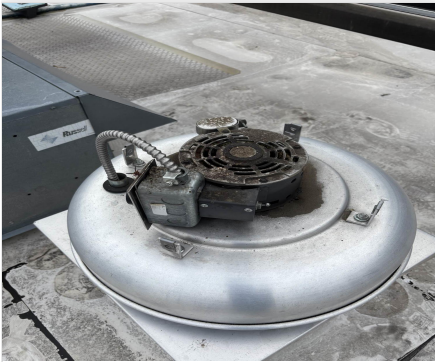
Issue Name : EF-1 Not Operational
Description : Fan off at disconnect. When briefly turned on, motor was seized. Left off, needs service or replacement.
Created By : National TAB **Assigned To :** National TAB - Brianna Biggs
Status : Open
Priority : High **Asset Tag :** EF1
Originated Date : 10/08/2025 - Christian Moller - National TAB

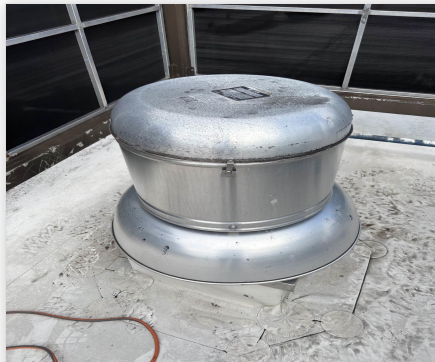
Issue Name : EF-2 No Speed Controller
Description : Fan does not have speed controller, unable to adjust airflow. Below design, unable to push air to combi-oven grille. Fan appeared wired to medium, wiring should be able to be adjusted to high.
Created By : National TAB **Assigned To :** National TAB - Brianna Biggs
Status : Open
Priority : High **Asset Tag :** EF2
Originated Date : 10/08/2025 - Christian Moller - National TAB

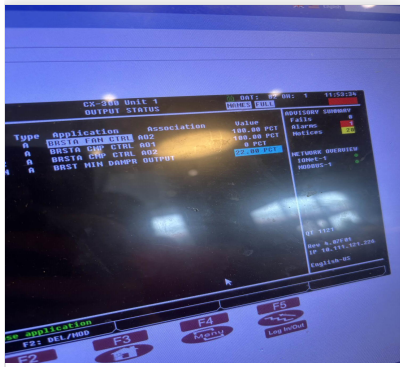
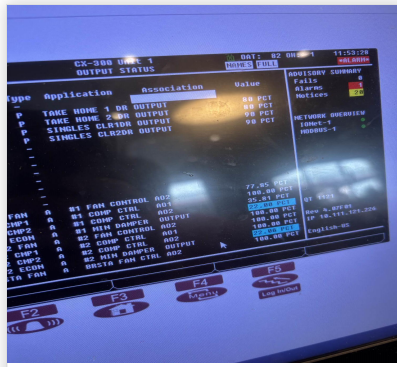
RTU's/AHU's

Evaporator coils are clean?

Pass

Condenser coils are clean?

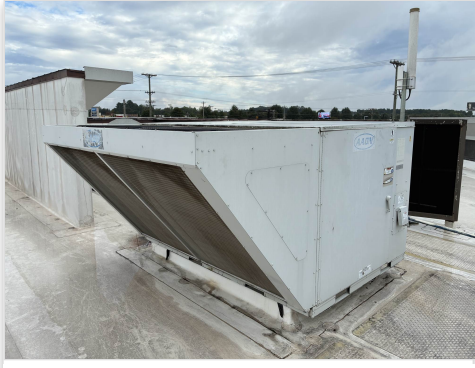
Asset: RT-1

Unit Data		
	Design	Actual
MFG	NA	AAON
Serial Num	-	201206-ANEK06806
Model Num	NA	RN -013-8-0-EAOA-152
Type	-	RTU
Configuration	-	VERTICAL
Num OA Filters 1	-	1
OA Filter Size 1	-	45x25

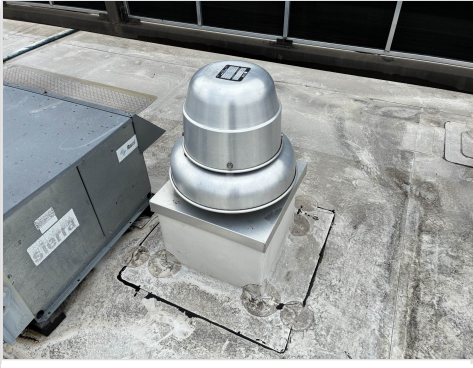
Asset: EF1

Unit Data		
	Design	Actual
MFG	NA	COOK
Model Num	NA	90 ACEH 90C15DH
Serial Num	-	418SE15927- 00/0000701
Type	-	UPBLAST
Configuration	-	VERTICAL

[1] FAN NOT OPERATIONAL, SEE ISSUE.

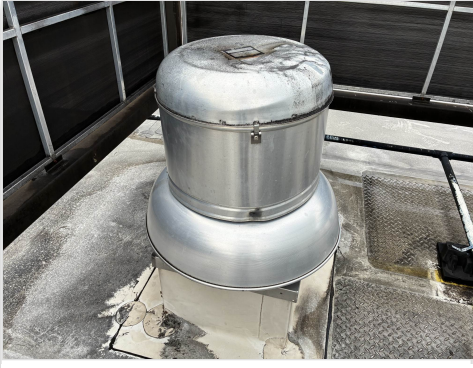
Asset: EF2

Unit Data		
	Design	Actual
MFG	NA	COOK
Model Num	NA	120 ACE 120C13D
Serial Num	-	418SDE15927- 00/0001901
Type	-	UPBLAST
Configuration	-	VERTICAL

[1] UNABLE TO INCREASE AIRFLOW; NO SPEED CONTROL. COMBI-OVEN GRILLE BELOW DESIGN AS RESULT.

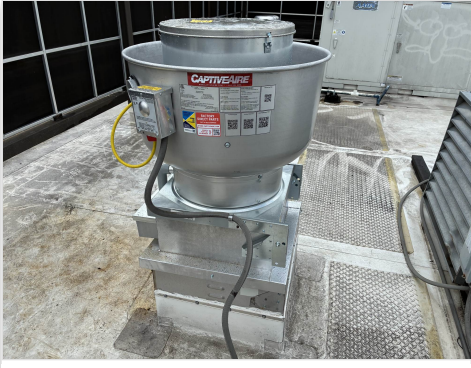
Asset: EF3

Unit Data		
	Design	Actual
MFG	NA	CAPTIVEAIRE
Model Num	NA	DU50HFA
Serial Num	-	7657309
Type	UPBLAST	UPBLAST
Configuration	VERTICAL	VERTICAL

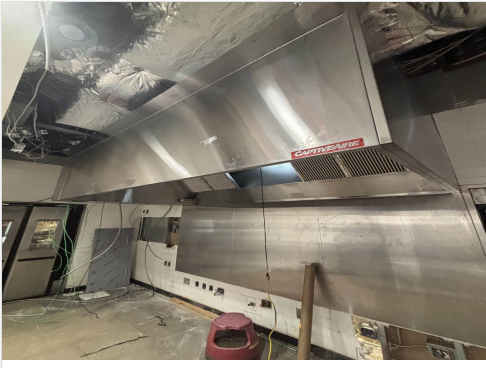
Asset: HD1

Unit Data		
	Design	Actual
MFG	CAPTIVEAIRE	CAPTIVEAIRE
Model Num	6030ND-2-F	6030ND-2
Job / Serial Num	-	7657309
Type	-	TYPE I CANOPY
Hood length	-	122"
Hood Width	-	60"
