Report: TAB Report
Function: Test, Adjust, & Balance
Date: 10/23/2025
Completed By: National TAB

PROJECT
10-06-25 QT #1121 EASLEY, SC

QUIKTRIP
4705 SOUTH 129TH EAST AVENUE
TULSA, OK 74134

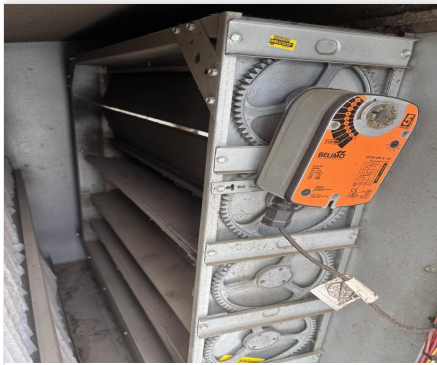
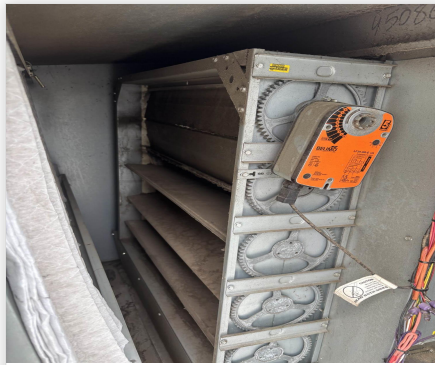
Issue Name : RTU 2 & 3 economizers don't work
Description : RTU 2&3 economizers do not work. When using the dial on the economizer itself as well as the Emerson board the flaps do not open.
Created By : National TAB **Assigned To :** National TAB - Brianna Biggs
Status : Open
Priority : High **Asset Tag :**
Originated Date : 10/08/2025 - Christian Moller - National TAB

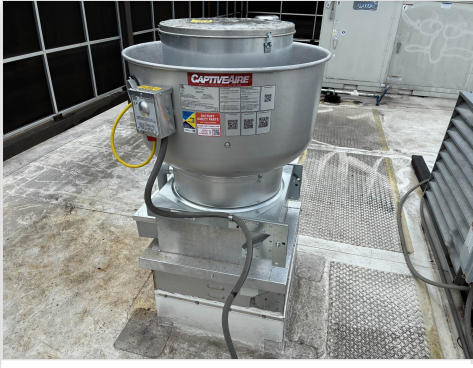
Unit Data - PHOTO LOG

Test Data		
	Design	Actual
CFM	1350	1410
Fan RPM	-	DD
Fan Rotation	-	CCW
Motor RPM	-	DD
System SetPt	-	HMI/55.0Hz
RL Voltage	-	208
RL Amperage	-	2.5
Total ESP	-	NR
Fan Inlet SP	-	NR
Fan Discharge SP	-	ATM

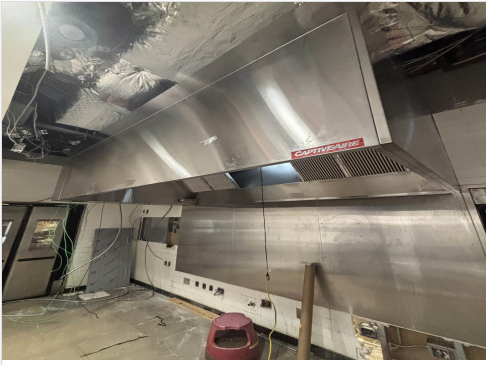
Unit Data - PHOTO LOG

Test Data Exhaust		
	Design	Actual
Filter Type	-	BAFFLE FILTER
Filter Size 1	-	16X20
Filter Qty 1	-	6
Filter AK factor size 1	-	2.08
Filter Total AK Area	-	12.48
Filter1 FPM	-	102
Filter2 FPM	-	115
Filter3 FPM	-	117
Filter4 FPM	-	116
Filter5 FPM	-	109
Filter6 FPM	-	122
Filter Ave FPM(corr)	-	113
CFM	1350	1410
