**Report: TAB Report**  
**Function: Test, Adjust, & Balance**  
**Date: 10/23/2025**  
**Completed By: National TAB**

**PROJECT**  
**10-06-25 QT #1121 EASLEY, SC**

4855 CALHOUN MEMORIAL HWY

QUIKTRIP  
4705 SOUTH 129TH EAST AVENUE  
TULSA, OK 74134

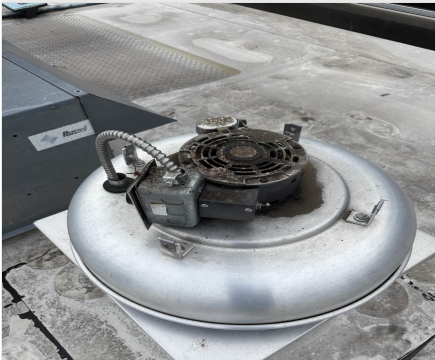
**Issue Name :** EF-1 not working  
**Description :** When attempting to turn on the fan the motor began to smoke.  
**Created By :** National TAB                      **Assigned To :** National TAB - Brianna Biggs  
**Status :** Open  
**Priority :** High                                      **Asset Tag :** EF1  
**Originated Date :** 10/08/2025 - Christian Moller - National TAB
