Nike

2000 E Rio Salado Pkwy, Ste 1253
Tempe, AZ 85281

Submission of
Certified Test, Adjust and Balance Report
February 16, 2024

PROJECT: Nike E Rio Salado Pkwy
LOCATION: Tempe, AZ
PROJECT #: 24033

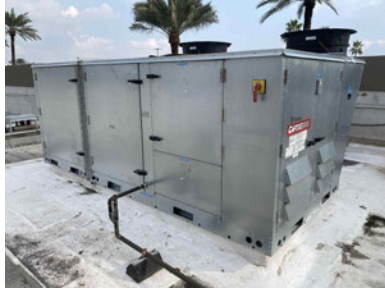
SYSTEM/UNIT: DOAS-01

Design Airflow (CFM)		Final Airflow (CFM)	
Design Total	3200	Actual Total CFM	3260
Design Grille Total	3200	Actual Grille Total CFM	Not Applicable
Design Return	0	Actual Return Air CFM	0
Design Min O/A	3200	Actual Min O/A CFM	3260
		Fan CFM Test Method	Face Velocity / Velgrid
		OA Method/Instrument	Face Velocity / Velgrid
		OA Ak (sq ft)	-
		OA Damper Position	100% Open
		RA Damper Position	Closed
Unit Design Data		Unit Data	
Submittal Make	Not Provided	Make (tag)	CaptiveAire
Submittal Model #	-	Model # (tag)	CASRTU3-20-15T
Submittal Airflow	Not Provided	Serial # (tag)	5575689
Sched./Sub. Volts	208	Location	Roof
Sched./Sub. Phase	3	Unit Discharge	Downblast
Sched./Sub. HP	Not Listed	Cooling Coil Location	Unit / Drawthru
Submittal BHP	Not Provided	Coil Area (sq ft)	12.3
Filter MERV Rating (Sched/Sub)	13	Clg Coil Vel (FPM)	265
		Fan Service	Supply
		Fan Type	Centrifugal (BI)
		Fan Discharge	Downblast
		Fan Arrangement	SWSI

Design Static Pressures (in wg)		Fan Design Data	
Design Ext SP	1.5	Submittal Motor RPM	Not Provided
Submittal Total SP	Not Provided	Submittal Fan RPM	-
Submittal Clg Coil Δ SP	-		
Filter Data		Fan Data	
Condition	Partially Loaded	Actual Fan RPM/Speed	100%
Filter Type	Pleated	Actual Motor RPM	Not Accessible
MERV Rating	8		
Filter Size Set 1 (in)	20x25x2	Electrical Data

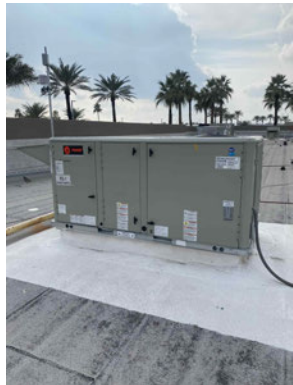
SYSTEM/UNIT: RTU-01

Design Airflow (CFM)		Final Airflow (CFM)	
Design Total	1750	Actual Total CFM	1830
Design Grille Total	1750	Actual Grille Total CFM	1830
Design Return	1610	Actual Return Air CFM	1693
Design Min O/A	140	Actual Min O/A CFM	137
Unit Design Data		Fan CFM Test Method	
Submittal Make	Not Provided	OA Method/Instrument	Supply Outlet Total
Submittal Model #	-	OA Ak (sq ft)	Face Velocity/RVA
Submittal Airflow	Not Provided	OA Damper Position	25% Open
Sched./Sub. Volts	208	RA Damper Position	75% Open
Sched./Sub. Phase	3	Unit Data	
Sched./Sub. HP	Not Listed	Make (tag)	Trane
Submittal BHP	Not Provided	Model # (tag)	WSC060H3R0A29
Filter MERV Rating (Sched/Sub)	13	Serial # (tag)	22461459L
Design Static Pressures (in wg)		Location	Roof
Design Ext SP	.5	Unit Discharge	Downblast
Submittal Total SP	Not Provided	Cooling Coil Location	Unit / Drawthru
Submittal Clg Coil Δ SP	-	Coil Area (sq ft)	11.1
Filter Data		Clg Coil Vel (FPM)	165

Condition	Partially Loaded	Fan Service	Supply
Filter Type	Pleated	Fan Type	Centrifugal (FC)
MERV Rating	8	Fan Discharge	Downblast
Filter Size Set 1 (in)	16/25/2	Fan Arrangement	DWDI

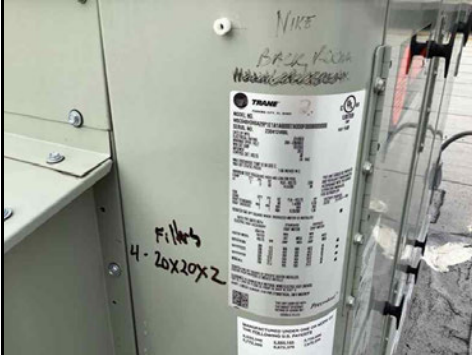
Make (tag) Photo:

Log: RTU-02 Unit was measured at 125% of design on low speed. No further action recommended.

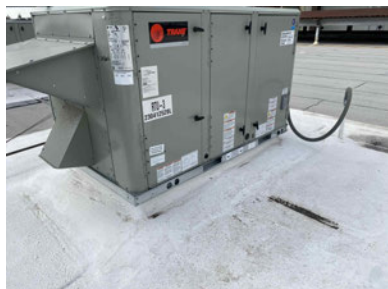
SYSTEM/UNIT: RTU-03

Design Airflow (CFM)		Final Airflow (CFM)	
Design Total	1400	Actual Total CFM	1744
Design Grille Total	1400	Actual Grille Total CFM	1744
Design Return	1400	Actual Return Air CFM	1744
Design Min O/A	0	Actual Min O/A CFM	0

Unit Design Data		Unit Data	
Submittal Make	Not Provided	Make (tag)	Trane
Submittal Model #	-	Model # (tag)	WSC048H3R8A28P8E1A1A6
Submittal Airflow	Not Provided	Model # (tag)	0007A000
Sched./Sub. Volts	208	Serial # (tag)	230412528L
Sched./Sub. Phase	3	Location	Roof
Sched./Sub. HP	Not Listed	Unit Discharge	Downblast
Submittal BHP	Not Provided	Cooling Coil Location	Unit / Drawthru
Filter MERV Rating (Sched/Sub)	13	Coil Area (sq ft)	8.4
		Clg Coil Vel (FPM)	208
		Fan Service	Supply
		Fan Type	Centrifugal (FC)
		Fan Discharge	Downblast
		Fan Arrangement	SWSI

Log: RTU-03 Unit was measured at 125% of design on low speed. No further action recommended.

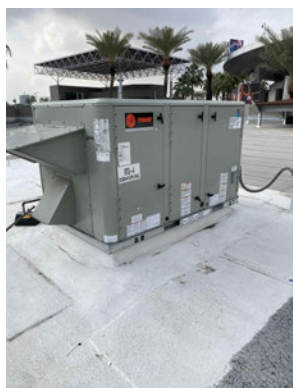
SYSTEM/UNIT: RTU-04

Design Airflow (CFM)		Final Airflow (CFM)	
Design Total	1400	Actual Total CFM	1492
Design Grille Total	1400	Actual Grille Total CFM	Not Applicable
Design Return	1400	Actual Return Air CFM	1492
Design Min O/A	0	Actual Min O/A CFM	0
Unit Design Data		Unit Data	
Submittal Make	Not Provided	Make (tag)	Trane
Submittal Model #	-	Model # (tag)	wsc048h3roa29poe1a1a60007a000f
Submittal Airflow	Not Provided	Serial # (tag)	230412516I
Sched./Sub. Volts	208	Location	Roof
Sched./Sub. Phase	3	Unit Discharge	Downblast
Sched./Sub. HP	Not Listed	Cooling Coil Location	Unit / Drawthru
Submittal BHP	Not Provided	Coil Area (sq ft)	8.4
Filter MERV Rating (Sched/Sub)	13	Clg Coil Vel (FPM)	178
Design Static Pressures (in wg)		Fan Design Data	
Design Ext SP	.5	Submittal Motor RPM	Not Provided
Submittal Total SP	Not Provided	Submittal Fan RPM	-
Submittal Clg Coil Δ SP	-	Fan Data	
Filter Data		Electrical Data	
Condition	Partially Loaded	Measurement Method	V/A Meter

Filter Type	Pleated	Motor Volts 1	214
MERV Rating	8	Motor Volts 2	216
Filter Size Set 1 (in)	20/20/2		
# Filters Set 1	4		
Filter Size Set 2 (in)	-		
# Filters Set 2	-		
Motor Nameplate Data			
Motor Make	No Access - Embedded Motor		
Motor Frame	Not Listed		
Motor HP	1.00		
Motor RPM	Not Listed		
Motor Volts	208		
Motor Phase	3

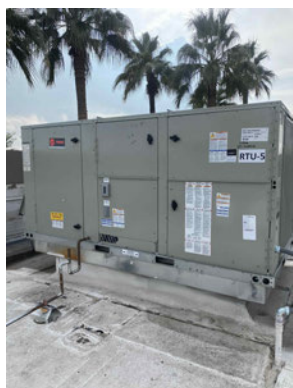
SYSTEM/UNIT: RTU-05

Design Airflow (CFM)		Final Airflow (CFM)	
Design Total	4850	Actual Total CFM	4847
Design Grille Total	4850	Actual Grille Total CFM	4847
Design Return	4850	Actual Return Air CFM	4847
Design Min O/A	0	Actual Min O/A CFM	0

Unit Design Data		Unit Data	
Submittal Make	Not Provided	Make (tag)	Trane
Submittal Model #	-	Model # (tag)	WSJ110A3S0002H0C0A10004
Submittal Airflow	Not Provided	Serial # (tag)	0000000
Sched./Sub. Volts	208	Location	231911087D
Sched./Sub. Phase	3	Unit Discharge	Roof
Sched./Sub. HP	Not Listed	Cooling Coil Location	Downblast
Submittal BHP	Not Provided	Coil Area (sq ft)	Unit / Drawthru
Filter MERV Rating (Sched/Sub)	13	Coil Area (sq ft)	25.1
		Clg Coil Vel (FPM)	193
		Fan Service	Supply
		Fan Type	Centrifugal (FC)
		Fan Discharge	Downblast
		Fan Arrangement	SWSI

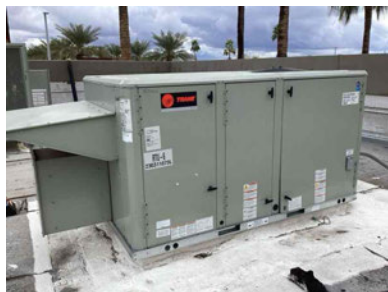
SYSTEM/UNIT: RTU-06

Design Airflow (CFM)		Final Airflow (CFM)	
Design Total	3850	Actual Total CFM	3844
Design Grille Total	3850	Actual Grille Total CFM	Not Applicable
Design Return	3850	Actual Return Air CFM	3844
Design Min O/A	0	Actual Min O/A CFM	0
Unit Design Data		Unit Data	
Submittal Make	Not Provided	Make (tag)	Trane
Submittal Model #	-	Model # (tag)	WSC120H3R0B29
Submittal Airflow	Not Provided	Serial # (tag)	230311073L
Sched./Sub. Volts	208	Location	Roof
Sched./Sub. Phase	3	Unit Discharge	Downblast
Sched./Sub. HP	Not Listed	Cooling Coil Location	Unit / Drawthru
Submittal BHP	Not Provided	Coil Area (sq ft)	12.1
Filter MERV Rating (Sched/Sub)	13	Clg Coil Vel (FPM)	318
Design Static Pressures (in wg)		Fan Design Data	
Design Ext SP	.6	Submittal Motor RPM	Not Provided
Submittal Total SP	Not Provided	Submittal Fan RPM	-
Submittal Clg Coil Δ SP	-	Fan Data	
Filter Data		Electrical Data	
Condition	Partially Loaded	Measurement Method	V/A Meter

Filter Type	Pleated	Motor Volts 1	218
MERV Rating	8	Motor Volts 2	216
Filter Size Set 1 (in)	25/20/2	Motor Nameplate Data	
# Filters Set 1	4	Motor Make	No Access - Embedded Motor
Filter Size Set 2 (in)	-	Motor Frame	-

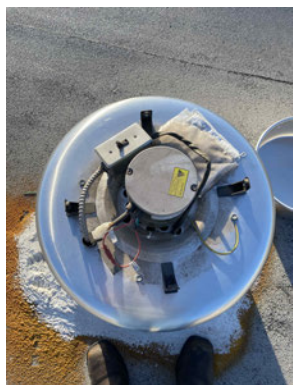
SYSTEM/UNIT: EF-01

Design Airflow (CFM)		Final Airflow (CFM)	
Design Airflow	325	Actual Airflow	220
Design Grille Airflow	325	Actual Grille Airflow	220
Unit Design Data		Unit Data	
Submittal Make	Not Provided	Make (tag)	Greenheck
Submittal Model #	Not Provided	Model # (tag)	G-080-VG-1-17-X
Submittal Airflow	Not Provided	Serial # (tag)	21818572
Sched./Sub. Volts	120	Unit Location	Roof
Sched./Sub. Phase	1	Unit Discharge	Downblast
Sched./Sub. HP	1/10	Fan Service	Exhaust
Submittal BHP	Not Provided	Fan Type	Centrifugal (BI)
Design Static Pressures (in wg)		Fan Design Data	
Design External SP	.5	Submittal Motor RPM	Not Provided
Submittal Total SP	Not Provided	Submittal Fan RPM	Not Provided
Motor Nameplate Data		Fan Data	
Motor Make (tag)	BroadOcean	Actual Fan RPM/Speed	Single Speed
Motor Frame (tag)	Not Listed	Actual Motor RPM	Not Accessible
Motor HP (tag)	1/10	Speed Cont. Position	10
Motor RPM (tag)	1800	Electrical Data	
Motor Volts (tag)	115	Measurement Method	Not Accessible

Motor Phase (tag)	1	Motor Volts 1	-
Motor Amps (tag)	1.38	Motor Volts 2	-
Motor S.F. (tag)	Not Listed	Motor Volts 3	-
Mtr % PF (tag)	-	Motor Amps 1	-
Mtr % Eff. (tag)	-	Motor Amps 2	-
Other Motor Data	-	Motor Amps 3	-
Drive Data		Operating HZ	60.0
Drive Type	Direct Drive	Starter Data	Not Applicable
Sheave Type	-	Approx. BHP	-
Fan Sheave Make	-	Corr. Nameplate Amps	-
Fan Shv Mod# or Size (in)	-		
Fan Sheave Bore (in.)	-		
Motor Sheave Make	-		
Mtr Shv Mod# or Size (in)	-

Log: EF-01 Fan is operating at 68% of design on high speed. Recommend sealing bottom of fan to chase better.

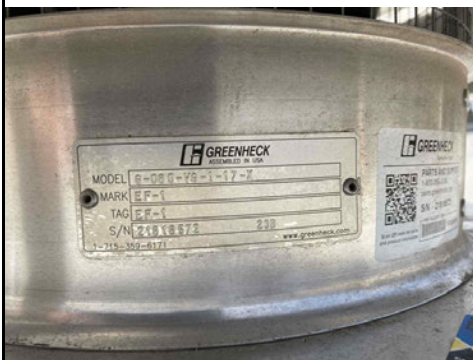
Make (tag) Photo:

Name: EF-01 Tag.jpg
 Captured: 2/16/2024 2:54 PM
 Caption:

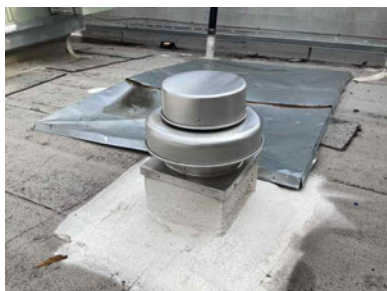
SYSTEM/UNIT: EF-03

Design Airflow (CFM)		Final Airflow (CFM)	
Design Airflow	640	Actual Airflow	509
Design Grille Airflow	640	Actual Grille Airflow	509
Unit Design Data		Unit Data	
Submittal Make	Not Provided	Make (tag)	Greenheck
Submittal Model #	Not Provided	Model # (tag)	G-095-VG-1-17-X
Submittal Airflow	Not Provided	Serial # (tag)	21818573
Sched./Sub. Volts	120	Unit Location	Roof
Sched./Sub. Phase	1	Unit Discharge	Downblast
Sched./Sub. HP	.17	Fan Service	Exhaust
Submittal BHP	Not Provided	Fan Type	Centrifugal (BI)
Design Static Pressures (in wg)		Fan Design Data	
Design External SP	.5	Submittal Motor RPM	Not Provided
Submittal Total SP	Not Provided	Submittal Fan RPM	Not Provided
Motor Nameplate Data		Fan Data	
Motor Make (tag)	BroadOcean	Actual Fan RPM/Speed	Single Speed
Motor Frame (tag)	Not Listed	Actual Motor RPM	Not Accessible
Motor HP (tag)	1/6	Speed Cont. Position	10
Motor RPM (tag)	1750	Electrical Data	
Motor Volts (tag)	115	Measurement Method	Not Accessible

Motor Phase (tag)	1	Motor Volts 1	-
Motor Amps (tag)	2.2	Motor Volts 2	-
Motor S.F. (tag)	Not Listed	Motor Volts 3	-
Mtr % PF (tag)	-	Motor Amps 1	-
Mtr % Eff. (tag)	-	Motor Amps 2	-
Other Motor Data	-	Motor Amps 3	-
Drive Data		Operating HZ	60.0
Drive Type	Direct Drive	Starter Data	Not Applicable
Sheave Type	-	Approx. BHP	-
Fan Sheave Make	-	Corr. Nameplate Amps	-
Fan Shv Mod# or Size (in)	-		
Fan Sheave Bore (in.)	-		
Motor Sheave Make	-		
Mtr Shv Mod# or Size (in)	-

Log: EF-03 Fan is operating at 80% of design on high speed. Recommend sealing bottom of fan to chase better.
