Report: FINAL TAB REPORT
Function: Test, Adjust, & Balance
Date: 10/24/2022

**10-10 CHIPOTLE #02-4407 PAYSON II, AZ
(PAYSON)**

108 S Beeline Hwy

PAYSON, AZ 85541

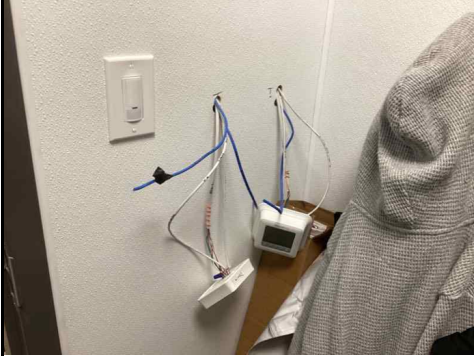
Name:	Thermostats have power? - Yes - T -stats not mounte.jpg				
Captured:	10/13/2022 1:14 PM

Issue ID:	0001	Status:	Open	Issue Priority:	
Equipment:	Project Checklist			Created Date: 13-Oct-22	
Issue Description:					
T-stats not mounted to wall. Grid point system not yet installed.					
Issue Type:	Installation				
Role Assignment:	Mechanical Contractor				
Comments / Signature:					
Issue Photos:

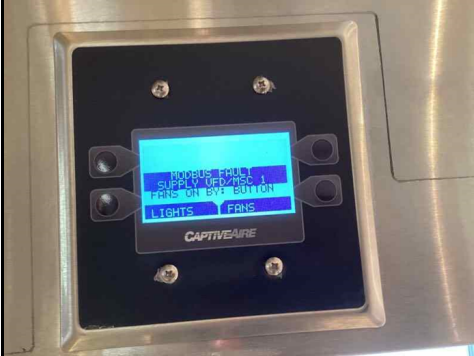
Name:	Hood is free of alarms? - No - Hood showing alarm .jpg				
Captured:	10/13/2022 5:26 PM

Issue ID:	0002	Status:	Open	Issue Priority:	
Equipment:	Project Checklist			Created Date: 13-Oct-22	
Issue Description:					
Hood showing alarm for supply fan VFD. Configuration screen in hood is also not monitoring amps from supply fan. All fans continue to run when turned off on HDMI.					
Issue Type:	Installation				
Role Assignment:	Mechanical Contractor				
Comments / Signature:					
Issue Photos:

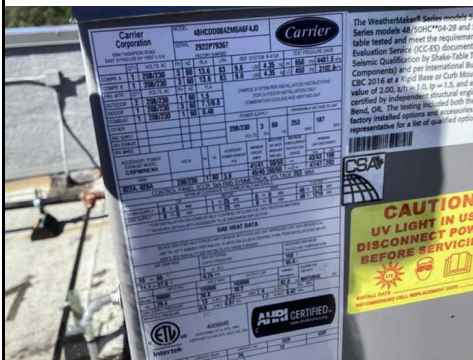
Name: Make (tag).jpg
Captured: 10/13/2022 12:51 PM
Caption:

Unit Data	
Make (tag)	Carrier
Model # (tag)	48HCDD08A2M5A6F4J0
Serial # (tag)	2922P79367
Location	Roof
Unit Discharge	Downblast
Cooling Coil Location	Unit / Drawthru
Coil Area (sq ft)	11.1
Clg Coil Vel (FPM)	276
Fan Service	Supply
Fan Type	Centrifugal (FC)
Fan Discharge	Downblast
Fan Arrangement	DWDI

SYSTEM/UNIT: RTU-01

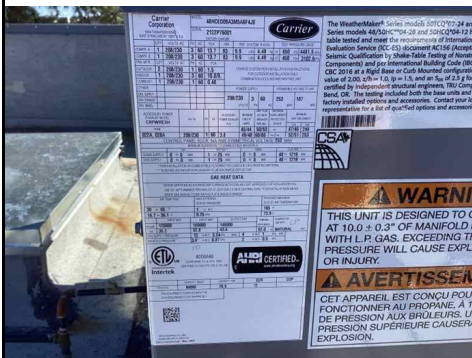
Name: Make (tag).jpg
Captured: 10/13/2022 12:32 PM
Caption:

Unit Data	
Make (tag)	Carrier
Model # (tag)	48HCED09A3M5A6F4J0
Serial # (tag)	2122P76001
Location	Roof
Unit Discharge	Downblast
Cooling Coil Location	Unit / Drawthru
Coil Area (sq ft)	11.1
Clg Coil Vel (FPM)	290
Fan Service	Supply
Fan Type	Centrifugal (FC)
Fan Discharge	Downblast
Fan Arrangement	DWDI

SYSTEM/UNIT: RTU-02

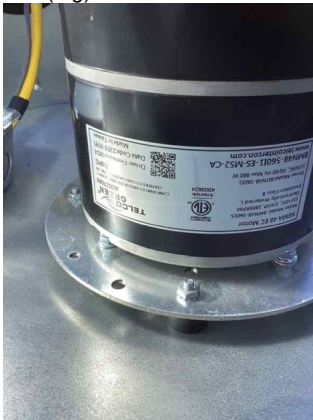
Name: Motor Make (tag).jpg
Captured: 10/13/2022 12:49 PM
Caption:

SYSTEM/UNIT: EF-01

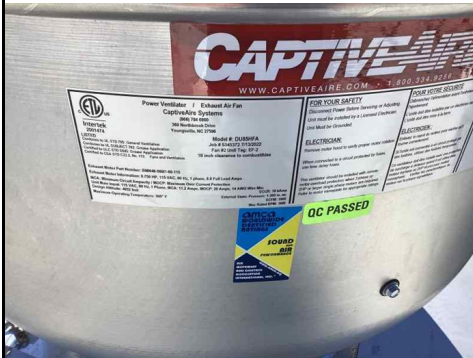
Name: Make (tag).jpg
Captured: 10/13/2022 12:49 PM
Caption:

Unit Data	
Make (tag)	CaptiveAire
Model # (tag)	DU85HFA
Serial # (tag)	5345372
Unit Location	Roof
Unit Discharge	Upblast
Fan Service	Exhaust
Fan Type	Centrifugal (BI)
Fan Discharge	Upblast
Fan Arrangement	SWSI

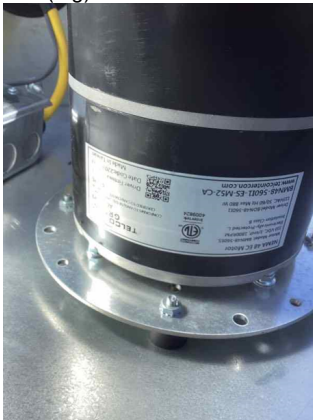
Name: Motor Make (tag).jpg
Captured: 10/13/2022 12:47 PM
Caption:

SYSTEM/UNIT: EF-02

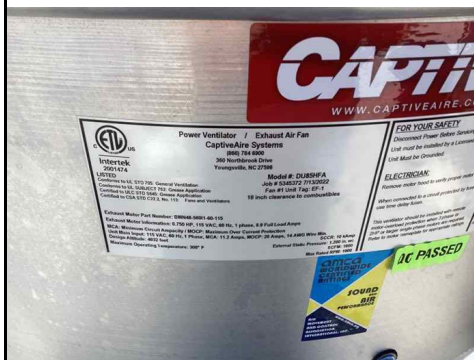
Name: Make (tag).jpg
Captured: 10/13/2022 12:47 PM
Caption:

Unit Data	
Make (tag)	CaptiveAire
Model # (tag)	DU85HFA
Serial # (tag)	5345372
Unit Location	Roof
Unit Discharge	Upblast
Fan Service	Exhaust
Fan Type	Centrifugal (BI)
Fan Discharge	Upblast
Fan Arrangement	SWSI

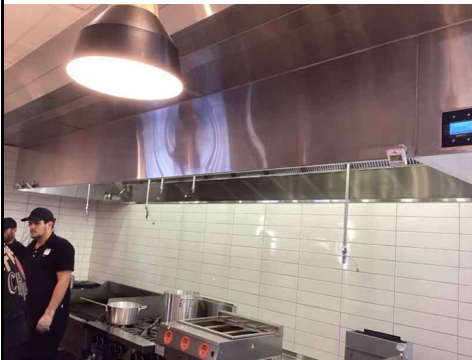
Name: Service.jpg
Captured: 10/13/2022 1:23 PM
Caption:

Verification - EF-02/HD-01
