Report: TAB REPORT
Function: Test, Adjust, & Balance
Date: 02/24/2023

**02-20-23 CHICK-FIL-A #05047 -
SEVIERVILLE, TN (HWY 66 FSU) NEW
STORE**

Project: 02-20-23 CHICK-FIL-A #05047 - SEVIERVILLE, TN (HWY 66 FSU) NEW STORE

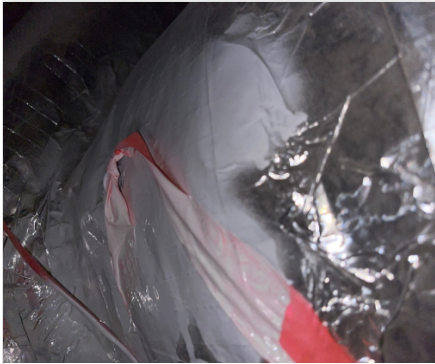
SGRD10.jpeg

Issue Name : CRITICAL - AC1 / DAMPER LOCATION

Description : AC1- SGRD10 DAMPER IS LOCATED AT THE 12 O'CLOCK POSITION PLANS CALL FOR SUPPLY DAMPERS TO BE LOCATED AT THE 9 O'CLOCK OR 3 O'CLOCK POSTION & AC1 EGRD8 RETURN DAMPER IS LOCATED AT THE 3 O'CLOCK POSITION PLANS CALL FOR DAMPER TO BE AT THE 6 O'CLOCK POSITION. RECOMMEND THESE DAMPERS BE RELOCATED TO THE CORRECT POSITION. PAGE: M-401 DETAIL: 2

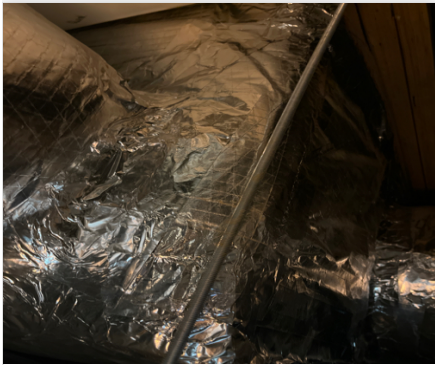
AC1.jpeg

Issue Name : CRITICAL - AC1 / RETURN DUCT TYPE

Description : AC1 RETURN DUCT DOES NOT SPAN OUT TO 96" IN WIDTH LIKE CALLED FOR IN PRINTS. RETURN DUCT WIDTH IS ONLY 80". UNIT TOTAL IS WITHIN DESIGN. THREE SUPPLY GRILLS ARE LOW OF DESIGN CFM. UNIT PULLEY IS MINIMIZED AND UNIT IS RUNNING NEAR FLA. PAGE: M-201 DETAIL: 1

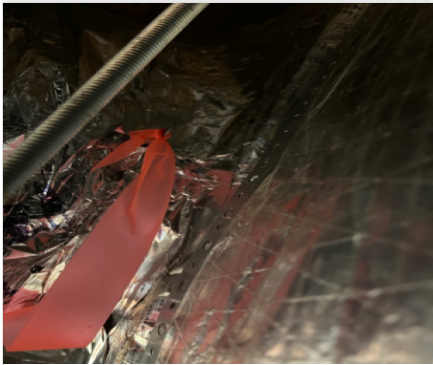
DAMPER.jpeg

Issue Name : CRITICAL - AC1, AC2, AC3 / DAMPER TYPES

Description : AC1 - SGRD1,2,4,10,11,13 & EGRD5,6,9 DO NOT HAVE RUSKIN TYPE DAMPER HANDLES INSTALLED. AC2- EGRD2 & EGRD3 DO NOT HAVE RUSKIN TYPE DAMPER HANDLES INSTALLED. AC3- SGRD4 & SGRD5 DO NOT HAVE RUSKIN TYPE DAMPER HANDLES INSTALLED. RECOMMEND THE CORRECT TYPE DAMPER HANDLE TO BE INSTALLED.

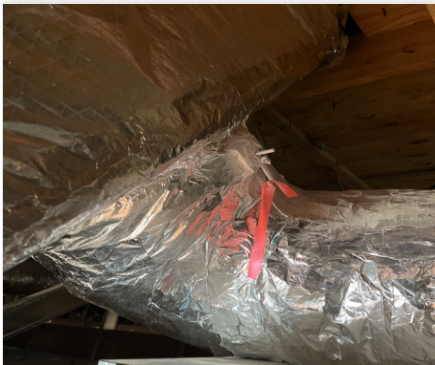
DAMPERLOCATION.jpeg

Issue Name : CRITICAL - AC3 / RETURN DAMPER LOCATIONS

Description : AC3 - EGRD2 & EGRD3 DAMPERS ARE LOCATED AT THE 3 O'CLOCK POSITION SHOULD BE LOCATED AT THE 6 O'CLOCK POSITION. RECOMMEND DAMPER LOCATION BE MOVED TO THE CORRECT POSTION. PAGE: M-401 DETAIL: 2

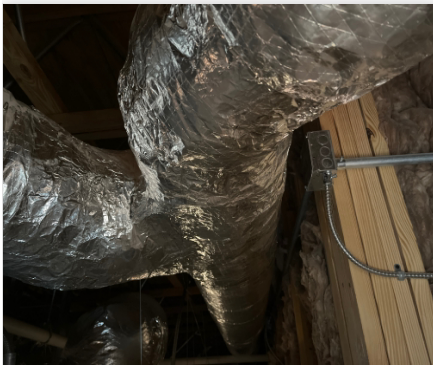
AC3.jpeg

Issue Name : CRITICAL - AC3 / SGRD14 DAMPER

Description : AC3 SGRD14 DAMPER IS NOT INSTALLED UNABLE TO BALANCE GRILL TO DESIGN CFM. RECOMMEND DAMPER BE INSTALLED. PAGE: M-201 DETAIL: 1

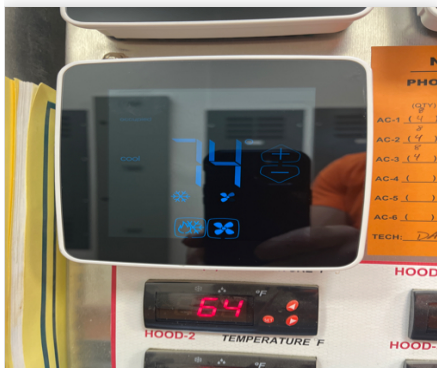
AC3.jpeg

Issue Name : CRITICAL - AC3 / TEMP. SENSOR COMMUNICATION

Description : AC3 TEMP. SENSOR IS NOT COMMUNICATING WITH THERMOSTAT. RECOMMEND THIS ISSUE BE FIXED ASAP. PAGE: M-501 DETAIL: 2

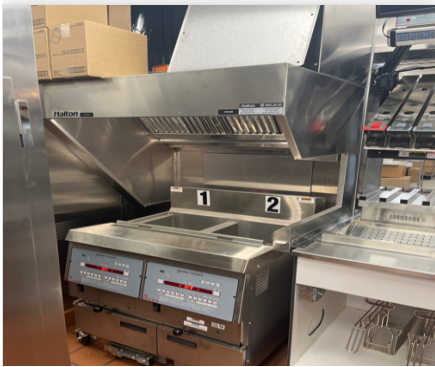
File.jpeg

Issue Name : CRITICAL - EF2 / UNOCCUPIED MODE

Description : EF2 DOES NOT TURN OFF WHEN STORE IS PLACED IN UNOCCUPIED MODE.

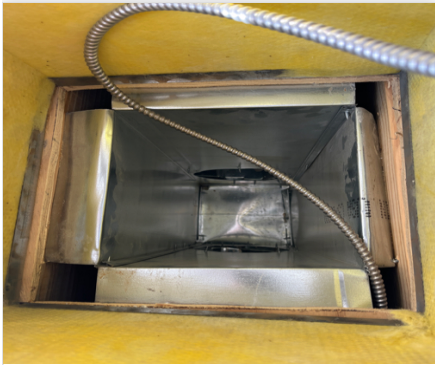
EF3DUCTWORK.jpeg

Issue Name : CRITICAL - EF3

Description : EF3 DUCTWORK IS NOT FLUSH WITH CURB. ABLE TO SEE INTO CEILING SPACE. DUCTWORK IS NOT LINED. BACK DRAFT DAMPER IS NOT INSTALLED. FAN IS NOT SECURED TO CURB. RECOMMEND ALL THESE ISSUES BE FIXED. PAGE: M-401
DETAIL: 4

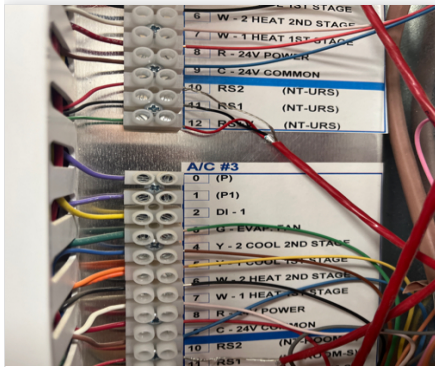
TERMINALS.jpeg

Issue Name : REVIEW + RECTIFY - AC1, AC2, AC3 / TERMINALS NOT WIRED

Description : AC1, AC2, AC3 TERMINALS P, P1, D1 ARE NOT WIRED. D1 WIRE NEEDS TO BE LANDED ON THE ESTOP TERMINAL IN EACH UNIT & TERMINAL WIRES FOR P & P1 NEED TO BE LANDED TO THE POTENTIOMETER MODULES IN EACH UNIT. RECOMMEND THESE TERMINALS BE WIRED AND LANDED TO THE CORRECT LOCATIONS ON EACH UNIT. PAGE: M-501
DETAIL: 2

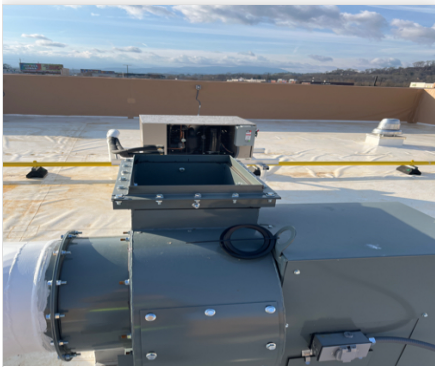
LEF2NOZZLES.jpeg

Issue Name : REVIEW + RECTIFY - EF1 & EF2 / NOZZLES

Description : EF1 & EF2 NOZZELS ARE NOT INSTALLED. RECOMMEND THESE BE INSTALLED ASAP. PAGE: M-401 DETAIL: 3

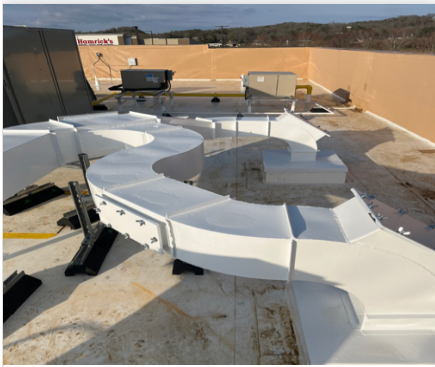
EF1DUCT.jpeg

Issue Name : REVIEW + RECTIFY - EF1 DUCT DESIGN

Description : EF1 GREASE DUCT INSTALLED IS A DIFFERENT DESIGN THEN CALLED FOR IN PRINTS. RECOMMEND THE CORRECT DESIGN BE INSTALLED. PAGE: M-250 DETAIL: 1

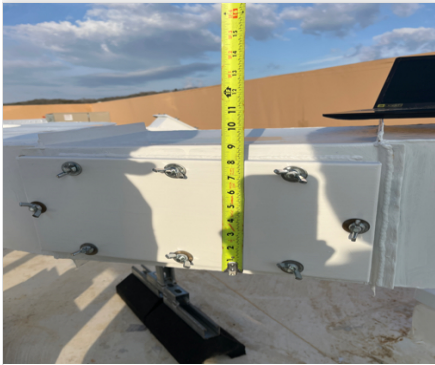
EF1CLEANOUTDOOR.jpeg

Issue Name : REVIEW + RECTIFY - EF1 GREASE CLEANOUT DOOR SIZE

Description : EF1 ONE GREASE CLEANOUT DOOR INSTALLED IS A DIFFERENT SIZE THEN CALLED FOR IN PRINTS. RECOMMEND THE CORRECT SIZE CLEANOUT DOOR BE INSTALLED. PLANS CALL FOR GREASE CLEAN OUT DOOR TO BE 10"X16". DOOR IS 8"X16" PAGE: M-250 DETAIL: 1

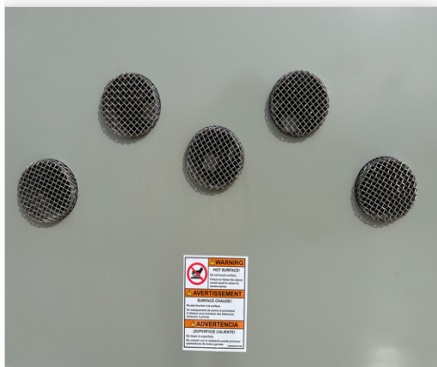
BAFFLES.jpeg

Issue Name : NON-CRITICAL - AC1 & AC3 / HEAT EXCHANGER BAFFLES

Description : AC1 & AC3 HEAT EXCHANGER BAFFLES NEED TO BE PULLED OUT TO THE MESH GUARD.

-Units are level? (Use a bubble level)	YES / AC1, AC2, AC3
-OA filters are installed?	YES / AC1, AC2, AC3
-Are the heat exchanger baffles located at the very end of the discharge (against screen)	NO / AC1 ALL BAFFLES NEED TO BE PULLED OUT & AC3 ONE OF THE BAFFLES NEED TO BE PULLED OUT YES / AC2
-All doors and panels are free from damage?	YES / AC1, AC2, AC3
-Any other physical damage to note?	NO PHYSICAL DAMAGE TO NOTE AT THIS TIME
-Clean filters installed inside the units?	YES / AC1, AC2, AC3
Additional comments:	N/A

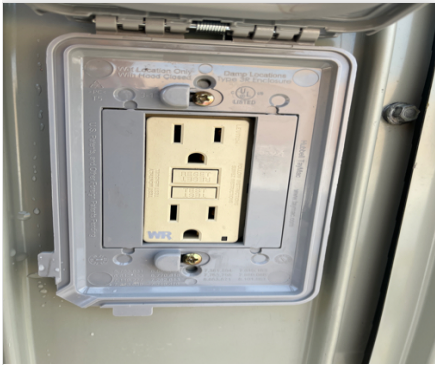
GFI.jpeg

Issue Name : NON-CRITICAL - AC1 / GFI NOT ENERGIZED

Description : AC1 GFI OUTLET IS NOT ENERGIZED. RECOMMEND THIS OUTLET BE POWERED. PAGE: M-401 NOTE: 11

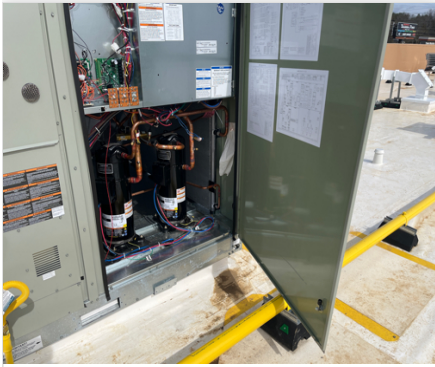
AC1.jpeg

Issue Name : NON-CRITICAL - AC1 / UNIT ACCESS DOOR OBSTRUCTION
Description : AC1 ELECTRICAL PANEL AND FILTER ACCESS DOOR ARE OBSTRUCTED BY GAS PIPE PAGE: P-250 NOTE: 1
Created By : National TAB **Assigned To :** National TAB - Dale Wheeler
Status : Open
Originated Date : 02/21/2023 - Dale Wheeler - National TAB

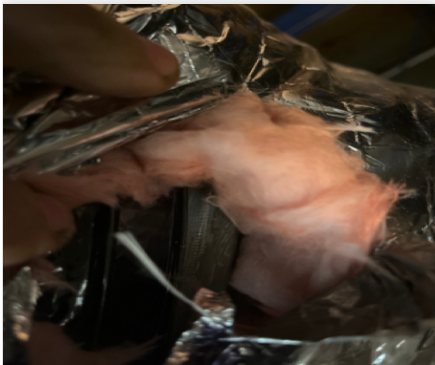
NOTAPE.jpeg

Issue Name : NON-CRITICAL - AC1, AC2, AC3 / INNER CORE NOT TAPED

Description : AC1, AC2, AC3 FLEX INNER CORE IS BANDED BUT NOT ALSO TAPED. RECOMMEND TAPE BE ADDED TO SECURE INNER FLEX CORE. PAGE: M-901 NOTE: N

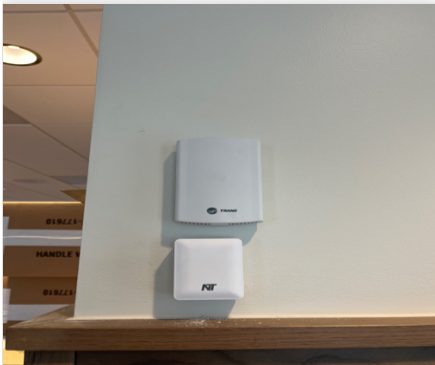
LABLES.jpeg

Issue Name : NON-CRITICAL - AC1, AC2, AC3 / SENSOR LABELS
Description : AC1, AC2, AC3 LABELS NEED TO BE INSTALLED ON ALL HUMIDITY AND TEMP. SENSORS. RECOMMEND ALL SENSORS BE LABELED. PAGE: M-501 NOTE: 4
Created By : National TAB **Assigned To :** National TAB - Dale Wheeler
Status : Open
Originated Date : 02/20/2023 - Dale Wheeler - National TAB

-Sensors labeled on wall adjacent to sensors (unless plans specifically state otherwise) and have the correct unit number and indicate whether they are temp or humidity?	NO / AC1, AC2, AC3 NO LABELS INSTALLED
-Temperature and humidity sensors are installed where shown on the drawing?	YES / AC1, AC2, AC3
Additional comments:	N/A

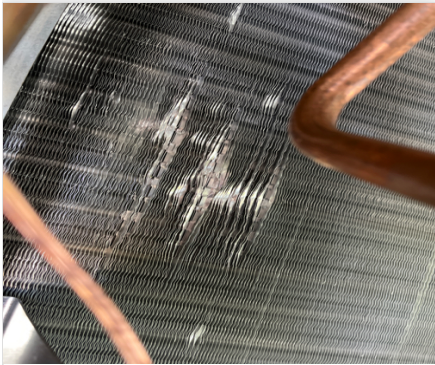
EVAP.jpeg

Issue Name : NON-CRITICAL - AC3 / EVAP COIL

Description : AC3 HAS SOME DAMAGE TO THE EVAP COIL. PAGE: M-901 NOTE: D

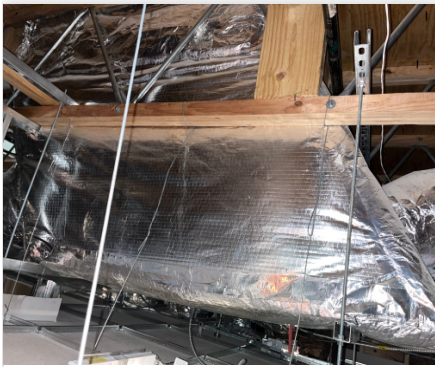
AC3.jpeg

Issue Name : NON-CRITICAL - AC3 / RETURN DUCT STYLE

Description : AC3 RETURN DUCT DROP INSTALLED IS A DIFFERENT DESIGN THEN WHAT IS CALLED FOR IN PRINTS. UNIT TOTAL IS WITHIN DESIGN CFM. PAGE: M-201 DETAIL: 1

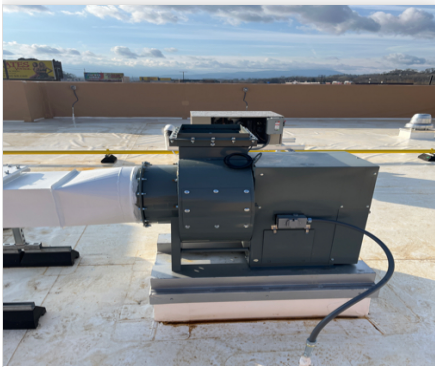
EF2DRIPGUARD.jpeg

Issue Name : NON-CRITICAL - EF1 & EF2 / DRIP GUARD

Description : EF1 & EF2 DRIP GUARDS NEED ARE NOT INSTALLED RECOMMEND THESE BE INSTALLED ASAP. PAGE: 401 DETAIL: 3

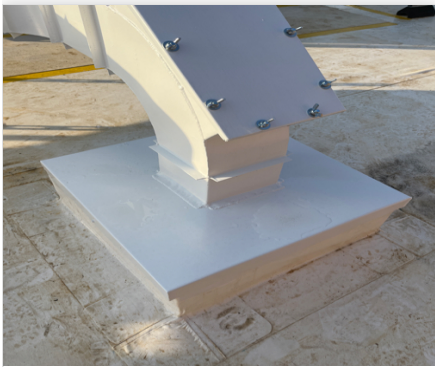
EF1CURBCAPS.jpeg

Issue Name : NON-CRITICAL - EF1 CURB CAP

Description : ONE CURBCAP ON EF1 HAS ONLY ONE SCREW SECURING IT. CURBCAP NEEDS TO BE SECURED ON PARRALEL SIDE.

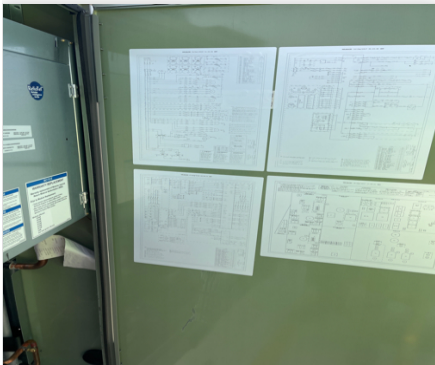
LAMINATED.jpeg

Issue Name : NON-CRITICAL - LAMINATED COPY OF WIRING DIAGRAM

Description : LAMINATED COPY OF WIRING DIAGRAM NEEDS TO BE PLACED IN THE ELECTRICAL CABINET OF EACH UNIT. PAGE: M-501 NOTE: 1

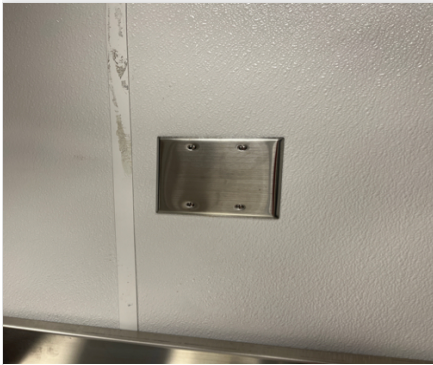
CONTROLS.jpeg

Issue Name : NON-CRITICAL - PASS THROUGH DOOR CONTROLS
Description : PASS THROUGH DOOR CONTROLS ARE NOT INSTALLED FAN CANNOT BE TESTED. PAGE: M-401 NOTE: 4
Created By : National TAB **Assigned To :** National TAB - Dale Wheeler
Status : Open
Originated Date : 02/23/2023 - Dale Wheeler - National TAB

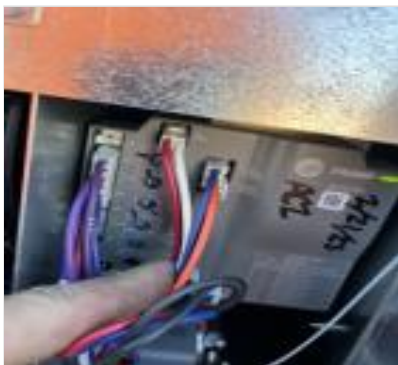
AC2.jpeg

ECONOMIZER POSITIONS MARKED AND DATED FOR EACH
AC

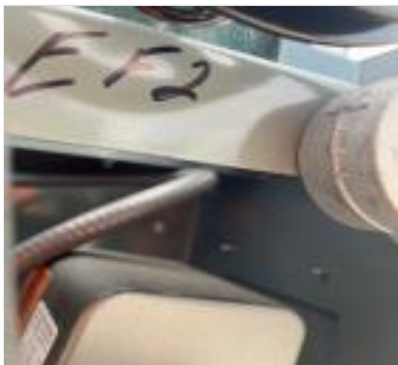
EF2TENSIONER.jpeg

EACH EF BELT TENSIONER POSITION MARKED

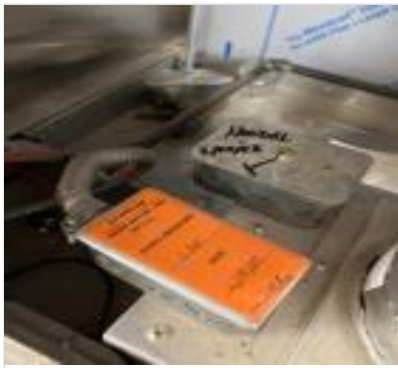
HOOD1L.jpeg

CAPTURE JET FINAL SETTINGS (MARKED AND DATED)

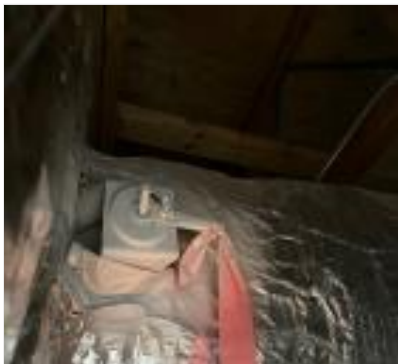
MARKEDDAMPER.jpeg

ONE MARKED BALANCING DAMPER
