PlanGrid Task Report - May 31, 2024

8 tasks in this report.

04884_New Bern Ave FSU (NC)

4411 New Bern Avenue, Raleigh, North Carolina

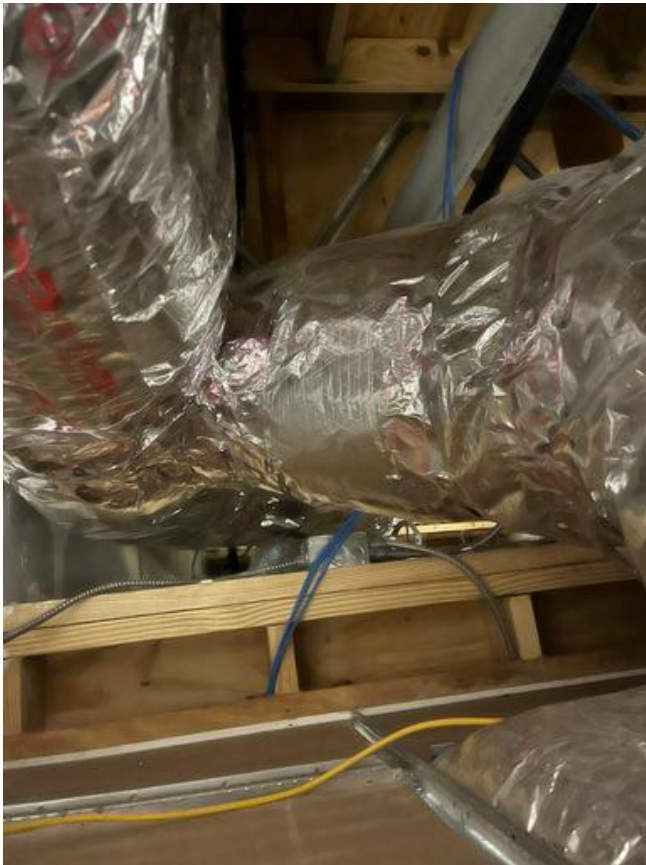
IMG_4358

#42 [DUCT 012] [NEW] CRITICAL – Damper(s) missing or inaccessible.

AC1 return grill RT1-2
damper is not installed.

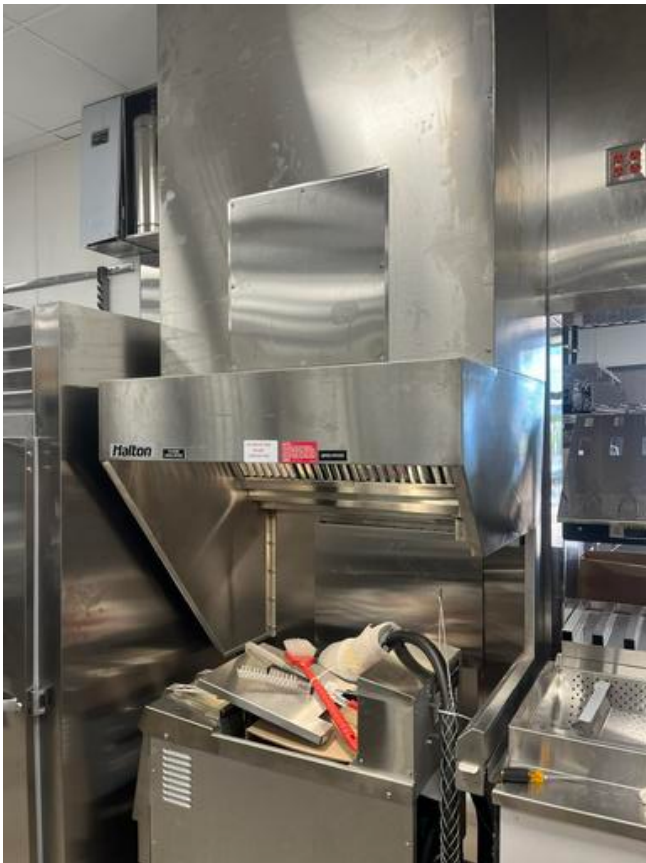
IMG_4380

#41 [HOOD 999] [NEW] (MISC)

Hood3 capture jet is factory installed and is running at max speed. Capture jet is hard piped and sealed with mastic but is low of design CFM. Hood capture is 100%.

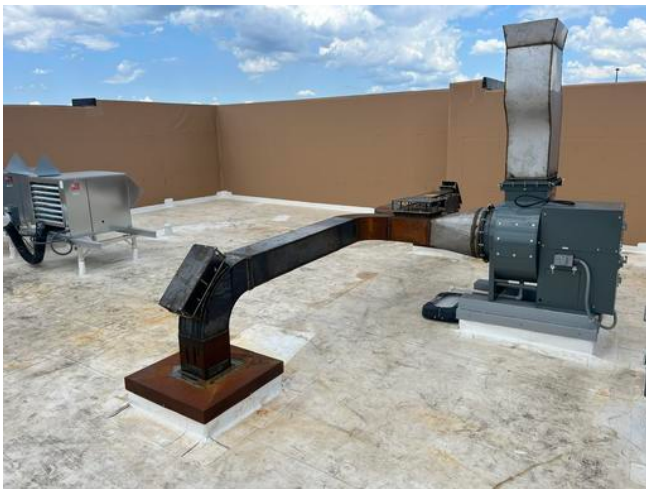
IMG_4340

#40 [EXHA 510] [NEW] Grease exhaust duct is not supported.

EF1 & EF2 grease duct support legs need to be installed.

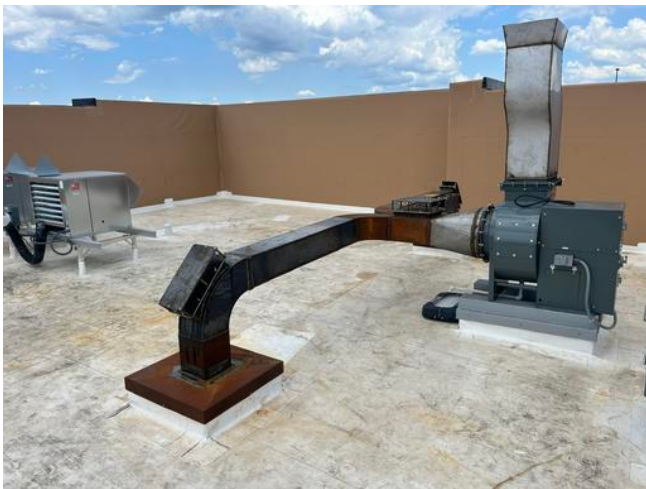
IMG_4340

#39 [EXHA 515] [NEW] Grease duct insulation

EF1 & EF2 rooftop grease duct has not been wrapped with insulation.

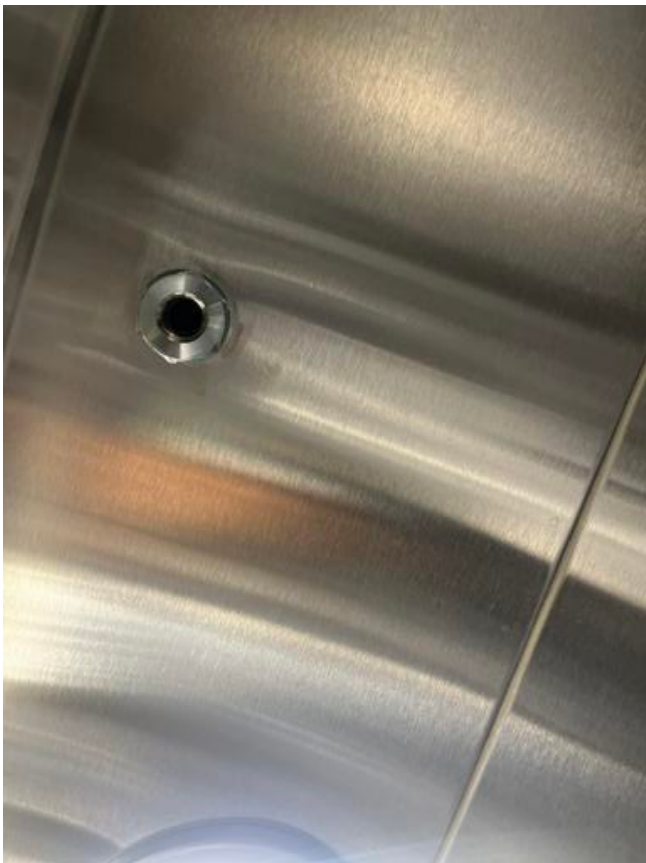
IMG_4337

#38 [HOOD 999] [NEW] (MISC)

Hood1R Ansul system piping install has not been completed.

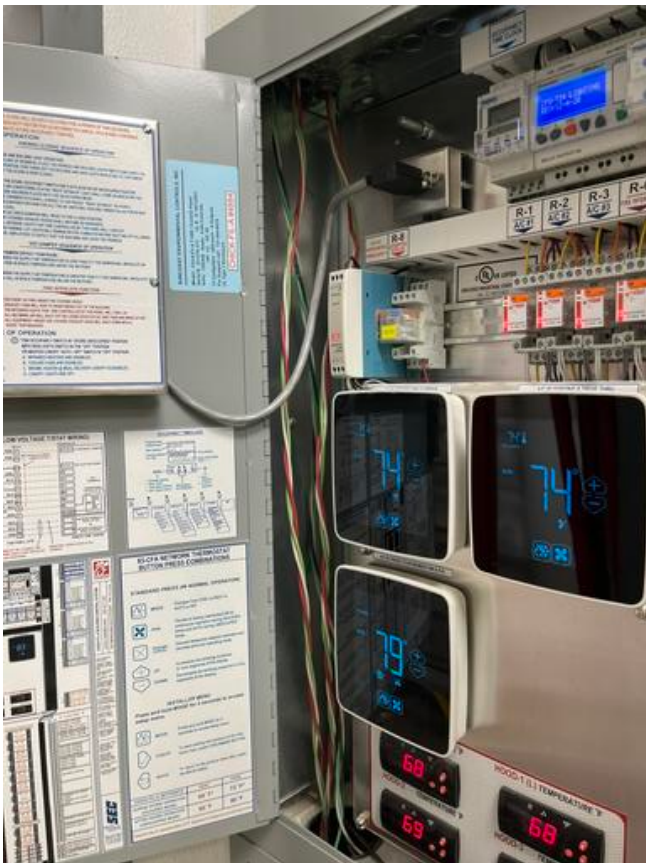
IMG_4345

#37 [CNTL 999] [NEW] (MISC) T-500

T-500 panel needs high voltage wiring cover installed.

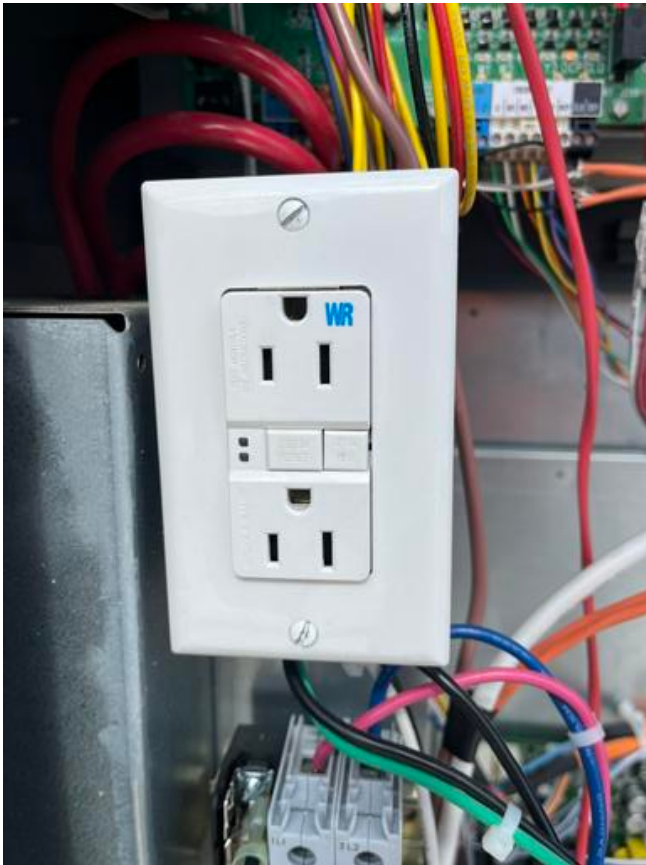
IMG_4353

#36 [UNIT 506] [NEW] Equipment GFI outlets.

AC1 GFI outlet is not operational.

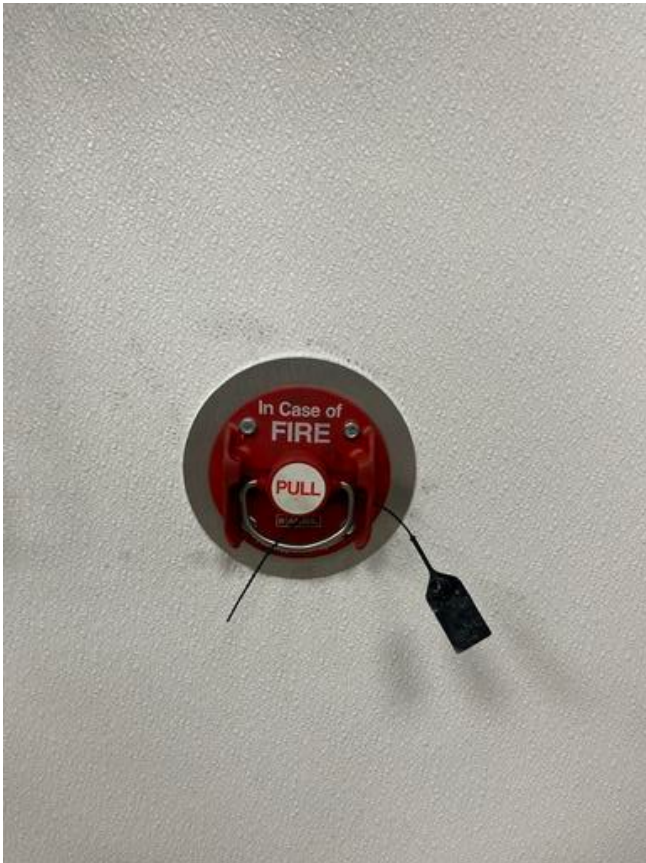
IMG_4339

#35 [CNTL 509] [NEW] Ansul pull labeling.

Label all Ansul pull stations
for which hoods they serve.
