Report: TAB REPORT
Function: Test, Adjust, & Balance
Date: 12/14/2023

PROJECT
12-11-23 CULVERS- PADDOCK LAKE, WI

Project Summary

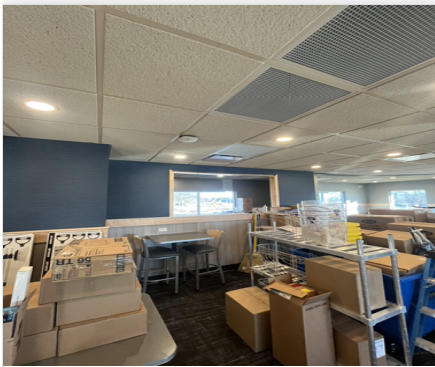
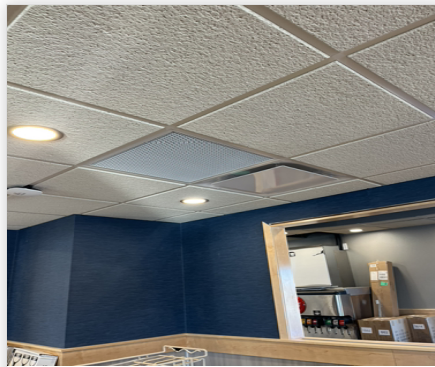
Issue Name : RTU-1: Return / Supply Diffuser Proximity
Description : In the dining area, a return and supply serving RTU-1 are positioned directly next to each other. This will cause short cycling. Recommend return and/or supply are repositioned.
Created By : National TAB **Assigned To :** National TAB - Michael McDonnell
Status : Open
Priority : Low **Asset Tag :**
Originated Date : 12/13/2023 - Michael McDonnell - National TAB

Dininglocation
12/13/2023

Proximity
12/13/2023

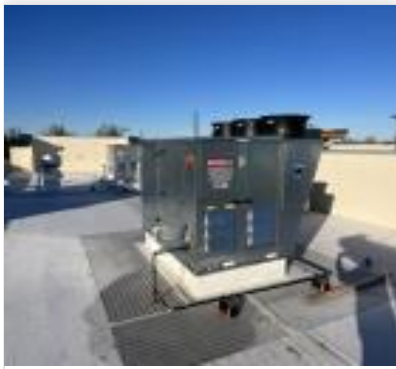
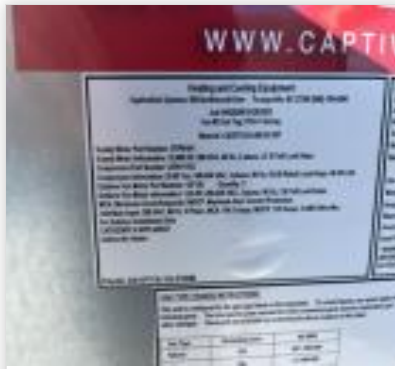
RTU-1-Dining
12/14/2023

Test Data		
	Design	Actual
SF CFM	6150	6073
SF RPM	-	1667
RA CFM	4400	4261
OA CFM	1750	1812
RL Voltage	-	189 @VFD
RL Amperage	-	24.0 @VFD
SF Rotation	-	CCW, CORRECT
Min OA Damper Position	-	4.9V
Min OA Damper Type	-	ECONOMIZER

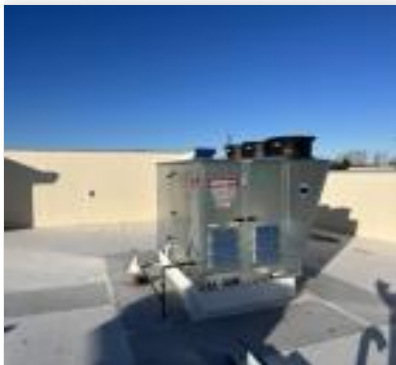
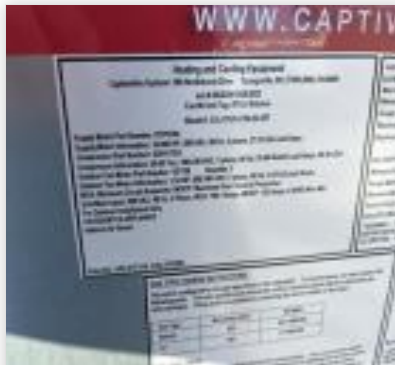
RTU-2-Kitchen
12/14/2023

Test Data		
	Design	Actual
SF CFM	6225	6246
SF RPM	-	1697
RA CFM	4525	4460
OA CFM	1700	1786
RL Voltage	-	193 @VFD
RL Amperage	-	25.2@VFD
SF Rotation	-	CCW, CORRECT
Min OA Damper Position	-	6.0V
Min OA Damper Type	-	ECONOMIZER

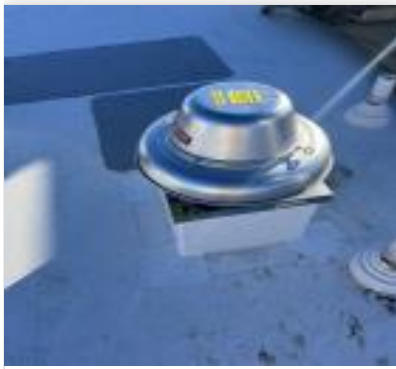
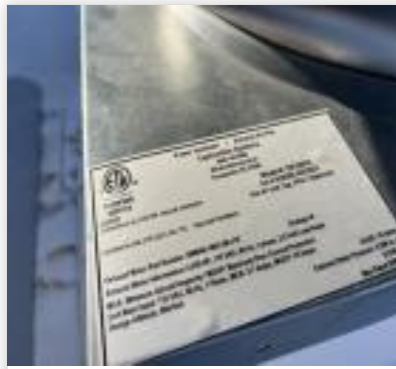
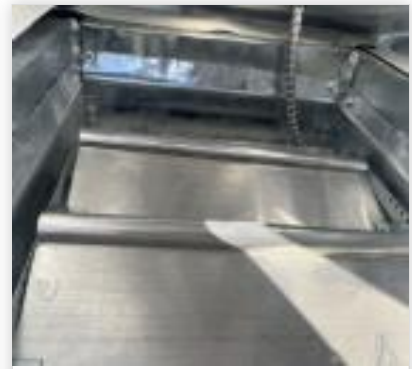
PRV-1-RR
12/14/2023

BackdraftDamper
12/14/2023

Test Data		
	Design	Actual
CFM	300	296
Fan RPM	1288	1448
Fan Rotation	-	CCW, CORRECT
Motor RPM	-	1448
System SetPt	-	75%
RL Voltage	-	121
RL Amperage	-	1.1
Total ESP	0.5"	0.34"
Fan Inlet SP	-	-0.34"
Fan Discharge SP	-	ATM

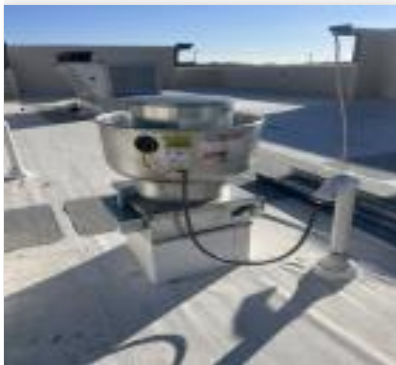
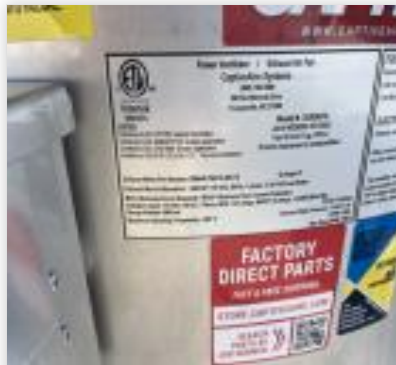
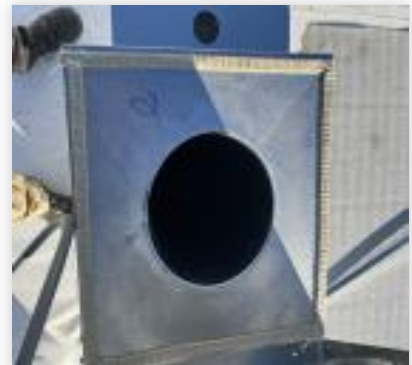
PRV-2-HD2-Fryer
12/14/2023

Test Data		
	Design	Actual
CFM	1500	1510
Fan RPM	1348	1221
Fan Rotation	-	CCW, CORRECT
Motor RPM	-	1221
System SetPt	-	61%
RL Voltage	-	122.3
RL Amperage	-	3.4
Total ESP	1.412	0.956"
Fan Inlet SP	-	-0.956"
Fan Discharge SP	-	ATM

[1] FAN SPEED CONTROLLED BY SPEED CONTROLLER IN FAN HOUSING.

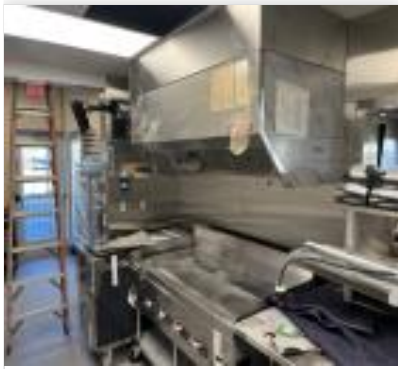
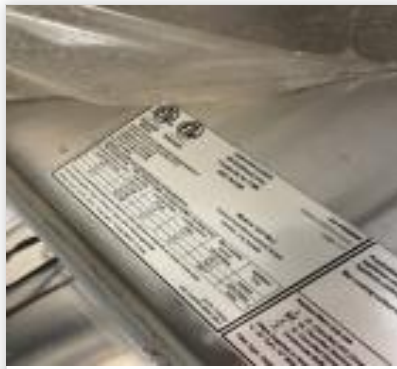
HD2-Griddle
12/14/2023

Design	Actual
Filter Type	SOLO FILTER	SOLO FILTER
Filter Size 1	16X16	16X16
Filter Qty 1	4	4
Filter AK factor size 1	1.62	1.62
Filter Total AK Area	6.48	6.48
Filter1 FPM	-	245
Filter2 FPM	-	236
Filter3 FPM	-	232
Filter4 FPM	-	220
Filter Ave FPM(corr)	-	233
CFM	1500	1510

[1] QUARTER END PANELS NOT INSTALLED.

[2] FAN SPEED NOT CONTROLLED THROUGH HMI, SPEED CONTROLLER MOUNTED IN FAN HOUSING.

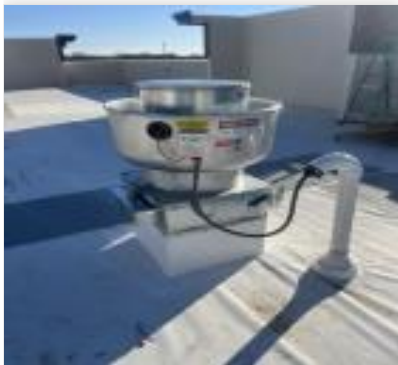
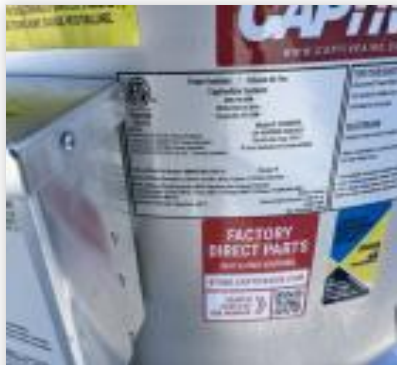
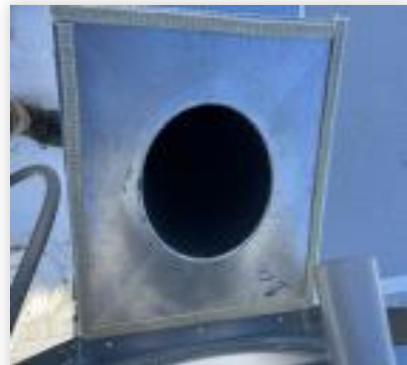
PRV3-HD1-Fryer
12/14/2023

Test Data		
	Design	Actual
CFM	1500	1547
Fan RPM	1348	1104
Fan Rotation	-	CCW, CORRECT
Motor RPM	-	1104
System SetPt	-	56%
RL Voltage	-	122.5
RL Amperage	-	2.5
Total ESP	1.250"	0.871"
Fan Inlet SP	-	-0.871"
Fan Discharge SP	-	ATM

[1] FAN SPEED CONTROLLED BY SPEED CONTROLLER IN FAN HOUSING.

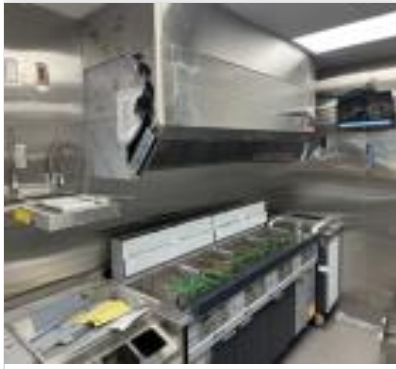
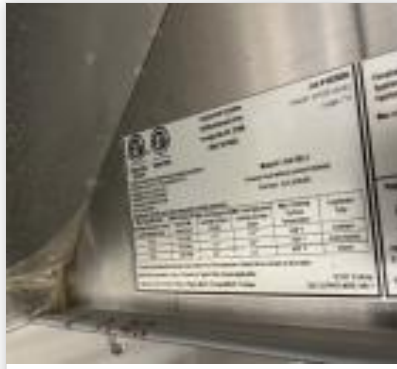
HD1-Fryer
12/14/2023

Test Data Exhaust		
	Design	Actual
Filter Type	SOLO FILTER	SOLO FILTER
Filter Size 1	16X16	16X16
Filter Qty 1	5	5
Filter AK factor size 1	1.62	1.62
Filter Total AK Area	8.10	8.10
Filter1 FPM	-	195
Filter2 FPM	-	197
Filter3 FPM	-	197
Filter4 FPM	-	206
Filter5 FPM	-	164
Filter Ave FPM(corr)	-	191
CFM	1500	1547

[1] QUARTER END PANELS NOT INSTALLED.

[2] FAN SPEED NOT CONTROLLED THROUGH HMI, SPEED CONTROLLER MOUNTED IN FAN HOUSING.

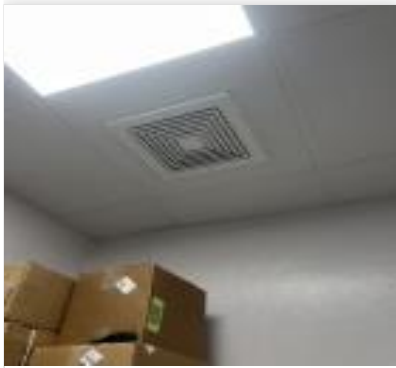
Mopfan
12/14/2023

Test Data		
	Design	Actual
CFM	-	81
Fan RPM	-	DD
Fan Rotation	-	CCW, CORRECT
Motor RPM	-	DD
System SetPt	-	SINGLE SPEED
RL Voltage	-	121
RL Amperage	-	1.0

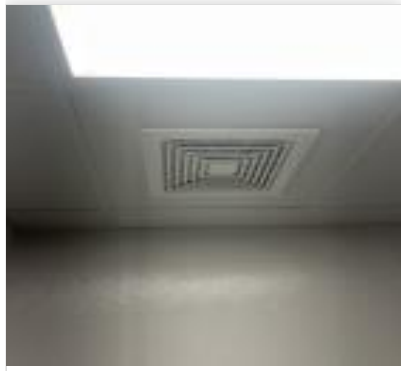
EmployeeRR
12/14/2023

Test Data		
	Design	Actual
CFM	75	82
Fan RPM	493	DD
Fan Rotation	-	CCW, CORRECT
Motor RPM	-	DD
System SetPt	-	SINGLE SPEED
RL Voltage	-	121
RL Amperage	-	1.0
