**Report: TAB Report**  
**Function: Test, Adjust, & Balance**  
**Date: 06/07/2024**

**06-03-24 WAWA #8187 TANNERSVILLE, PA**

Project: 06-03-24 WAWA #8187 TANNERSVILLE, PA

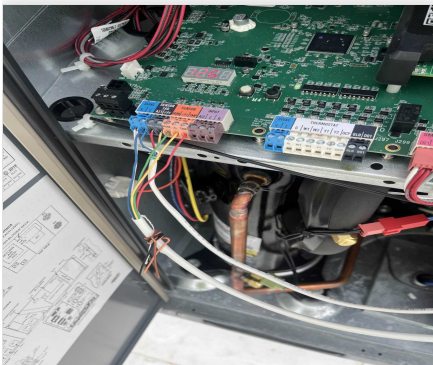
IMG\_6803  
06/05/2024

**Issue Name :** RTU Sensor Wiring  
**Description :** RTU sensor wiring is not run per manufacturers specifications. Typical thermostat wiring was used. Spec calls for separate sets of two wire shielded for the humidity sensor and temperature sensor. Recommend replacing wire to ensure sensor will read correctly preventing any space comfort issues.

2 conductor shielded cable has one wire landed to Vin, one to GND, and the shield wire is not connected.      Fail

For second shielded cable, one wire is landed to Vout and the shield wire is not connected.      Fail

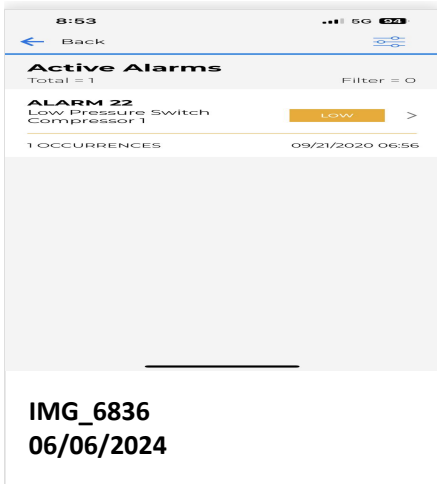
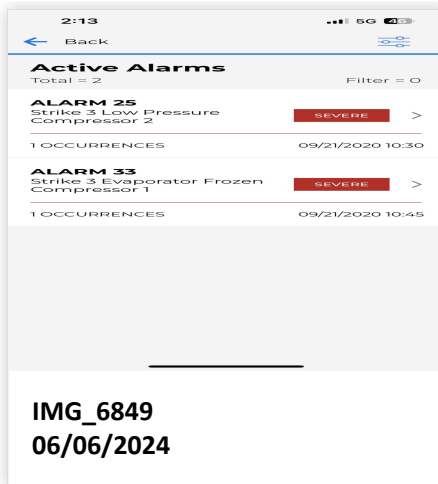
**Issue Name :** RTU- Alarms  
**Description :** RTU-1 has an alarm for compressor 1 low pressure causing compressor one to not run and subsequently dehumidification is disabled. Rtu-2 was running normally during the second day until it had a few alarms for cooling causing the unit to complete shut down. Recommend MC go through cooling systems of all RTUs to ensure proper health

- **06/07/2024 National TAB - Tyler Youells**
  - Note: RTU-1 Fails Cooling and Dehumidification temperature tests

RTU-1 HAS COMPRESSOR 1 LOW PRESSURE SWITCH ALARM RTU-2 HAS ALARM 25 AND ALARM 33 RELATING TO COMPRESSORS 1 AND 2 (SEVERE ALARM CAUSING UNIT SHUTDOWN.)

RTU-1: FAIL EAT:72.2 /LAT:65.9 RTU-2:PASS EAT:73.1/LAT 58.8 RTU-3: PASS EAT:70.4/LAT 55.7

RTU-1 FAIL RTU-2 PASS (EAT:72.5/LAT:68.4) RTU-3 PASS (EAT 72.3/LAT:71.2)

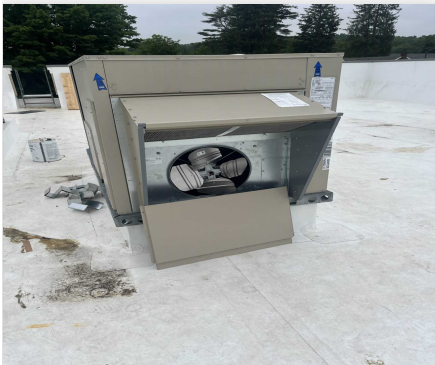
IMG\_6802  
06/05/2024

**Issue Name :** RTU-3 Power exhaust Kit  
**Description :** The factory shipping cover is installed on RTU-3 power exhaust. Cover needs to be removed and backdraft louvers installed for proper function and operation of the power exhaust. Recommend contacting Lennox if Backdraft louvers cannot be located. Not TAB Critical  
**Created By :** National TAB                      **Assigned To :** National TAB - Tyler Youells  
**Status :** Open  
**Priority :** High                                      **Asset Tag :**  
**Originated Date :** 06/05/2024 - Tyler Youells - National TAB
