**Report: TAB Report**  
**Function: Test, Adjust, & Balance**  
**Date: 01/09/2026**  
**Completed By: National TAB**

**PROJECT**  
**02-23-26 QT #1042 GASTONIA, NC**

QUIKTRIP  
4705 SOUTH 129TH EAST AVENUE  
TULSA, OK 74134

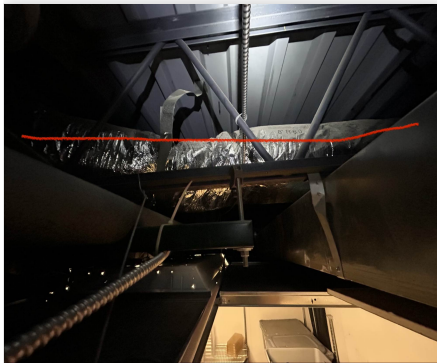
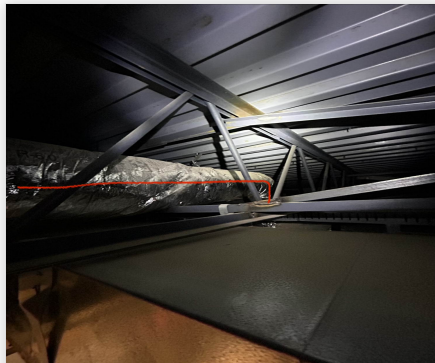
**Issue Name :** Damper inaccessible Workroom.  
**Description :** SGRD 3-6 workroom damper inaccessible. The air wants to go to the back 2 diffusers, which is not allowing to proportionally balance.  
**Created By :** National TAB                      **Assigned To :** National TAB - Dan Hertenstein  
**Status :** Open  
**Priority :** Medium                                      **Asset Tag :** SGRD6  
**Originated Date :** 02/26/2026 - Jearod Ferrette - National TAB

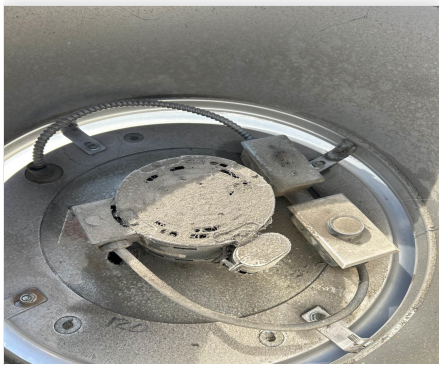
**Issue Name :** EF-2 low flow  
**Description :** EF-2 restroom/ combo-oven grille has low flow. Motor set at max on the dail. Currently at 42% of design.  
**Created By :** National TAB                      **Assigned To :** National TAB - Dan Hertenstein  
**Status :** Open  
**Priority :** Medium                                      **Asset Tag :** EF2  
**Originated Date :** 02/26/2026 - Jearod Ferrette - National TAB

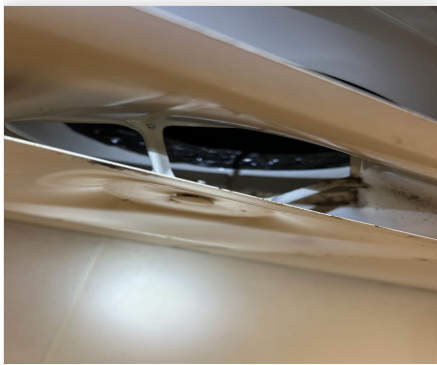
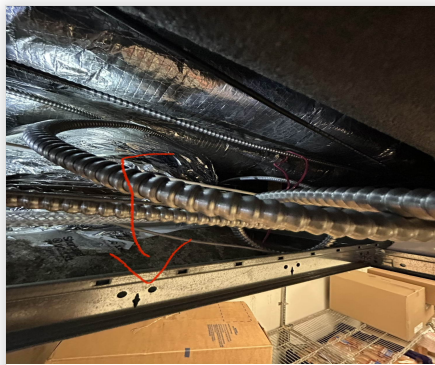
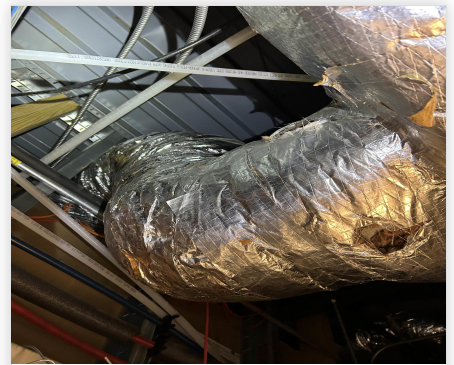
**Issue Name :** Missing damper  
**Description :** SGRD 3-5 missing damper. The air wants to go to the back 2 diffusers, which is not allowing to proportionally balance.  
**Created By :** National TAB                      **Assigned To :** National TAB - Dan Hertenstein  
**Status :** Open  
**Priority :** Medium                                      **Asset Tag :** SGRD5  
**Originated Date :** 02/26/2026 - Jearod Ferrette - National TAB

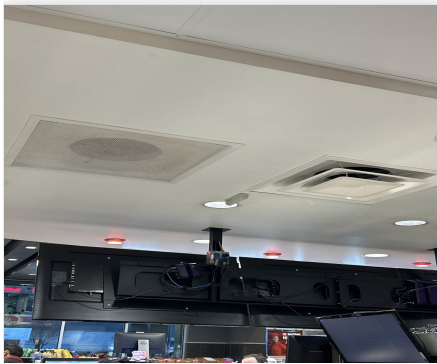
**Issue Name :** Specified diffusers not installed  
**Description :** SGRD 3-1 to 3-4 diffusers are not design style per plans.  
**Created By :** National TAB                      **Assigned To :** National TAB - Dan Hertenstein  
**Status :** Open  
**Priority :** Medium                                      **Asset Tag :** RT-3  
**Originated Date :** 02/26/2026 - Jearod Ferrette - National TAB

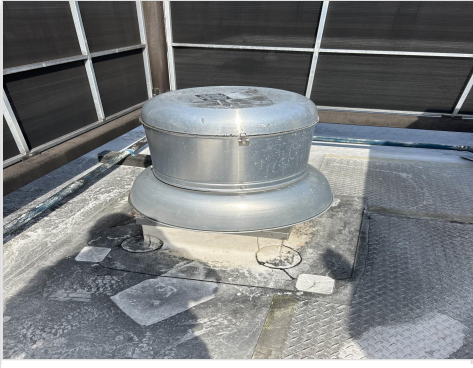
Test Data		
	Design	Actual
CFM	525	223
Fan RPM	-	DD
Fan Rotation	-	CCW
Motor RPM	-	DD
System SetPt	-	MAX
RL Voltage	-	NA
RL Amperage	-	NA
Total ESP	-	0.15"
Fan Inlet SP	-	-0.15"
Fan Discharge SP	-	ATMO
