Report: TAB Report
Function: Test, Adjust, & Balance
Date: 01/09/2026
Completed By: National TAB

PROJECT
02-23-26 QT #1042 GASTONIA, NC

Project: 02-23-26 QT #1042 GASTONIA, NC

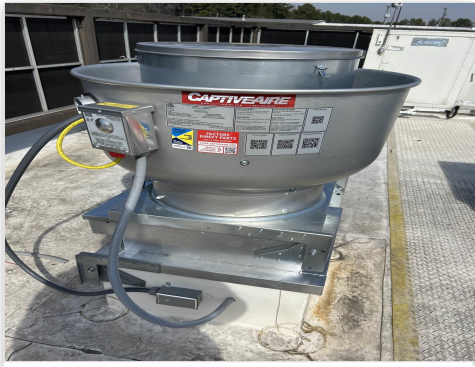
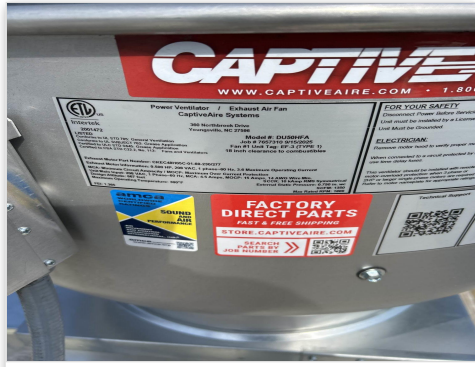
Asset: EF3

Test Data		
	Design	Actual
CFM	1350	1347
Fan RPM	-	1209
Fan Rotation	-	CCW
Motor RPM	-	1209
System SetPt	-	52.8
RL Voltage	-	NA
RL Amperage	-	NA
Total ESP	-	0.32"
Fan Inlet SP	-	-0.32"
Fan Discharge SP	-	ATMO

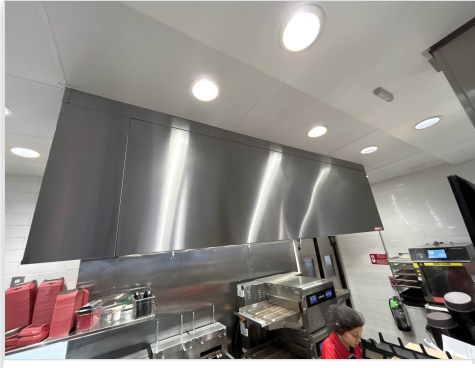
Asset: HD1

Test Data Exhaust		
	Design	Actual
Filter Type	CAPTRATE SOLO FILTER	CAPTRATE SOLO FILTER
Filter Size 1	20X16	20X16
Filter Qty 1	6	6
Filter AK factor size 1	2.08	2.08
Filter Total AK Area	12.48	12.48
Filter1 FPM	-	106
Filter2 FPM	-	111
Filter3 FPM	-	123
Filter4 FPM	-	108
Filter5 FPM	-	103
Filter6 FPM	-	101
Filter Ave FPM(corr)	-	108
CFM	1350	1347
