Report: TAB Report
Function: Test, Adjust, & Balance
Date: 01/09/2026
Completed By: National TAB

PROJECT
02-23-26 QT #1042 GASTONIA, NC

Project: 02-23-26 QT #1042 GASTONIA, NC

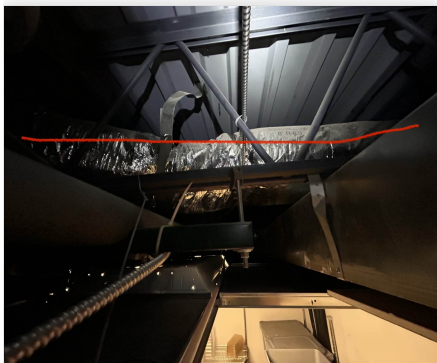
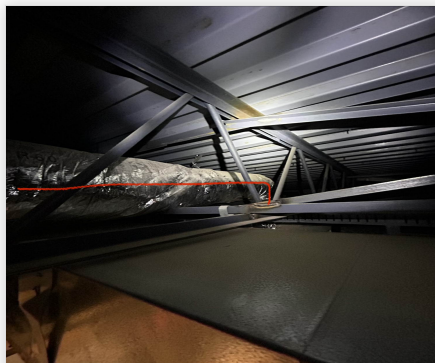
Issue Name : RTU-3: Dampers inaccessible or Not Installed
Description : Diffuser 3-6 damper is inaccessible. Diffuser 3-5 does not have a damper installed. Both diffusers are higher on airflow and need to be dampened to bring other diffusers into design.
Created By : National TAB **Assigned To :** National TAB - Dan Hertenstein
Status : Open
Priority : Medium **Asset Tag :** SGRD6
Originated Date : 02/26/2026 - Jearod Ferrette - National TAB

Asset	Notes	Date	Written By
SGRD5	Missing damper	02/26/2026	Jearod Ferrette
SGRD6	Damper inaccessible	02/26/2026	Jearod Ferrette

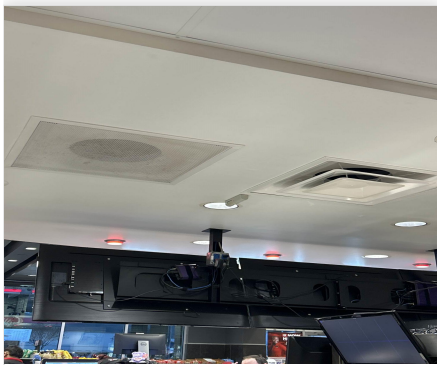
Issue Name : RTU-3: Specified diffusers not installed
Description : SGRD 3-1 to 3-4 diffusers are not design style per plans / Diffuser schedule.
Created By : National TAB **Assigned To :** National TAB - Dan Hertenstein
Status : Open
Priority : Medium **Asset Tag :** RT-3
Originated Date : 02/26/2026 - Jearod Ferrette - National TAB

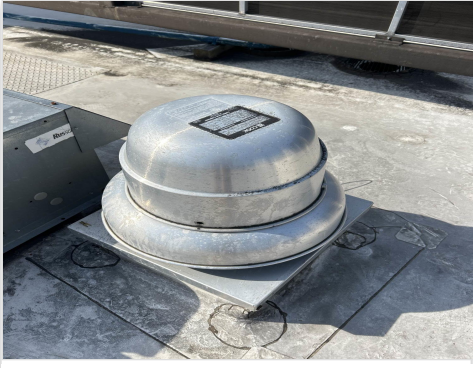
Asset: EF1

Test Data		
	Design	Actual
CFM	225	224
Fan RPM	-	DD
Fan Rotation	-	CCW
Motor RPM	-	DD
System SetPt	-	MAX
Total ESP	-	0.16"
Fan Inlet SP	-	-0.16"
Fan Discharge SP	-	ATMO

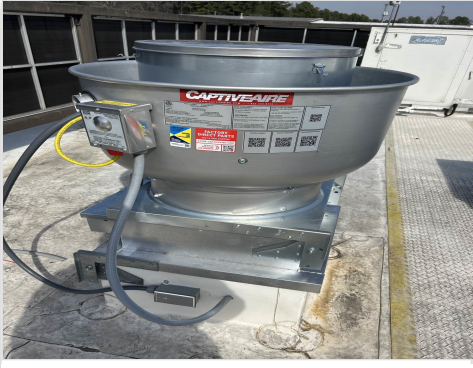
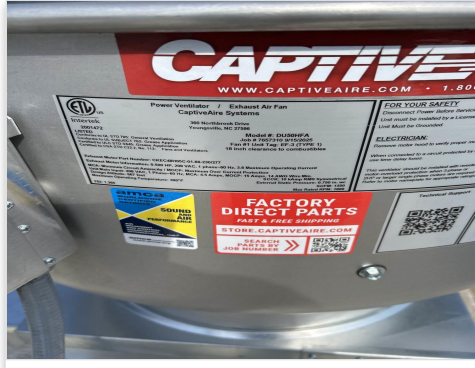
Asset: EF3

Test Data		
	Design	Actual
CFM	1350	1347
Fan RPM	-	1209
Fan Rotation	-	CCW
Motor RPM	-	1209
System SetPt	-	52.8
Total ESP	-	0.32"
Fan Inlet SP	-	-0.32"
Fan Discharge SP	-	ATMO

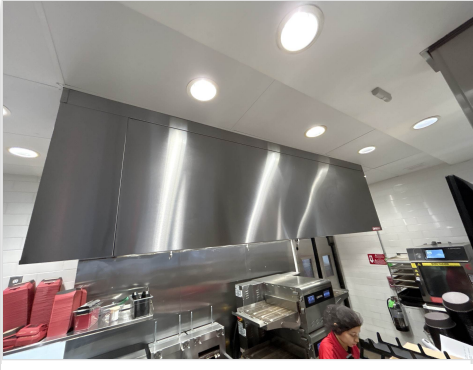
Asset: HD1

Test Data Exhaust		
	Design	Actual
Filter Type	CAPTRATE SOLO FILTER	CAPTRATE SOLO FILTER
Filter Size 1	20X16	20X16
Filter Qty 1	6	6
Filter AK factor size 1	2.08	2.08
Filter Total AK Area	12.48	12.48
Filter1 FPM	-	106
Filter2 FPM	-	111
Filter3 FPM	-	123
Filter4 FPM	-	108
Filter5 FPM	-	103
Filter6 FPM	-	101
Filter Ave FPM(corr)	-	108
CFM	1350	1347
