**Report: TAB Report**  
**Function: Test, Adjust, & Balance**  
**Date: 01/12/2026**  
**Completed By: National TAB**

**PROJECT**  
**03-23-26 QT #1412 PHOENIX, AZ**

QUIKTRIP  
4705 SOUTH 129TH EAST AVENUE  
TULSA, OK 74134

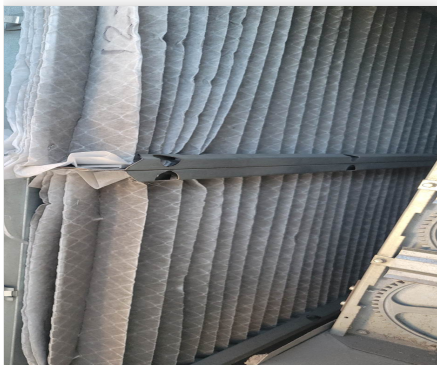
**Issue Name :** DIRTY FILTERS  
**Description :** Filters on all units are dirty, more so than picture shows.  
**Created By :** National TAB                      **Assigned To :** National TAB - Dan Hertenstein  
**Status :** Open  
**Priority :** InfoOnly                                      **Asset Tag :**  
**Originated Date :** 01/16/2026 - Christine Weale - National TAB

- **03/26/2026 National TAB - Ethan Van Orden**
  - On return trip on 3/26 unit filters still dirty recommend replacing them.

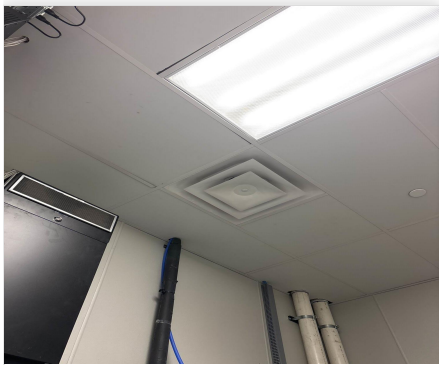
**Issue Name :** RTU-3 SGRD7  
**Description :** RTU-3 has 7 diffusers. Diffuser 6 is slightly low to follow the total scheduled design.  
**Created By :** National TAB                      **Assigned To :** National TAB - Dan Hertenstein  
**Status :** Open  
**Priority :** InfoOnly                                      **Asset Tag :**  
**Originated Date :** 03/26/2026 - Ethan Van Orden - National TAB

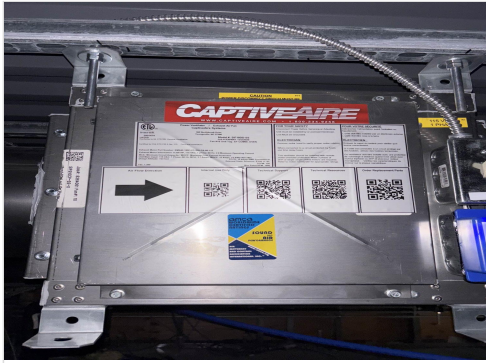
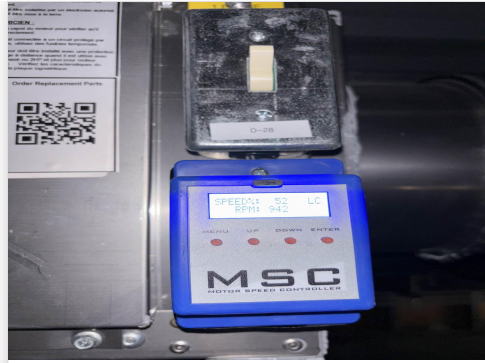
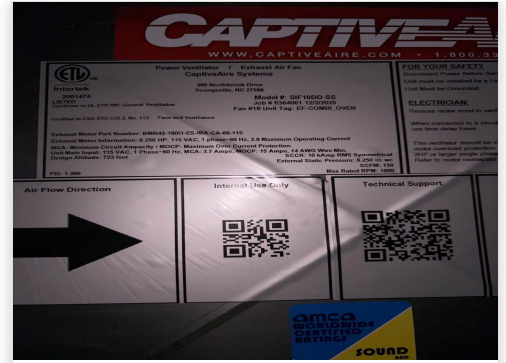
03/26/2026

EF is above the fridge set point is 52% and RPMS is 941
