Report: TAB REPORT
Function: Test, Adjust, & Balance
Date: 02/15/2024

10-02-23 KROGER #018-615 - LIVONIA, MI

Project: 10-02-23 KROGER #018-615 - LIVONIA, MI

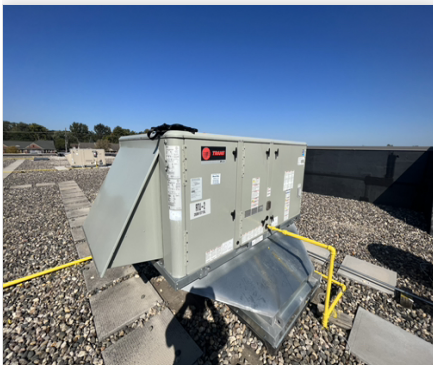
EXISTINGRTU-2
10/05/2023

Issue Name : (Existing RTU-2) Upstairs Office Unit
Description : Unit is not functional at this time, spoke to Kroger technician JD, as well as Justin. They informed me the issue with the unit is it needs a new control board. Control board is ordered, and will be installed once it arrives. Please let us know when this unit is running and free of alarms.
Created By : National TAB **Assigned To :** National TAB - Dylan Crisman
Status : Open
Priority : High **Asset Tag :**
Originated Date : 10/05/2023 - Dylan Crisman - National TAB

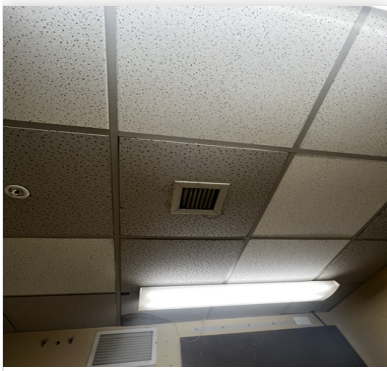
DiffuserServerRoom
10/19/2023

-
- **10/19/2023 National TAB - Dylan Crisman**
 - Unit is now functional, although when read out the unit is low on airflow at 925/1600 CFM. Also, diffuser in the conference room is operating at 35 CFM out of design of 300 CFM. Appears that a larger diffuser and duct is needed to increase airflow.
-

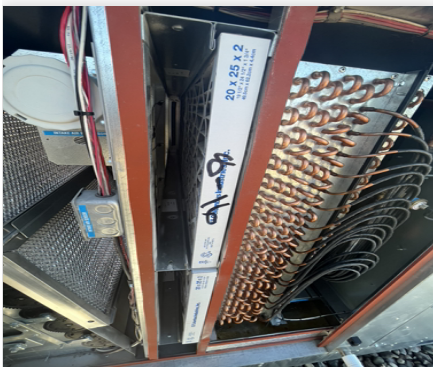
DOAS-1
10/04/2023

Issue Name : DOAS1/DOAS2 final filters missing
Description : DOAS-1/DOAS-2 both are missing 4 of the 8 final filters recommend installing matching 20x25x2 pleated filters in both units.
Created By : National TAB **Assigned To :** National TAB - Dylan Crisman
Status : Open
Priority : **Asset Tag :**
Originated Date : 10/04/2023 - Dylan Crisman - National TAB

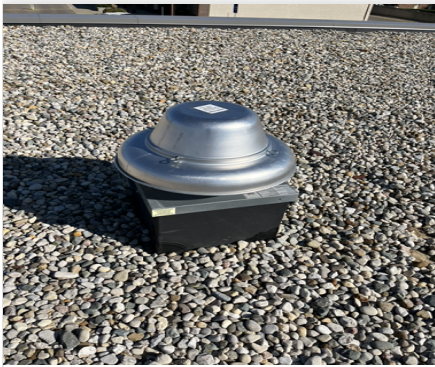
EF-EC
10/18/2023

Issue Name : EF-EC1 low on flow
Description : Exhaust Fan is low on flow 501/600 CFM. Unit is at max speed on speed controller.
Created By : National TAB **Assigned To :** National TAB - Dylan Crisman
Status : Open
Priority : Low **Asset Tag :**
Originated Date : 10/18/2023 - Dylan Crisman - National TAB

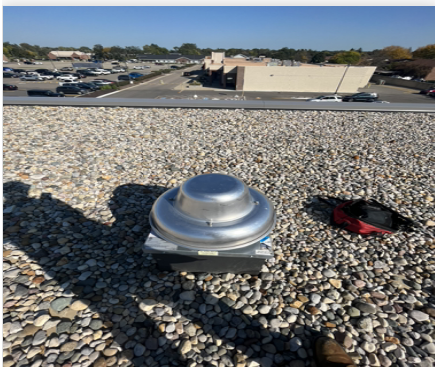
EF-R2
10/17/2023

Issue Name : EF-R2 (Pharmacy) low on flow
Description : Fan is at max speed on speed controller and operating at 87 CFM out of 150 CFM design
Created By : National TAB **Assigned To :** National TAB - Dylan Crisman
Status : Open
Priority : Low **Asset Tag :**
Originated Date : 10/17/2023 - Dylan Crisman - National TAB

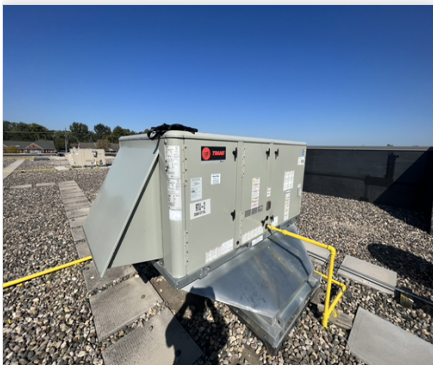
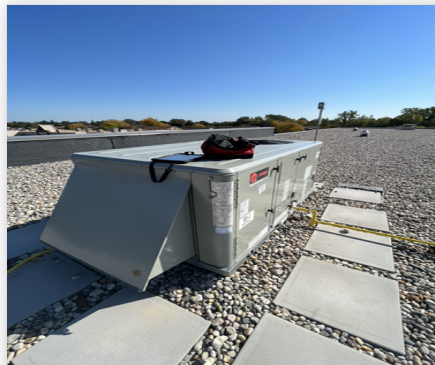
Issue Name : EX-RTU-2/RTU-3 Economizers not functional
Description : Economizers on existing units RTU-2/RTU-3 Are not responding to setpoint changes on HMI controller nor DCV potentiometers. Had to be manually set.
Created By : National TAB **Assigned To :** National TAB - Dylan Crisman
Status : Open
Priority : Medium **Asset Tag :**
Originated Date : 10/19/2023 - Dylan Crisman - National TAB

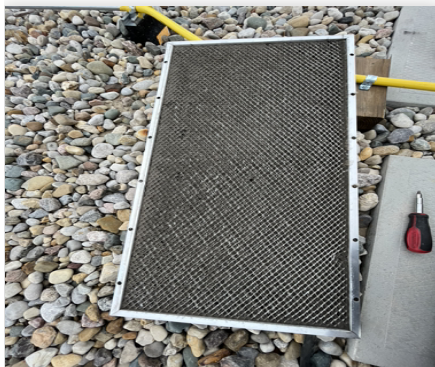
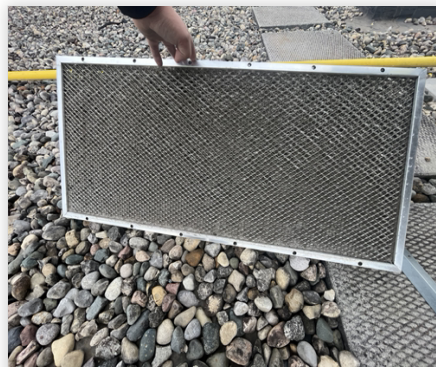
Issue Name : Existing RTU-2/RTU-3 OA filters dirty
Description : OA filters for both units are considerably dirty and are restricting airflow. They need to be thoroughly cleaned or replaced.
Created By : National TAB **Assigned To :** National TAB - Dylan Crisman
Status : Open
Priority : High **Asset Tag :**
Originated Date : 10/19/2023 - Dylan Crisman - National TAB

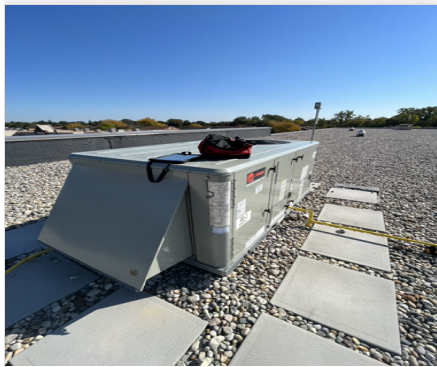
RTU-3(2)
10/19/2023

Issue Name : Existing unit RTU-3 (Pickup area) low on flow
Description : Existing unit RTU-3 is low on flow. Airflow is 1283 CFM out of design of 1600 CFM. Unit is direct drive and the speed controller is set for the highest speed.
Created By : National TAB **Assigned To :** National TAB - Dylan Crisman
Status : Open
Priority : Medium **Asset Tag :**
Originated Date : 10/19/2023 - Dylan Crisman - National TAB

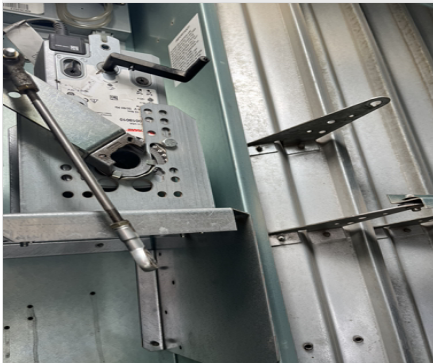
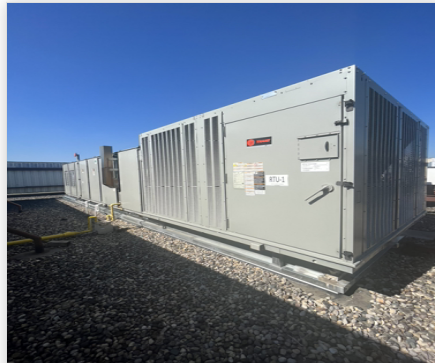
Issue Name : Exusting Unit RTU-1 (Sales floor) OA damper broken
Description : Actuator for RTU-1 outside air intake is broken. Had to manually set damper to achieve design airflow. Recommend servicing and setting to the manually set position.
Created By : National TAB **Assigned To :** National TAB - Dylan Crisman
Status : Open
Priority : High **Asset Tag :**
Originated Date : 10/19/2023 - Dylan Crisman - National TAB

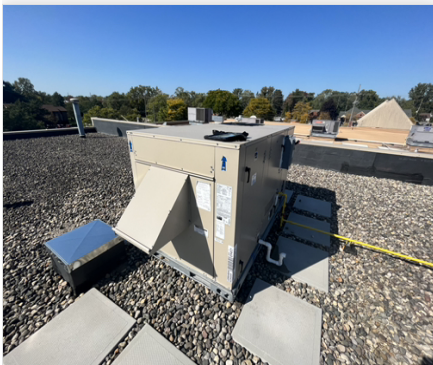
RTU-8
10/19/2023

Issue Name : RTU-8 Bakery High on Airflow
Description : RTU-8 bakery is high on airflow. (1653 CFM out of 1550 CFM design). Adjusted the fan speed through the CORE app but there was no change in airflow.
Created By : National TAB **Assigned To :** National TAB - Dylan Crisman
Status : Open
Priority : Medium **Asset Tag :**
Originated Date : 10/19/2023 - Dylan Crisman - National TAB
