National TAB  
1329 E. KEMPER ROAD  
SUITE 4210  
CINCINNATI, OH 45246

**Report: TAB REPORT**  
**Function: Test, Adjust, & Balance**  
**Date: 02/15/2024**

**PROJECT**  
**10-02-23 KROGER #018-615 - LIVONIA, MI**

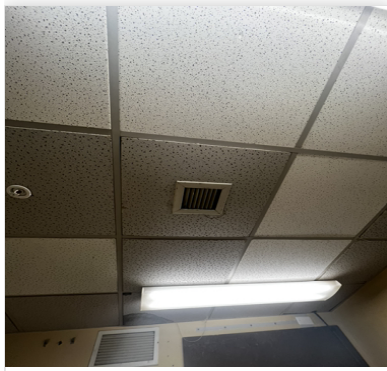
**DiffuserServerRoom**  
**10/19/2023**

- Unit is now functional, although when read out the unit is low on airflow at 925/1600 CFM. Also, diffuser in the conference room is operating at 35 CFM out of design of 300 CFM. Appears that a larger diffuser and duct is needed to increase airflow.
-

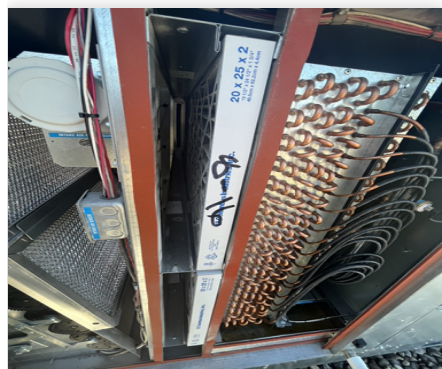
DOAS-1  
10/04/2023

**Issue Name :** DOAS1/DOAS2 final filters missing  
**Description :** DOAS-1/DOAS-2 both are missing 4 of the 8 final filters recommend installing matching 20x25x2 pleated filters in both units.  
**Created By :** National TAB                      **Assigned To :** National TAB - Dylan Crisman  
**Status :** Open  
**Priority :**                                              **Asset Tag :**  
**Originated Date :** 10/04/2023 - Dylan Crisman - National TAB

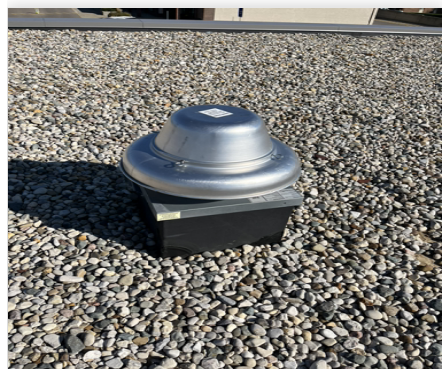
EF-EC  
10/18/2023

**Issue Name :** EF-EC1 low on flow  
**Description :** Exhaust Fan is low on flow 501/600 CFM. Unit is at max speed on speed controller.  
**Created By :** National TAB                      **Assigned To :** National TAB - Dylan Crisman  
**Status :** Open  
**Priority :** Low                                      **Asset Tag :**  
**Originated Date :** 10/18/2023 - Dylan Crisman - National TAB

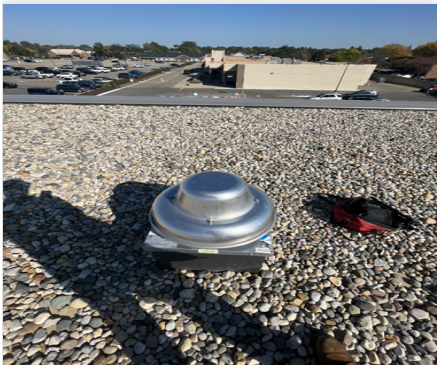
EF-R2  
10/17/2023

**Issue Name :** EF-R2 (Pharmacy) low on flow  
**Description :** Fan is at max speed on speed controller and operating at 87 CFM out of 150 CFM design  
**Created By :** National TAB  
**Assigned To :** National TAB - Dylan Crisman  
**Status :** Open  
**Priority :** Low  
**Asset Tag :**  
**Originated Date :** 10/17/2023 - Dylan Crisman - National TAB

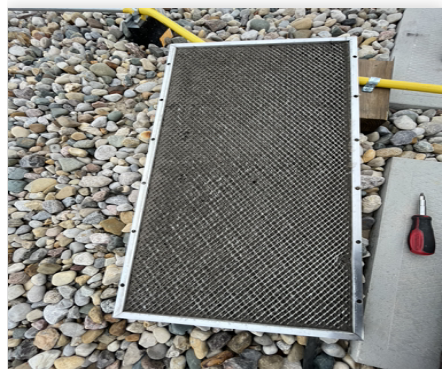
RTU-3(2)  
10/19/2023

**Issue Name :** Existing RTU-2/RTU-3 OA filters dirty  
**Description :** OA filters for both units are considerably dirty and are restricting airflow. They need to be thoroughly cleaned or replaced.  
**Created By :** National TAB                      **Assigned To :** National TAB - Dylan Crisman  
**Status :** Open  
**Priority :** High                                      **Asset Tag :**  
**Originated Date :** 10/19/2023 - Dylan Crisman - National TAB

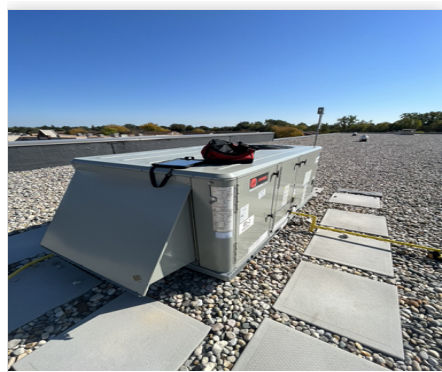
RTU-3(2)  
10/19/2023

**Issue Name :** Existing unit RTU-3 (Pickup area) low on flow  
**Description :** Existing unit RTU-3 is low on flow. Airflow is 1283 CFM out of design of 1600 CFM. Unit is direct drive and the speed controller is set for the highest speed.  
**Created By :** National TAB                      **Assigned To :** National TAB - Dylan Crisman  
**Status :** Open  
**Priority :** Medium                      **Asset Tag :**  
**Originated Date :** 10/19/2023 - Dylan Crisman - National TAB

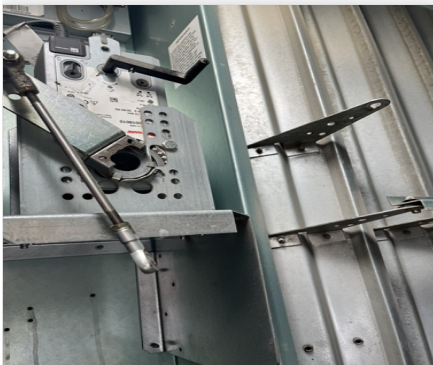
Actuator  
10/19/2023

**Issue Name :** Exusting Unit RTU-1 (Sales floor) OA damper broken  
**Description :** Actuator for RTU-1 outside air intake is broken. Had to manually set damper to achieve design airflow. Recommend servicing and setting to the manually set position.  
**Created By :** National TAB      **Assigned To :** National TAB - Dylan Crisman  
**Status :** Open  
**Priority :** High      **Asset Tag :**  
**Originated Date :** 10/19/2023 - Dylan Crisman - National TAB

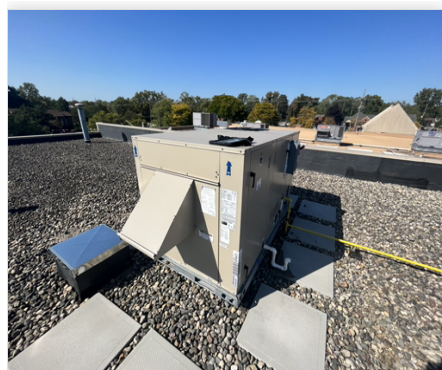
RTU-8  
10/19/2023

**Issue Name :** RTU-8 Bakery High on Airflow  
**Description :** RTU-8 bakery is high on airflow. (1653 CFM out of 1550 CFM design). Adjusted the fan speed through the CORE app but there was no change in airflow.  
**Created By :** National TAB                      **Assigned To :** National TAB - Dylan Crisman  
**Status :** Open  
**Priority :** Medium                      **Asset Tag :**  
**Originated Date :** 10/19/2023 - Dylan Crisman - National TAB
