Report: TAB Report
Function: Test, Adjust, & Balance
Date: 09/29/2025
Completed By: National TAB

PROJECT
09-22-25 QT #1116 ANDERSON, SC

Project: 09-22-25 QT #1116 ANDERSON, SC

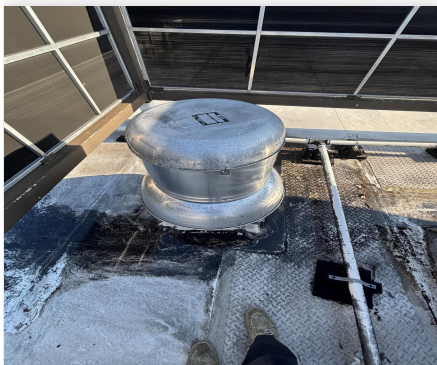
Issue Name : EF-2 no damper
Description : There is no damper on the men's RR grille, the exhaust fan is over design and to get the combo oven exhaust grille to design would mean increasing the fan and men's RR by a lot.
Created By : National TAB **Assigned To :** National TAB - Dan Hertenstein
Status : Open
Priority : **Urgent** **Asset Tag :** EF2
Originated Date : 09/24/2025 - Christian Moller - National TAB

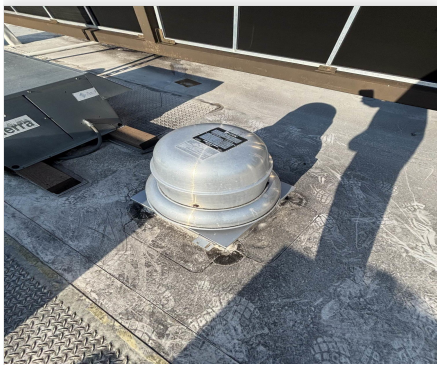
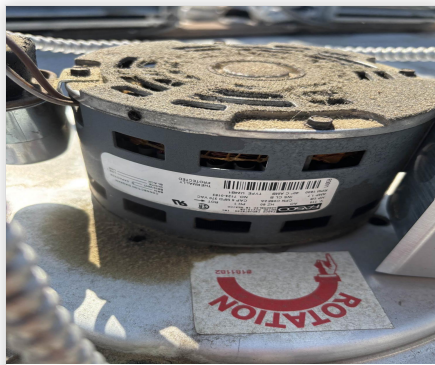
Issue Name : EF-2 speed controller not working
Description : The women's RR exhaust fan is high and the speed controller does not change the fans speed. It is stuck in high speed.
Created By : National TAB **Assigned To :** National TAB - Dan Hertenstein
Status : Open
Priority : Medium **Asset Tag :** EF1
Originated Date : 09/24/2025 - Christian Moller - National TAB

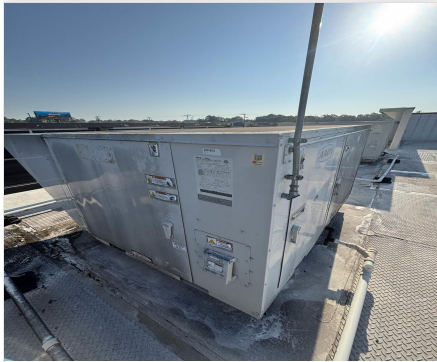
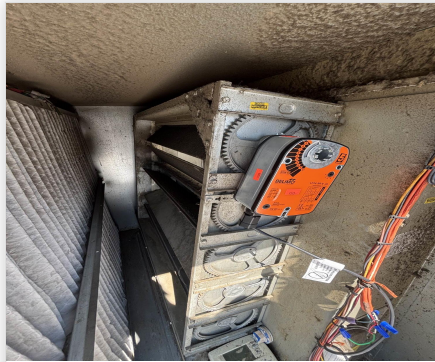
Issue Name : RTU 3 economizer does not close far enough
Description : QT would like OA to be taken at 800 and 350 CFM, the economizer doesn't close the damper far enough to achieve 350 CFM.
Created By : National TAB **Assigned To :** National TAB - Dan Hertenstein
Status : Open
Priority : Low **Asset Tag :** RT-3
Originated Date : 09/24/2025 - Christian Moller - National TAB

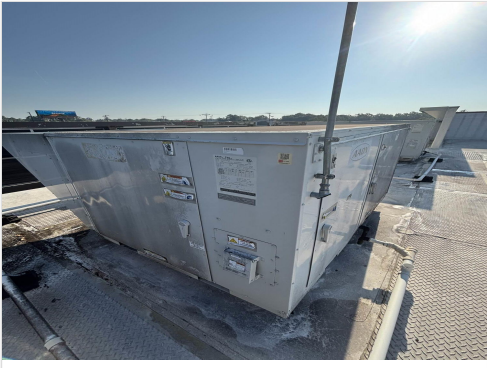
Unit Data - PHOTO LOG

Test Data		
	Design	Actual
SF CFM	4200	4394
RA CFM	3400	3525
OA CFM	800	869
RL Voltage	-	206/205/206
RL Amperage	-	5.7/6.7/6.8
SF Rotation	-	CCW
SF System SetPt	-	VFD/35Hz
RA Damper Position	-	4"
Min OA Damper Position	-	1"
Min OA Damper Type	-	ECON

Notes:
ECONOMIZER will not close far enough for 350 CFM.

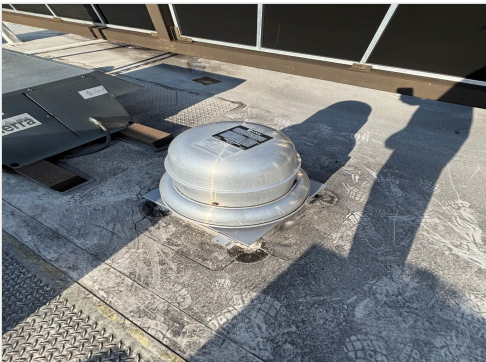
Unit Data - PHOTO LOG

Test Data		
	Design	Actual
CFM	225	289
Fan RPM	-	
Fan Rotation	-	CCW
Motor RPM	-	
System SetPt	-	SPEED CONTROLLER / HIGH SPEED
RL Voltage	-	111
RL Amperage	-	1.22
Total ESP	-	0.23"
Fan Inlet SP	-	-0.23"
Fan Discharge SP	-	ATM

Notes:
Speed controller stuck at high speed.

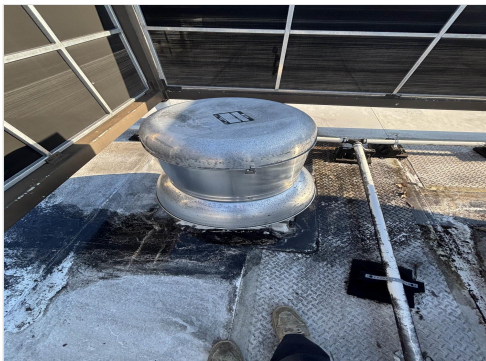
Unit Data - PHOTO LOG

Test Data		
	Design	Actual
CFM	525	549
Fan RPM	-	-
Fan Rotation	-	CCW
Motor RPM	-	-
System SetPt	-	Speed Controller / High speed
RL Voltage	-	110
RL Amperage	-	2.4
Total ESP	-	0.46"
Fan Inlet SP	-	-0.46"
Fan Discharge SP	-	ATM

Notes:
Men's RR diffuser does not have a damper, exhaust cannot be shifted to the combi oven.

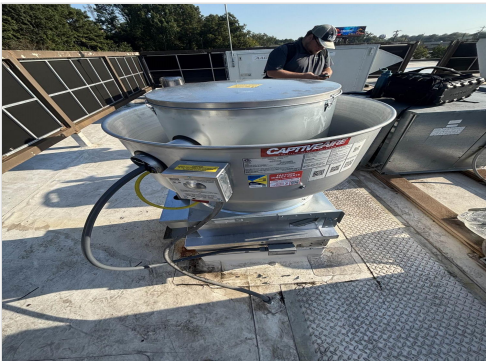
Unit Data - PHOTO LOG

Test Data		
	Design	Actual
CFM	1350	1310
Fan Rotation	-	CCW
System SetPt	-	HMI / 54.8Hz
RL Voltage	-	207
RL Amperage	-	2.6
Total ESP	-	NR
Fan Inlet SP	-	NR
Fan Discharge SP	-	ATM

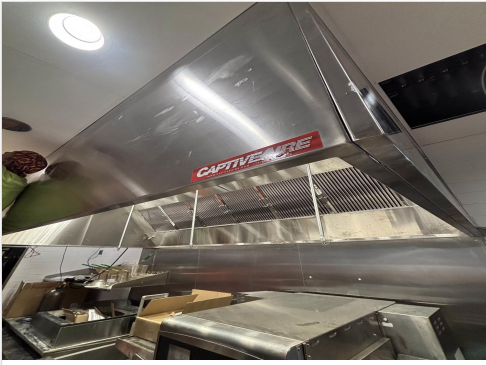
Unit Data - PHOTO LOG

Unit Data		
	Design	Actual
MFG	CAPTIVEAIRE	CAPTIVEAIRE
Model Num	6030 ND-2-F	6030 ND-2
Job / Serial Num	-	7657320
Type	TYPE I CANOPY	TYPE I CANOPY
Hood length	-	122"
Hood Width	-	60"

Test Data Exhaust		
	Design	Actual
Filter Type	-	BAFFLE FILTERS
Filter Size 1	-	16x20
Filter Qty 1	-	6
Filter AK factor size 1	-	2.08
Filter Total AK Area	-	12.48
Filter1 FPM	-	102
Filter2 FPM	-	112
Filter3 FPM	-	108
Filter4 FPM	-	109
Filter5 FPM	-	105
Filter6 FPM	-	99
Filter Ave FPM(corr)	-	105
CFM	1350	1310
