**Report: TAB Report
Function: Test, Adjust, & Balance
Date: 02/23/2026
Completed By: National TAB**

02-09-26 QT #1132 SPARTANBURG, SC

**QUIKTRIP
4705 SOUTH 129TH EAST AVENUE
TULSA, OK 74134**

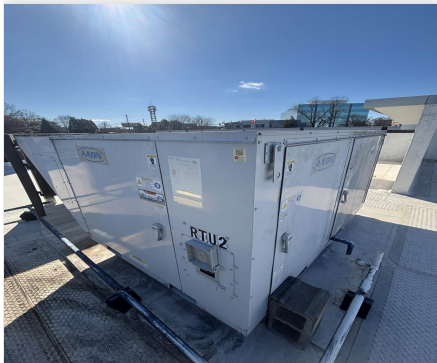
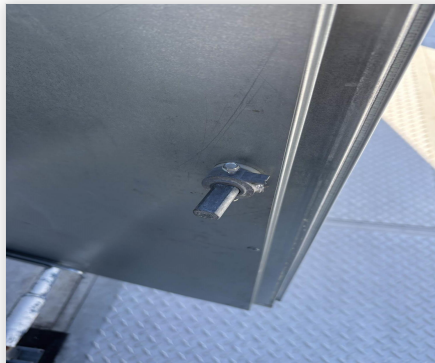
Issue Name : RTU 2 door lock broken
Description : The compressor door lock is broken. A cinder block is holding the door shut temporarily.
Created By : National TAB **Assigned To :** National TAB - Dan Hertenstein
Status : Open
Priority : Low **Asset Tag :**
Originated Date : 02/23/2026 - Christian Moller - National TAB

[3] Compressor door lock broken. SEE ISSUES.

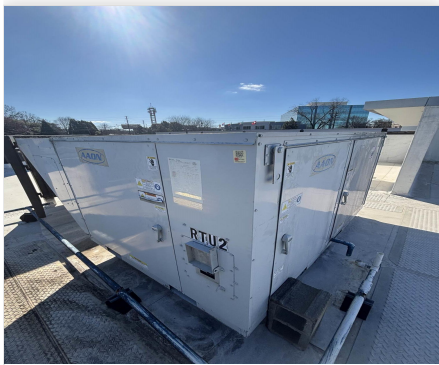
Issue Name : RTU 2 fan rotation wrong
Description : RTU 2 is not getting much airflow due to the rotation of the fan. Rotation is wrong and will need to be corrected for full balance.
Created By : National TAB **Assigned To :** National TAB - Dan Hertenstein
Status : Open
Priority : Urgent **Asset Tag :** RT-2
Originated Date : 02/23/2026 - Christian Moller - National TAB

[1] Fan spinning backwards giving low air flow. SEE ISSUES.

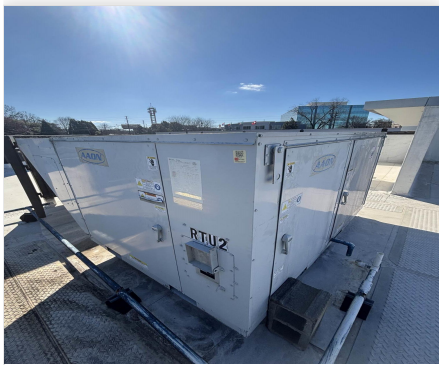
Issue Name : RTU 2 no OA set
Description : Due to the low flow an accurate OA that will work when the unit is running properly could not be set. Once the fan is fixed OA can be set.
Created By : National TAB **Assigned To :** National TAB - Dan Hertenstein
Status : Open
Priority : Urgent **Asset Tag :** RT-2
Originated Date : 02/23/2026 - Christian Moller - National TAB

[2] Due to low flow OA was not set. SEE ISSUES.

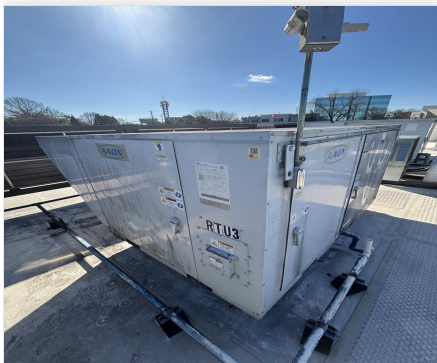
Issue Name : RTU 3 not working
Description : RTU 3 has power however the fan is not running. Unit was hard reset to verify the problem as well as put in hand and still is not working. Amperage was 0.1 at the VFD. Unit was left off. NEEDS IMMEDIATE MAINTENANCE.
Created By : National TAB **Assigned To :** National TAB - Dan Hertenstein
Status : Open
Priority : Urgent **Asset Tag :** RT-3
Originated Date : 02/23/2026 - Christian Moller - National TAB

[4] Unit not running. SEE ISSUES.

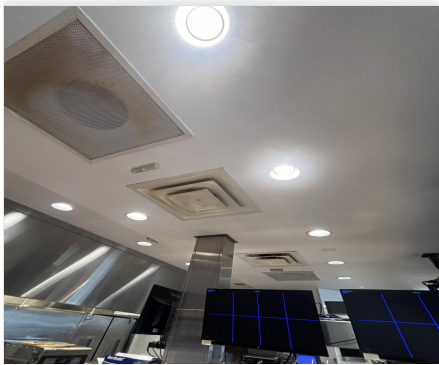
Issue Name : Wrong cook line diffusers
Description : RTU 3's cook line diffusers are incorrect. TITUS Louvered supply grilles with adjustable deflectors are the correct diffusers to be installed.
Created By : National TAB **Assigned To :** National TAB - Dan Hertenstein
Status : Open
Priority : Medium **Asset Tag :** RT-3
Originated Date : 02/23/2026 - Christian Moller - National TAB

[5] Wrong cook line diffusers. SEE ISSUES.

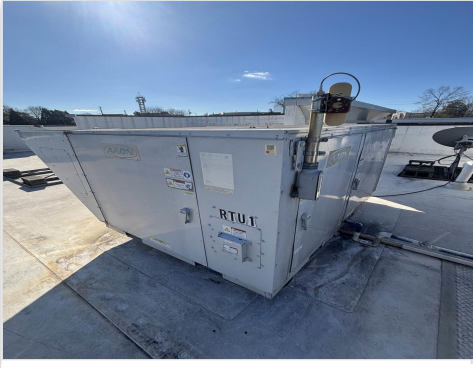
Asset: RT-1

Unit Data	
	Actual
MFG	AAON
Serial Num	201206-ANEK06807
Model Num	RN-013-8-0-EA0A-152
Num OA Filters 1	1
OA Filter Size 1	45X24
Num Final Filter 1	2
Final Filter Size 1	56X45

Test Data		
	Design	Actual
SF CFM	4200	4279
SF RPM	-	DD
OA CFM (Hoods On)	800	841
OA CFM (Hoods Off)	350	348
RL Voltage	-	205/208/208
RL Amperage	-	5.0/5.6/5.7
VFD Max SetPt	-	36Hz
VFD Min SetPt	-	24Hz
OA Damper Position (Hoods On)	-	46%
OA Damper Position (Hoods Off)	-	17%

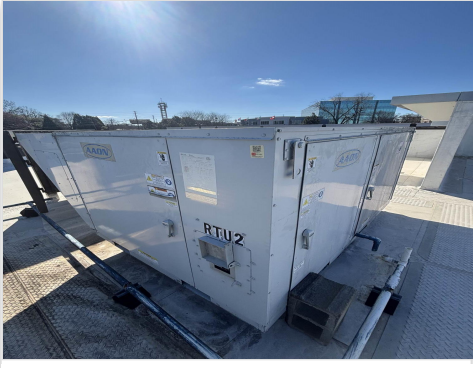
Asset: RT-2

Unit Data	
	Actual
MFG	AAON
Serial Num	201206-ANEK06808
Model Num	RN-013-8-0-EA0A-152
Num OA Filters 1	1
OA Filter Size 1	45X24
Num Final Filter 1	2
Final Filter Size 1	56X45

Test Data		
	Design	Actual
SF CFM	4200	1800
SF RPM	-	DD
OA CFM (Hoods On)	800	823
OA CFM (Hoods Off)	350	347
RL Voltage	-	204/207/208
RL Amperage	-	7.2/6.9/5.2
VFD Max SetPt	-	36Hz
VFD Min SetPt	-	24Hz
OA Damper Position (Hoods On)	-	46%
OA Damper Position (Hoods Off)	-	17%

General	
	Actual
Fan Rotation Correct	NO
Unit Filters Clean	YES
Condensate Drain Installed	YES

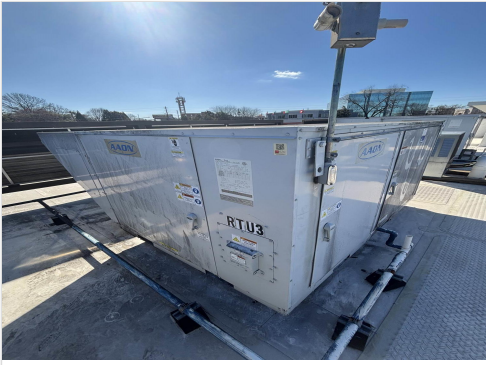
Asset: RT-3

Unit Data	
	Actual
MFG	AAON
Serial Num	201206-ANEK06809
Model Num	RN-013-8-0-EA0A-152
Num OA Filters 1	1
OA Filter Size 1	45X24
Num Final Filter 1	2
Final Filter Size 1	56X45

Test Data		
	Design	Actual
SF CFM	4200	0
SF RPM	-	DD
OA CFM (Hoods On)	800	0
OA CFM (Hoods Off)	350	0
RL Voltage	-	204/208/208
RL Amperage	-	0.1 @ VFD
VFD Max SetPt	-	36Hz
VFD Min SetPt	-	24Hz
OA Damper Position (Hoods On)	-	46%
OA Damper Position (Hoods Off)	-	17%

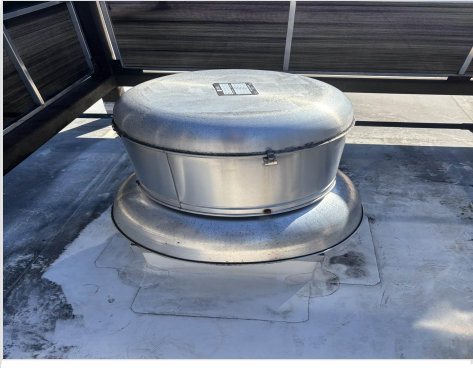
Asset: EF2

Unit Data		
	Design	Actual
MFG	NA	COOK
Model Num	NA	120 ACE 120C15D
Serial Num	-	410SE18515- 00/0001705
Type	-	DOWNBLAST
Configuration	-	VERTICAL

Test Data		
	Design	Actual
CFM	525	520
Fan RPM	-	DD
Fan Rotation	-	CORRECT
Motor RPM	-	DD
System SetPt	-	SPEED CONTROLLER /MEDIUM SPEED
RL Voltage	-	115
RL Amperage	-	2.5
Total ESP	-	0.46"
Fan Inlet SP	-	-0.46"
Fan Discharge SP	-	ATM

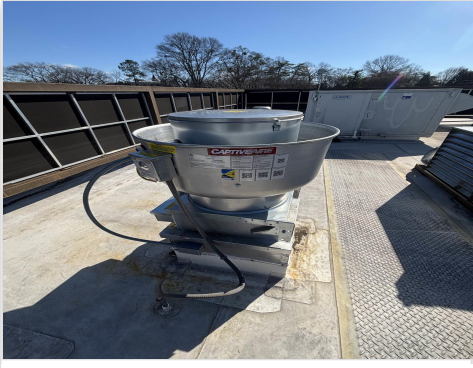
Asset: EF3

Unit Data		
	Design	Actual
MFG	NA	CAPTIVEAIRE
Model Num	NA	DU50HFA
Serial Num	-	8318559
Type	UPBLAST	UPBLAST
Configuration	VERTICAL	VERTICAL

Test Data		
	Design	Actual
CFM	1350	1410
Fan RPM	-	DD
Fan Rotation	-	CORRECT
Motor RPM	-	DD
System SetPt	-	HMI / 53.8Hz
RL Voltage	-	213
RL Amperage	-	2.4
Total ESP	0.75"	0.62"
Fan Inlet SP	-	-0.62"
Fan Discharge SP	-	ATM

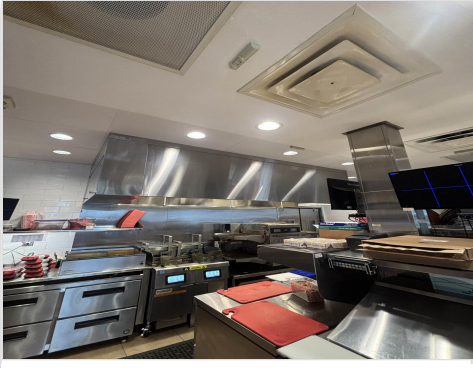
Asset: HD1

Unit Data		
	Design	Actual
MFG	CAPTIVEAIRE	CAPTIVEAIRE
Model Num	6030ND-2-F	6030ND-2
Job / Serial Num	-	8318559
Type	TYPE I CANOPY	TYPE I CANOPY
Hood length	108"	108"
Hood Width	60"	60"

Test Data Exhaust		
	Design	Actual
Filter Type	CAPTRATE SOLO FILTER	BAFFLE FILTERS
Filter Size 1	20X16	20X16
Filter Qty 1	6	6
Filter AK factor size 1	2.08	2.08
Filter Total AK Area	12.48	12.48
Filter1 FPM	-	103
Filter2 FPM	-	116
Filter3 FPM	-	127
Filter4 FPM	-	116
Filter5 FPM	-	111
Filter6 FPM	-	109
Filter Ave FPM(corr)	-	113
CFM	1350	1410

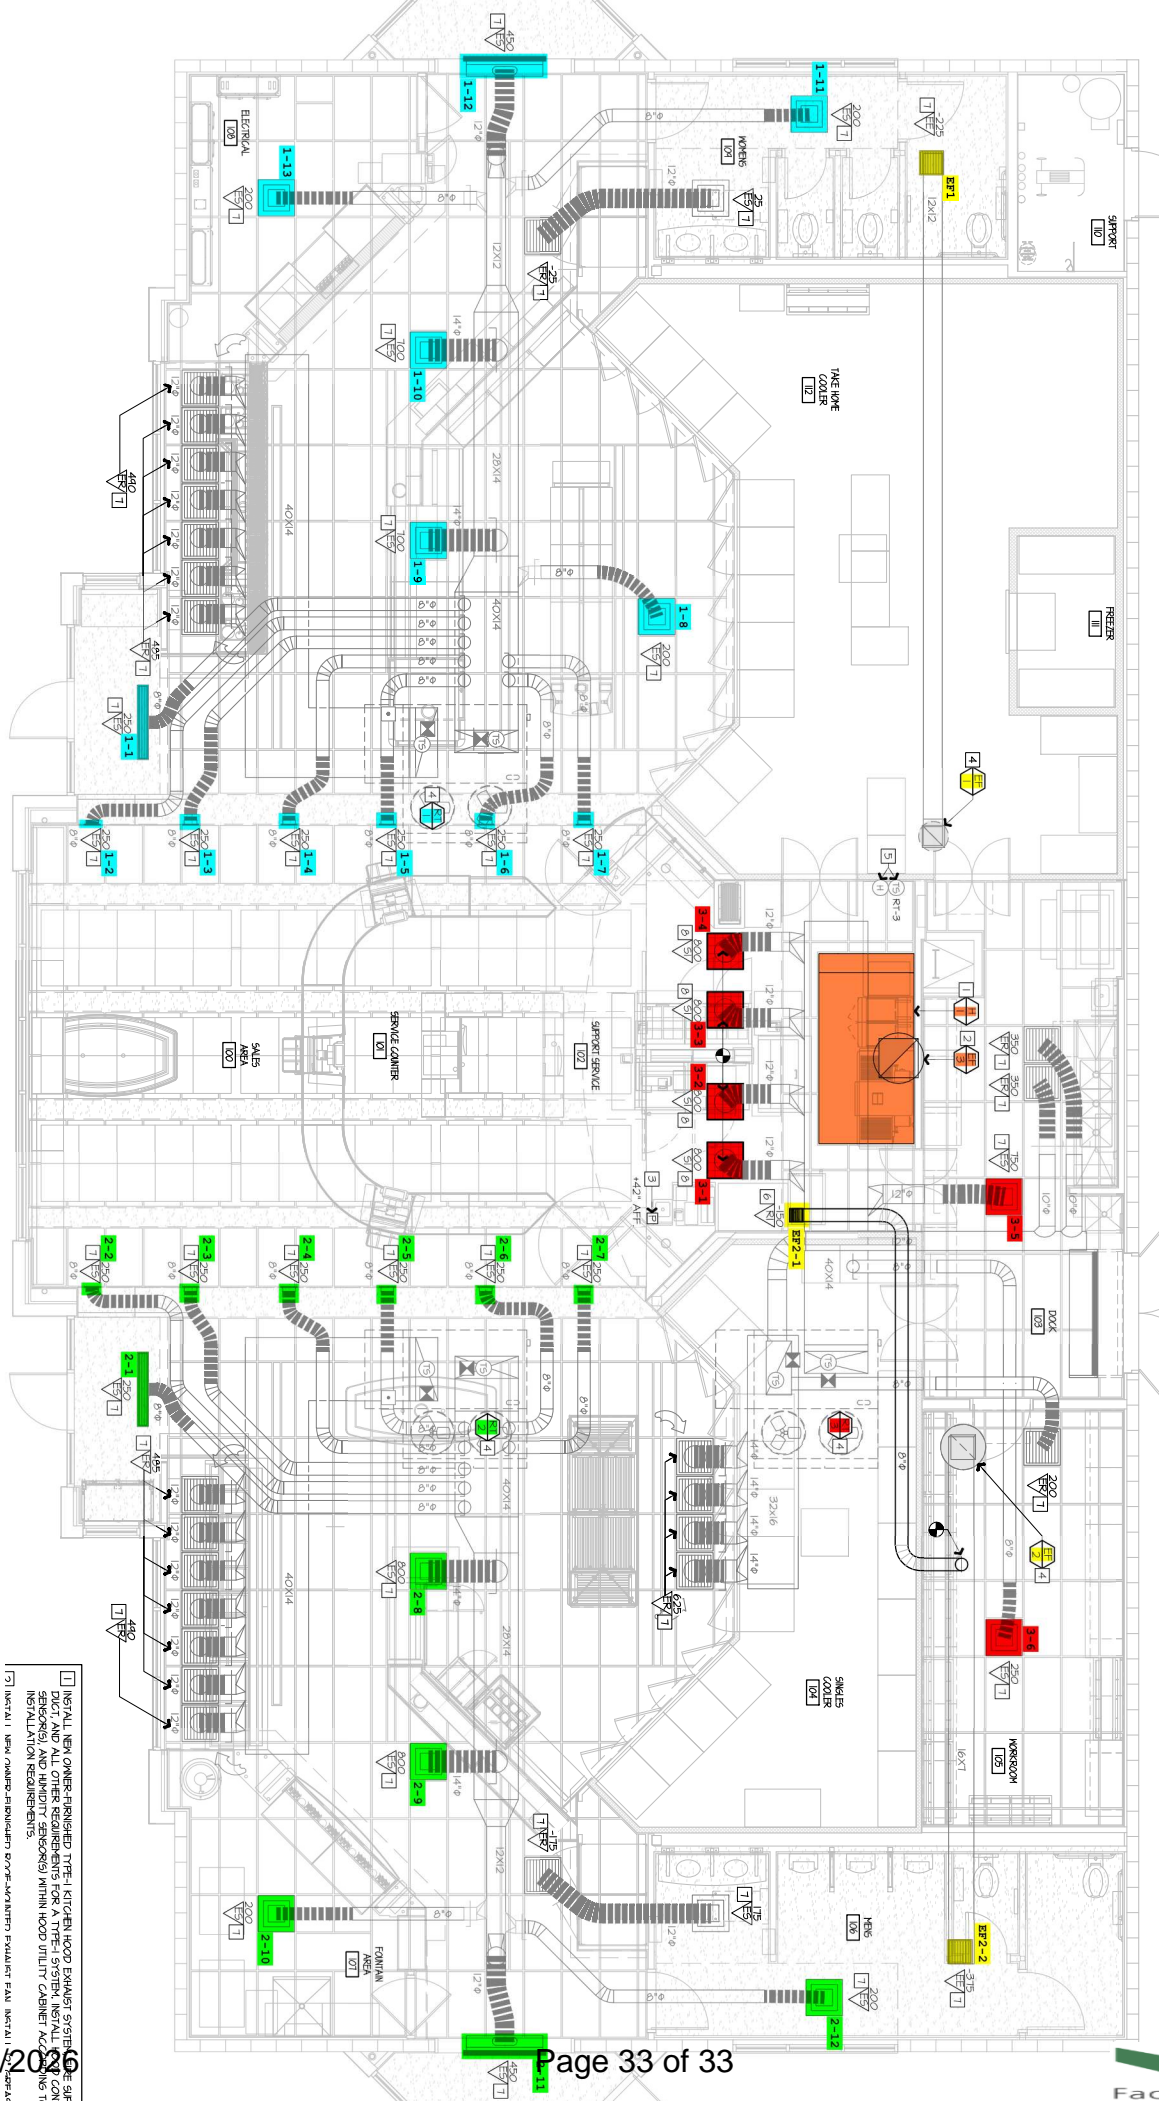
- 1-1 INSTALL NEW OWNER-FURNISHED TYPE-I KITCHEN HOOD EXHAUST SYSTEMS, SUPPLY DUCT, AND ALL OTHER REQUIREMENTS FOR A TYPE-I SYSTEM INSTALL AND CONNECT TO EXISTING EXHAUST SYSTEMS WITHIN HOOD UTILITY CABINET AND TO EXISTING EXHAUST SYSTEMS.
- 2-1 INSTALL NEW OWNER-FURNISHED BOVE-AWNING EXHAUST FAN INSTALL
