**Report: TAB REPORT**  
**Function: Test, Adjust, & Balance**  
**Date: 08/04/2025**  
**Completed By: National TAB**

## 08-04-25 CHIPOTLE #5250 WASUSAU, WI

225407 RIB MOUNTAIN DR

Project: 08-04-25 CHIPOTLE #5250 WASUSAU, WI

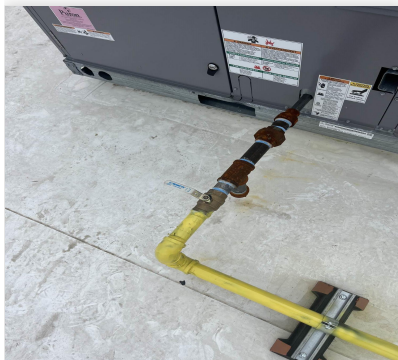
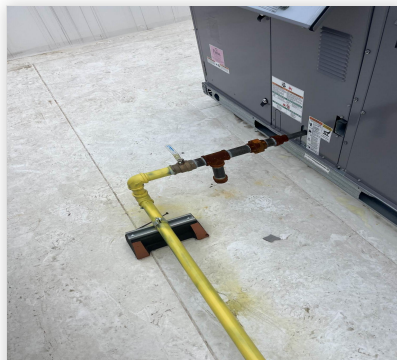
Is gas piping installed and valves turned on?

No

Valves were turned off during TAB. Notified MC and GC.

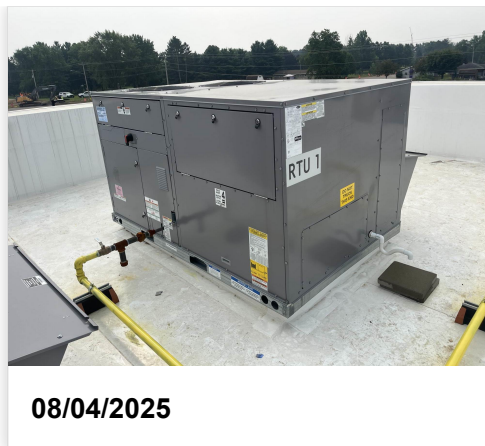
## Unit Data - PHOTO LOG

Asset: RTU1

AREA: KITCHEN

Unit Data		
	Design	Actual
MFG	CARRIER	CARRIER
Serial Num	-	0424P63051
Model Num	48FC-M12	48FCFN12D3
Type	RTU	RTU
Configuration	VERTICAL	VERTICAL
Num OA Filters 1	-	1
OA Filter Size 1	-	35X19.5
Num Final Filter 1	-	4
Final Filter Size 1	-	20X20X2

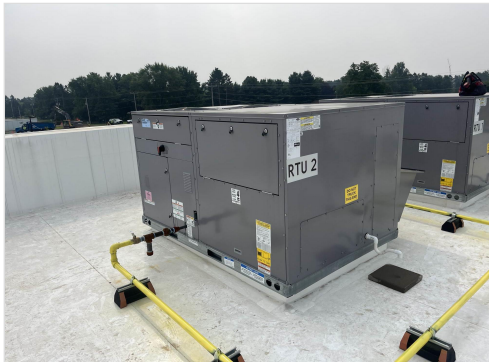
### Unit Data - PHOTO LOG

Asset: RTU2

AREA: DINING

Unit Data		
	Design	Actual
MFG	CARRIER	CARRIER
Serial Num	-	0524P63466
Model Num	48FC-M12	48FCFN12D3
Type	RTU	RTU
Configuration	VERTICAL	VERTICAL
Num OA Filters 1	-	1
OA Filter Size 1	-	35X19.5
Num Final Filter 1	-	4
Final Filter Size 1	-	20X20X2

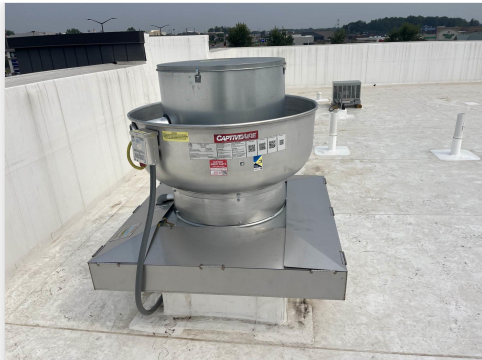
### Unit Data - PHOTO LOG

Asset: EF1

AREA:HOOD FAN

Unit Data		
	Design	Actual
MFG	CAPTIVEAIRE	CAPTIVEAIRE
Model Num	DU180HFA	DU180HFA
Serial Num	-	6820702
Type	UPBLAST	UPBLAST
Configuration	VERTICAL	VERTICAL

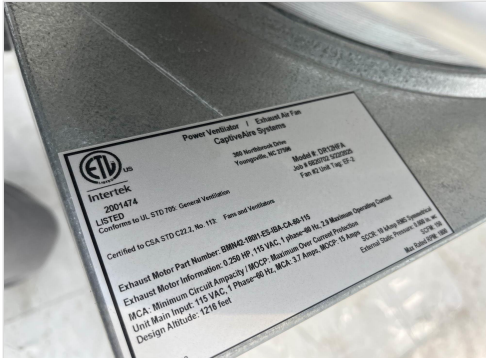
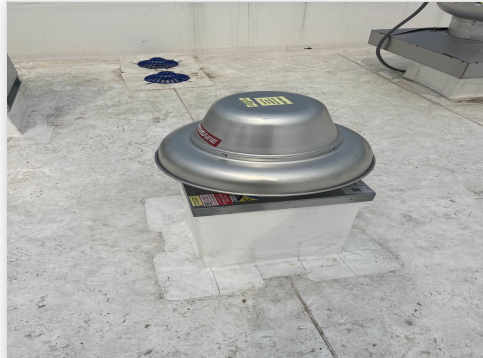
### Unit Data - PHOTO LOG

Asset: EF2

AREA:RESTROOMS

Unit Data		
	Design	Actual
MFG	CAPTIVEAIRE	CAPTIVEAIRE
Model Num	DR12HFA	DR12HFA
Serial Num	-	6820702
Type	DOWNBLAST	DOWNBLAST
Configuration	VERTICAL	VERTICAL

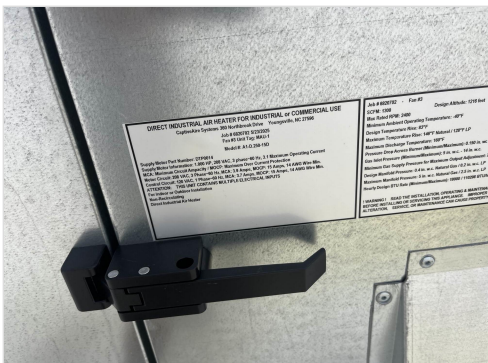
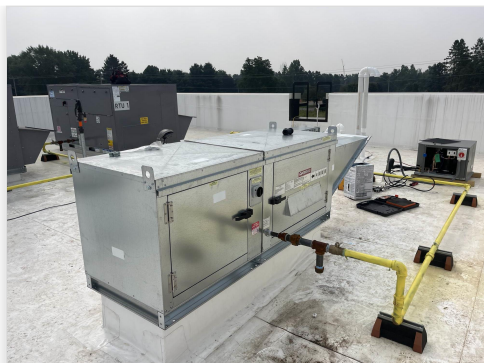
### Unit Data - PHOTO LOG

Asset: MUA1

AREA:HOOD MUA

Unit Data		
	Design	Actual
MFG	CAPTIVEAIRE	CAPTIVEAIRE
Model Num	A1-D.250-15D	A1-D.250-15D
Serial Num	-	6820702
Type	MUA	MUA
Configuration	VERTICAL	VERTICAL

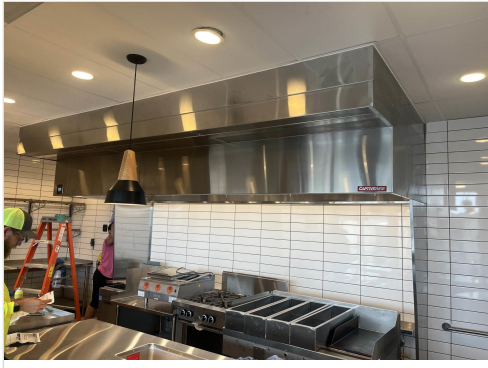
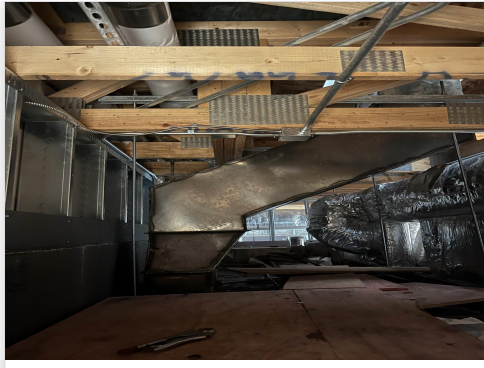
## Unit Data - PHOTO LOG

Asset: HD1

AREA: KITCHEN HOOD

Unit Data		
	Design	Actual
MFG	CAPTIVEAIRE	CAPTIVEAIRE
Model Num	5424 ND-2-ACPSP-F	5424 ND-2-ACPSP-F
Job / Serial Num	-	6820702
Type	TYPE I - CANOPY	TYPE I - CANOPY
Hood length	153"	153"
Hood Width	54"	54"
Supply Plenum Type	-	ACPSP
Supply Plenum Width	-	9"
Supply Plenum Length	-	165"

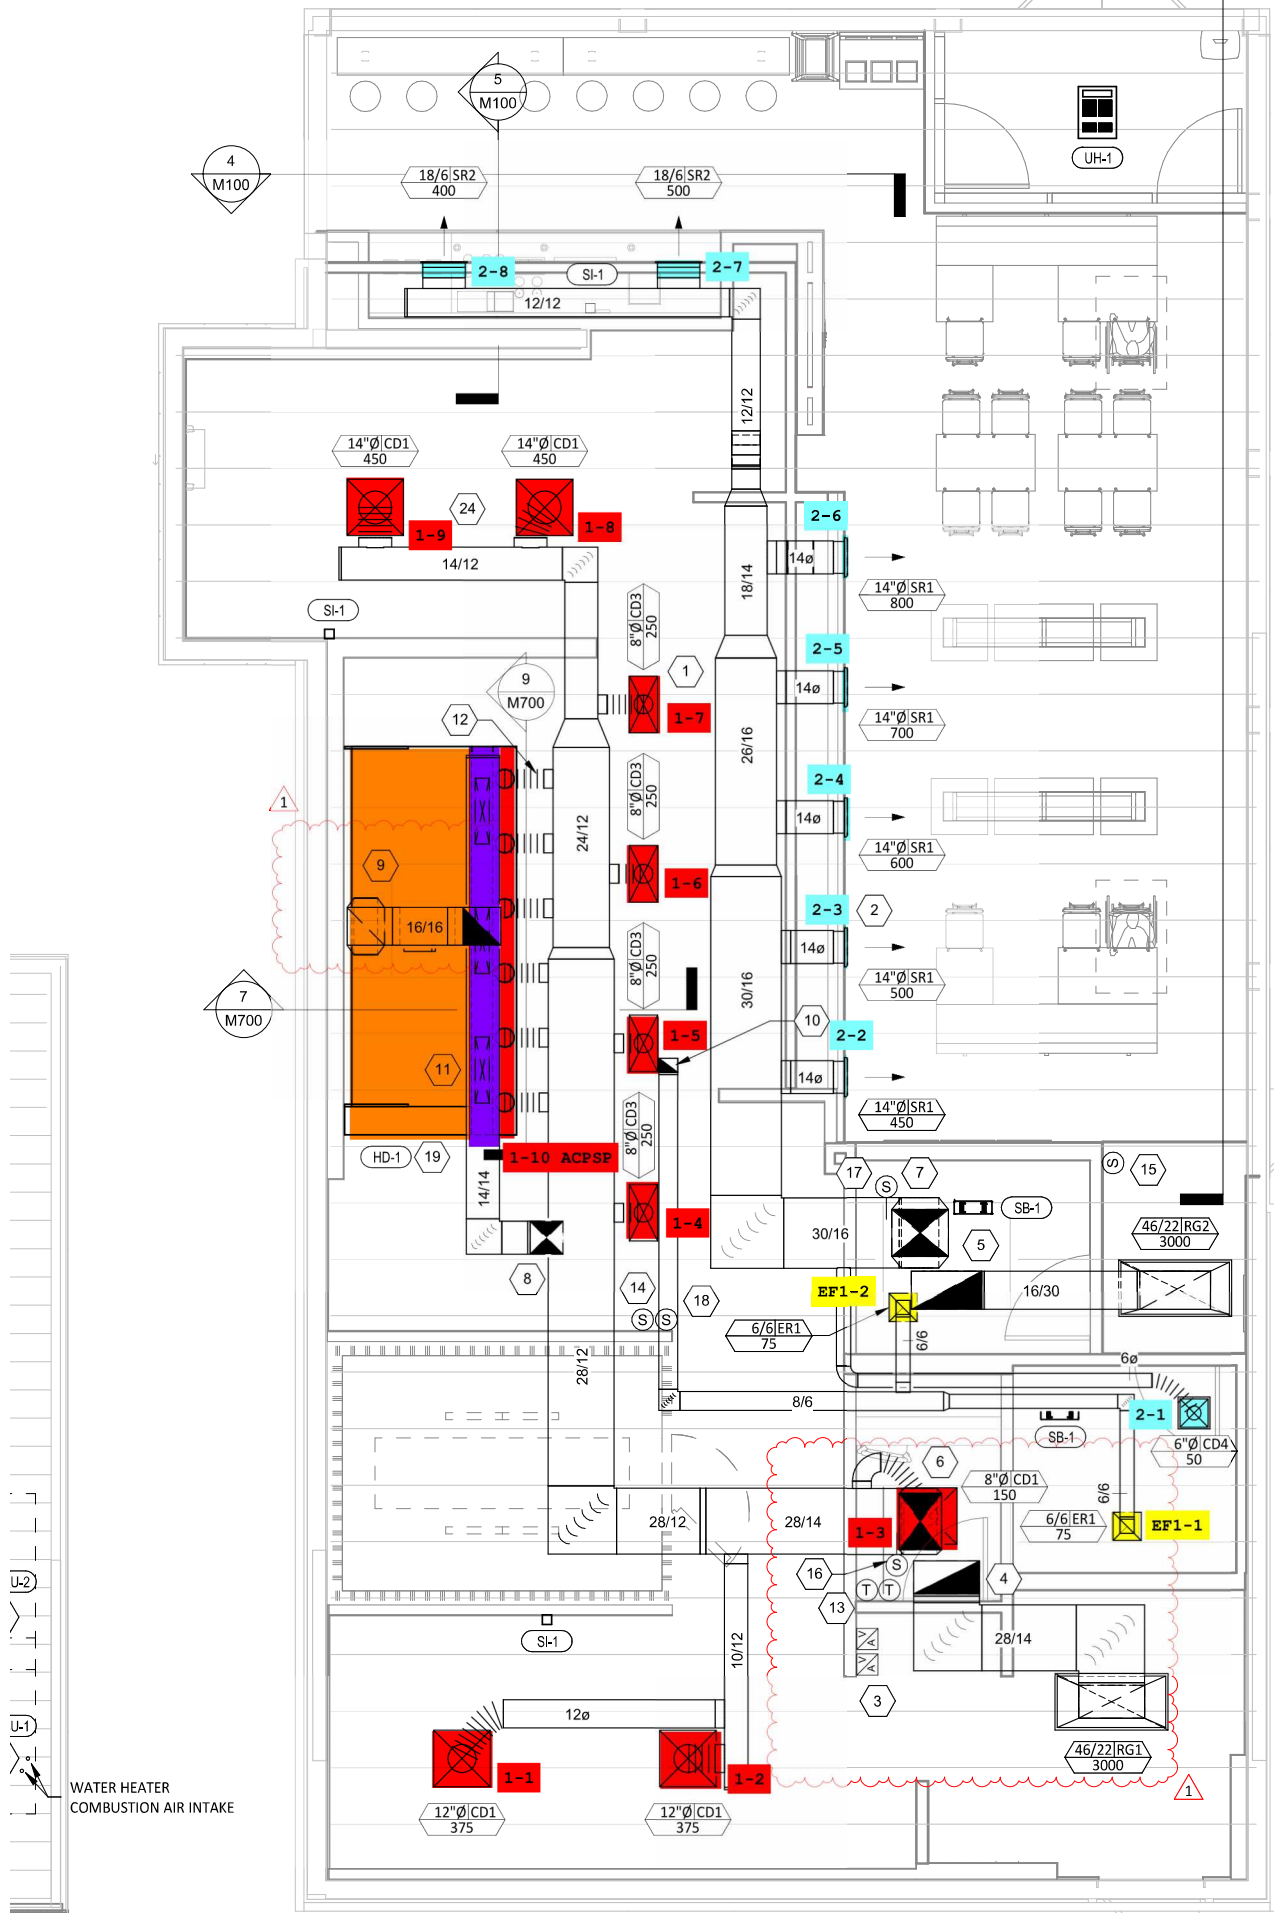
### HVAC FLOOR PLAN

WATER HEATER  
COMBUSTION AIR INTAKE
