Report: TAB REPORT
Function: Test, Adjust, & Balance
Date: 08/04/2025
Completed By: National TAB

PROJECT
08-04-25 CHIPOTLE #5250 WAUSAU, WI

Project: 08-04-25 CHIPOTLE #5250 WAUSAU, WI

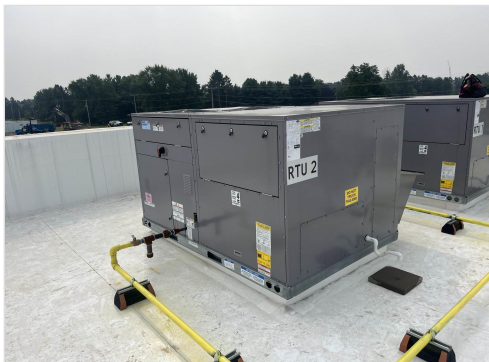
Unit Data - PHOTO LOG

Unit Data		
	Design	Actual
MFG	CARRIER	CARRIER
Serial Num	-	0524P63466
Model Num	48FC-M12	48FCFN12D3
Type	RTU	RTU
Configuration	VERTICAL	VERTICAL
Num OA Filters 1	-	1
OA Filter Size 1	-	35X19.5
Num Final Filter 1	-	4
Final Filter Size 1	-	20X20X2

Test Data		
	Design	Actual
SF CFM	4000	4146
SF RPM	-	1686
RA CFM	3000	3179
OA CFM	1000	967
RL Voltage	-	213/213/213
RL Amperage	-	4.3/4.5/4.5
SF Rotation	-	CORRECT
SF System SetPt	-	7.1 VDC
RA Damper Position	-	MECHANICALLY LINKED
Min OA Damper Position	-	5.15VDC (39%)
Min OA Damper Type	-	ECONOMIZER
OA Enthalpy Setpt	-	ES5

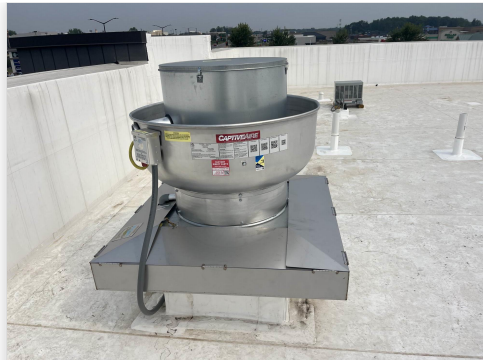
Unit Data - PHOTO LOG

Unit Data		
	Design	Actual
MFG	CAPTIVEAIRE	CAPTIVEAIRE
Model Num	DU180HFA	DU180HFA
Serial Num	-	6820702
Type	UPBLAST	UPBLAST
Configuration	VERTICAL	VERTICAL

Test Data		
	Design	Actual
CFM	2550	2561
Fan RPM	-	1026
Fan Rotation	-	CCW, CORRECT
Motor RPM	-	1026
System SetPt	-	52.6 HZ
RL Voltage	-	105 @ VFD
RL Amperage	-	4.9 @ VFD
Total ESP	1.450"	0.96"
Fan Inlet SP	-	-0.96"
Fan Discharge SP	-	ATM

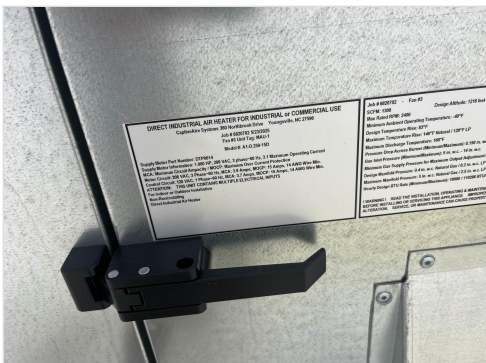
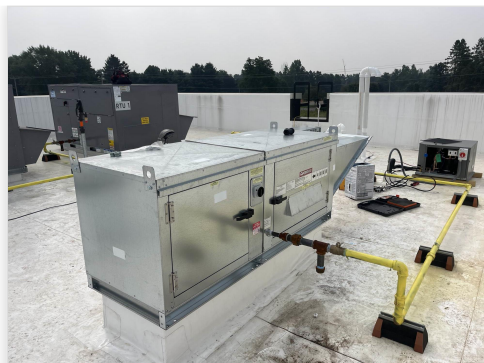
Unit Data - PHOTO LOG

Unit Data		
	Design	Actual
MFG	CAPTIVEAIRE	CAPTIVEAIRE
Model Num	A1-D.250-15D	A1-D.250-15D
Serial Num	-	6820702
Type	MUA	MUA
Configuration	VERTICAL	VERTICAL

Test Data		
	Design	Actual
CFM	1300	1349
SF RPM	-	1291
Motor RPM	-	1291
SF System SetPt	-	44.5 HZ
RL Voltage	-	100@ VFD
RL Amperage	-	2.1 @ VFD
Total ESP	-	0.42"
Fan Discharge SP	-	0.42"

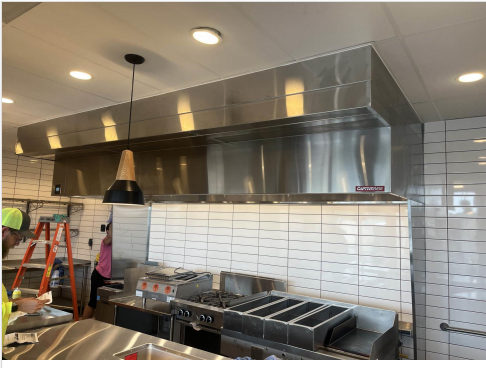
Unit Data - PHOTO LOG

Unit Data		
	Design	Actual
MFG	CAPTIVEAIRE	CAPTIVEAIRE
Model Num	5424 ND-2-ACPSP-F	5424 ND-2-ACPSP-F
Job / Serial Num	-	6820702
Type	TYPE I - CANOPY	TYPE I - CANOPY
Hood length	153"	153"
Hood Width	54"	54"
Supply Plenum Type	-	ACPSP
Supply Plenum Width	-	9"
Supply Plenum Length	-	165"

Test Data Exhaust		
	Design	Actual
Filter Type	CAPTRATE SOLO	CAPTRATE SOLO
Filter Size 1	16X16	16X16
Filter Qty 1	9	9
Filter AK factor size 1	1.62	1.62
Filter Total AK Area	14.58	14.58
Filter1 FPM	-	174
Filter2 FPM	-	166
Filter3 FPM	-	201
Filter4 FPM	-	195
Filter5 FPM	-	187
Filter6 FPM	-	161
Filter7 FPM	-	167
Filter8 FPM	-	163
Filter Ave FPM(corr)	-	175.67
CFM	2550	2561
