Report: TAB Report
Function: Test, Adjust, & Balance
Date: 07/31/2025
Completed By: National TAB

PROJECT
07-28-25 WAWA #7400 GREENFIELD, IN

Project: 07-28-25 WAWA #7400 GREENFIELD, IN

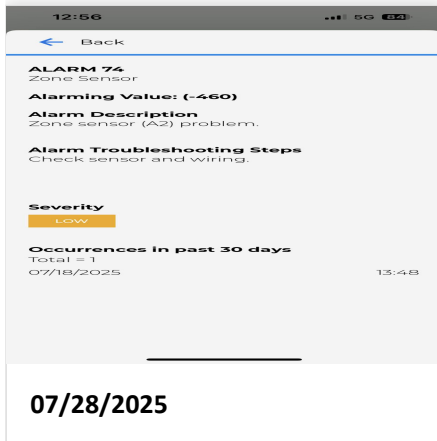
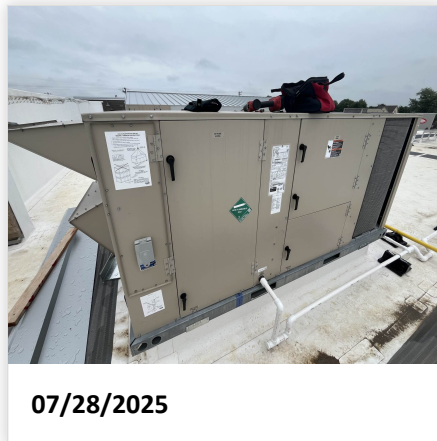
Issue Name : RTU-1 Zone sensor Alarm
Description : RTU-1 has an alarm for zone sensor, recommend inspecting wiring at space sensor and confirm wires are landed properly from the sensor to wiring at the units electric panel.
Created By : National TAB **Assigned To :** National TAB - Dylan Crisman
Status : Open
Priority : High **Asset Tag :**
Originated Date : 07/28/2025 - Dylan Crisman - National TAB

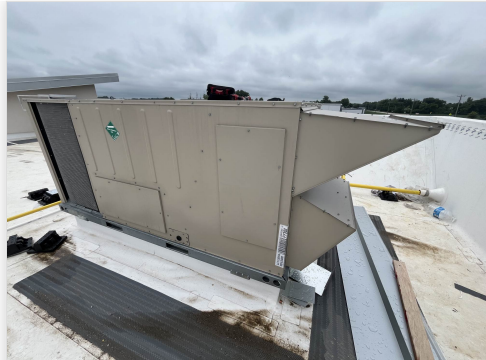
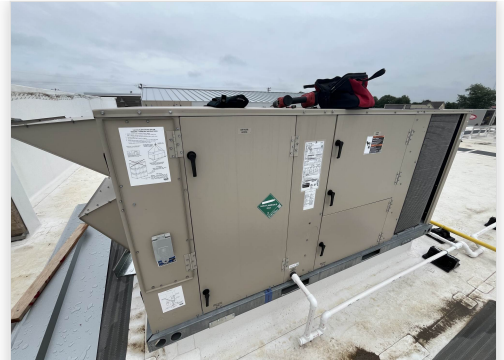
Unit Data - PHOTO LOG

Asset: RTU1

Test Data		
	Design	Actual
SF CFM	4500	4593
SF RPM	-	1424
MOTOR RPM	-	1424
RA CFM	3800	3874
OA CFM	700	719
RL Voltage	-	208/208/209
RL Amperage	-	4.4/4.3/4.4
SF System SetPt	-	80%
RA Damper Position	-	MECHANICAL LINKAGE
RA Damper Type	-	ECONOMIZER
OA Damper Position	-	18%
OA Damper Type	-	ECONOMIZER

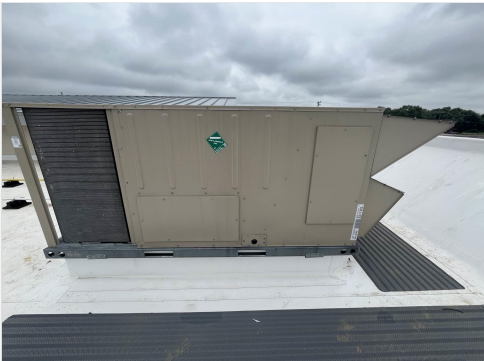
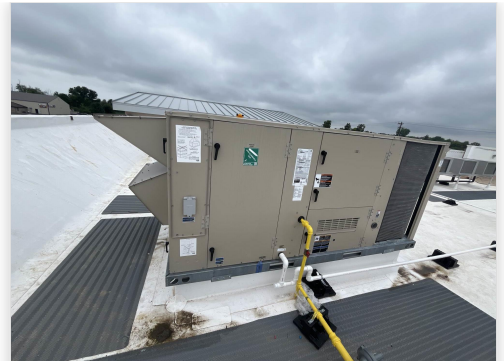
Unit Data - PHOTO LOG

Asset: RTU2

Test Data		
	Design	Actual
SF CFM	3400	3474
SF RPM	-	961
MOTOR RPM	-	961
RA CFM	3020	3068
OA CFM	380	406
RL Voltage	-	208/206/209
RL Amperage	-	1.6/1.7/1.7
SF System SetPt	-	54%
RA Damper Position	-	MECHANICAL LINKAGE
RA Damper Type	-	ECONOMIZER
OA Damper Position	-	27%
OA Damper Type	-	ECONOMIZER

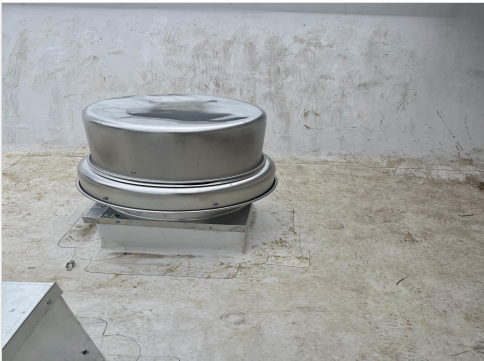
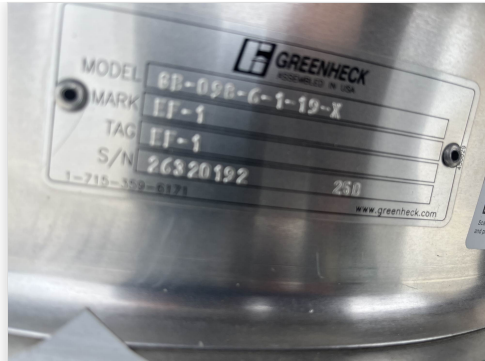
Unit Data - PHOTO LOG

Asset: EF1

Test Data		
	Design	Actual
CFM	375	366
Fan RPM	-	1352
Fan Rotation	-	CCW
Motor RPM	-	1760
System SetPt	-	3 TURNS OPEN
Total ESP	.38"	0.41"
Fan Inlet SP	-	-0.41"
Fan Discharge SP	-	ATM

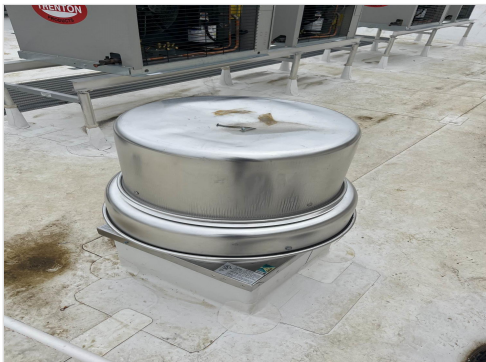
Unit Data - PHOTO LOG

Asset: EF2

Test Data		
	Design	Actual
CFM	400	413
Fan RPM	-	1180
Fan Rotation	-	CCW
Motor RPM	-	1752
System SetPt	-	3 TURNS OPEN
Total ESP	.38"	0.29"
Fan Inlet SP	-	-0.29"
Fan Discharge SP	-	ATM

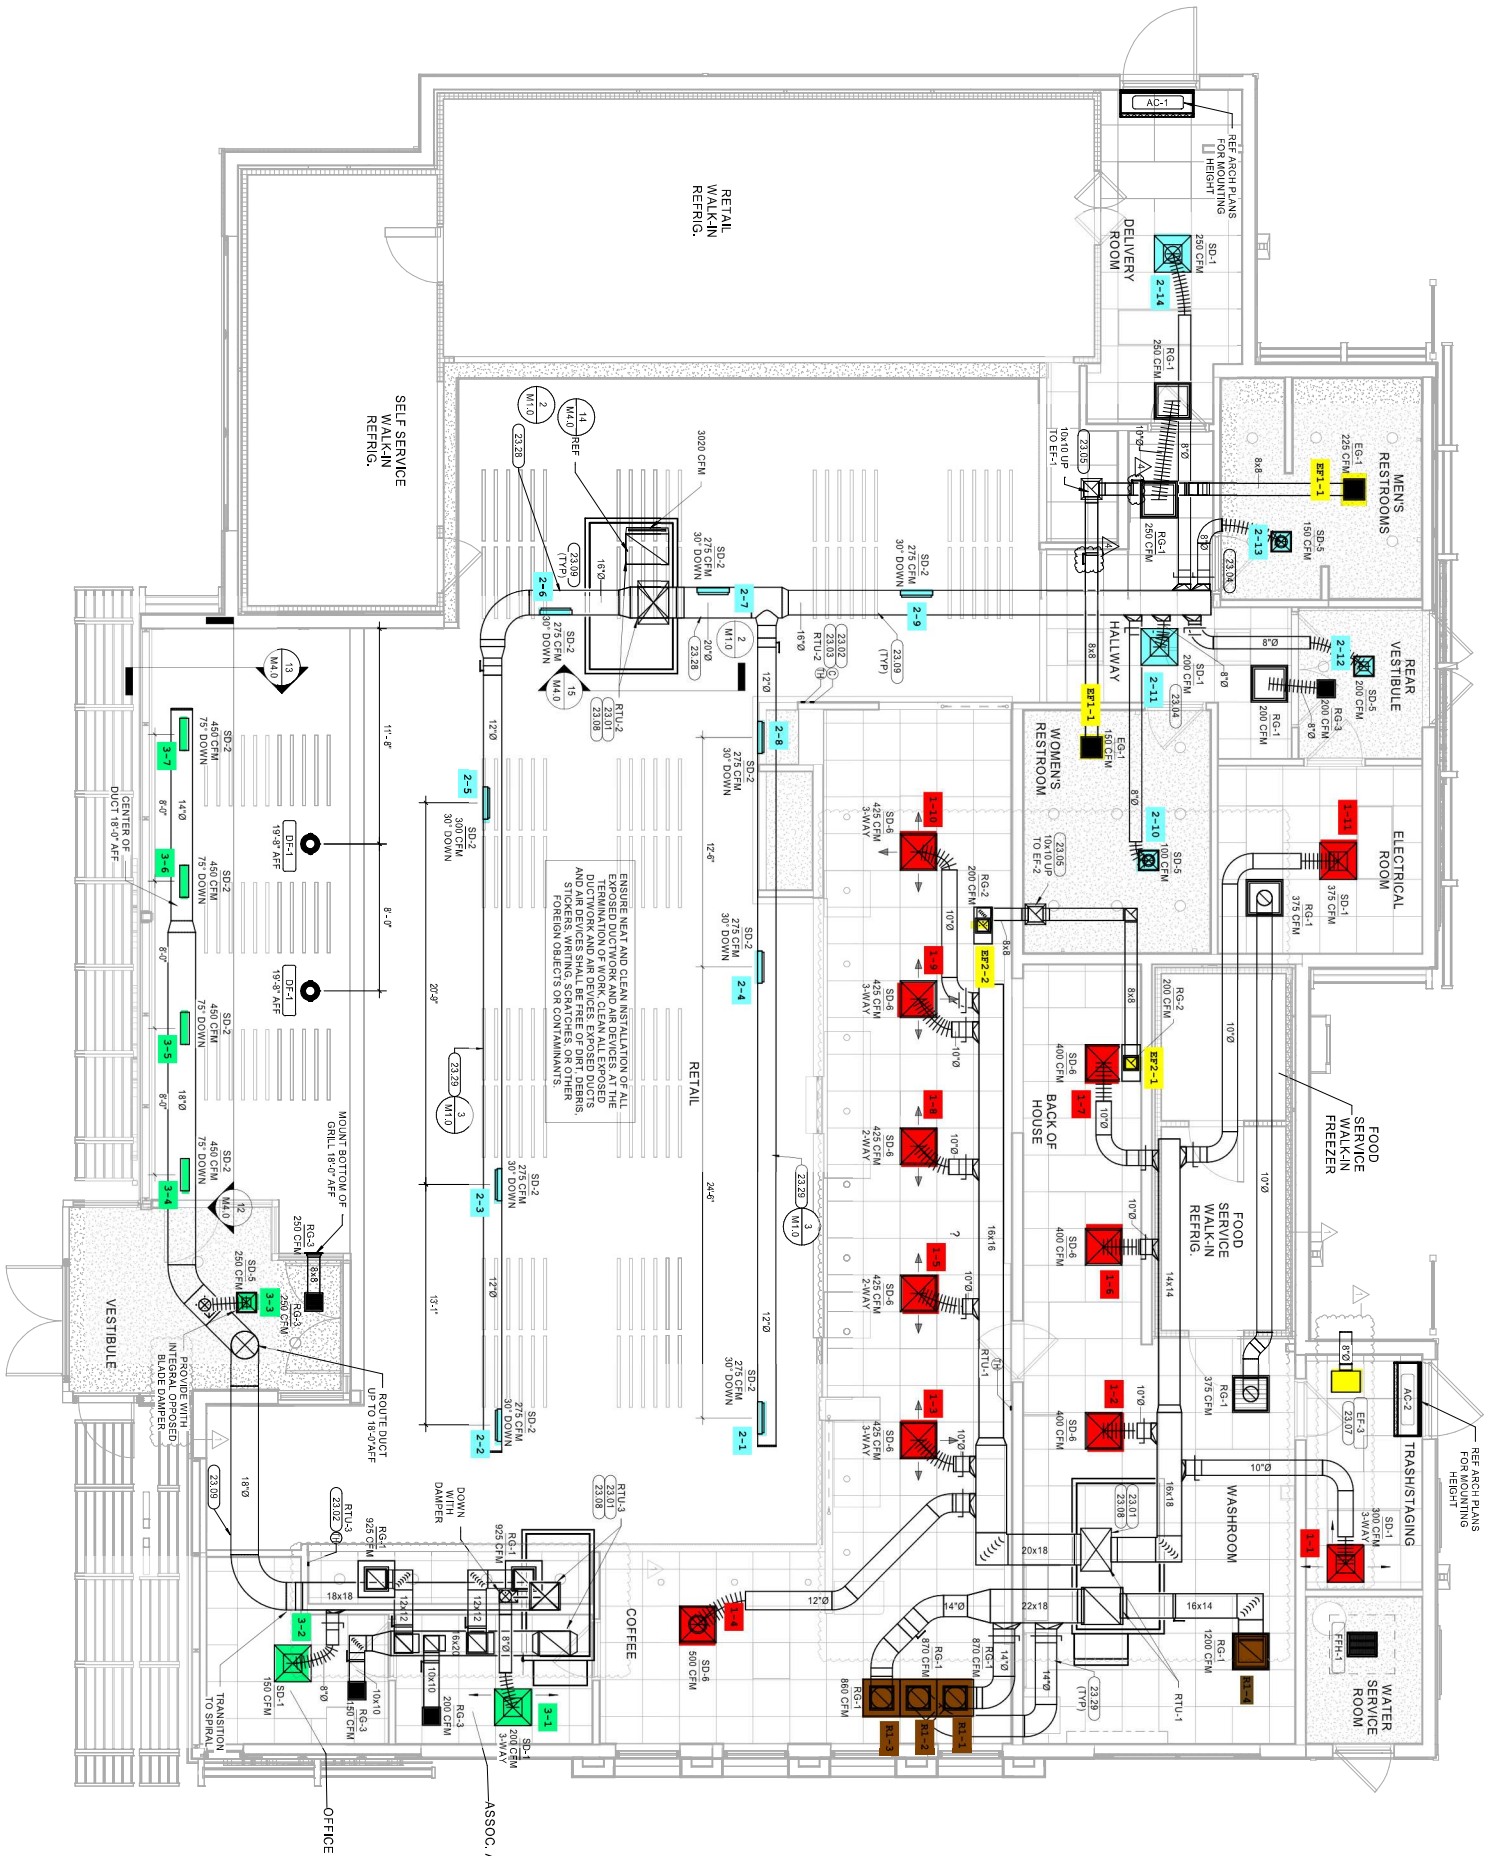
Issue Name : EF-3 low on flow
Description : EF-3 is low on flow at 127/200CFM. unable to change speeds as the fan is missing the speed controller. Per plans it should have a speed controller installed for speed adjustment. Recommend installing speed controller so it can be sped up.
Created By : National TAB **Assigned To :** National TAB - Dylan Crisman
Status : Open
Priority : High **Asset Tag :**
Originated Date : 07/29/2025 - Dylan Crisman - National TAB

Fan is low on flow at 127/200CFM. Fan is missing speed controller, unable to adjust speeds. Issue created.
