Report: TAB REPORT
Function: Test, Adjust, & Balance
Date: 01/29/2025
Completed By: National TAB

PROJECT
01-20-25 CULVERS AVON PARK, FL

Project: 01-20-25 CULVERS AVON PARK, FL

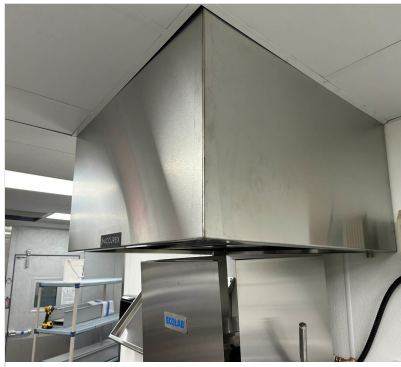
Top of enclosure not sealed against ceiling

Issue Name : Hoods - Not Sealed At Ceiling
Description : All hoods have a small gap between the top enclosure and the ceiling grid. Recommend sealing.
Created By : National TAB **Assigned To :** National TAB - Will Turnbough
Status : Open
Priority : Low **Asset Tag :** HD1
Originated Date : 01/24/2025 - Mark Johnson - National TAB

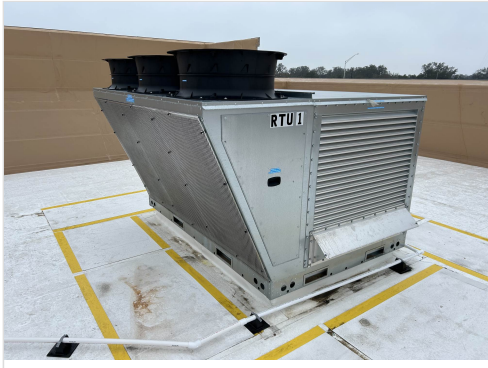
Unit Data - PHOTO LOG

Unit Data		
	Design	Actual
MFG	CAPTIVEAIRE	CAPTIVEAIRE
Serial Num	-	6282185
Model Num	CASTRUE452-2420TDOAS	CAS-HVAC3-E.452-24-20T
Type	RTU	RTU
Configuration	VERTICAL	VERTICAL
Num OA Filters 1	-	4
OA Filter Size 1	-	16x25x2
Num Final Filter 1	-	8
Final Filter Size 1	-	20x25x2

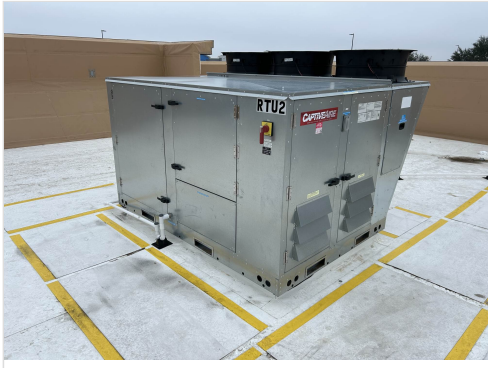
Unit Data - PHOTO LOG

Unit Data		
	Design	Actual
MFG	CAPTIVEAIRE	CAPTIVEAIRE
Serial Num	-	6282185
Model Num	CASTRUE452-2420TDOAS	CAS-HVAC3-E.452-24-20T
Type	RTU	RTU
Configuration	VERTICAL	VERTICAL
Num OA Filters 1	-	4
OA Filter Size 1	-	16x25x2
Num Final Filter 1	-	8
Final Filter Size 1	-	20x25x2

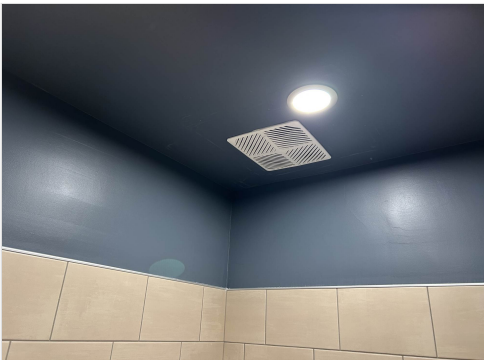
Unit Data - PHOTO LOG

Unit Data		
	Design	Actual
MFG	ACCUREX	ACCUREX
Model Num	XCR-A200	XCR-A200
Serial Num	-	25037577
Type	CEILING	CEILING
Configuration	VERTICAL	VERTICAL

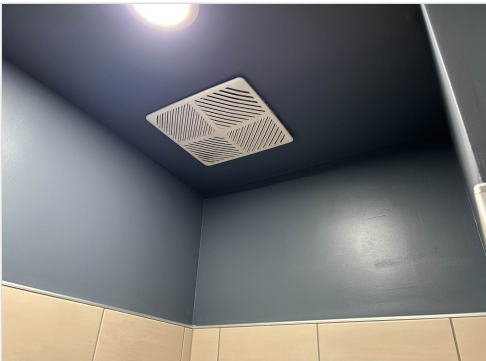
Unit Data - PHOTO LOG

Unit Data		
	Design	Actual
MFG	ACCUREX	ACCUREX
Model Num	XCR-B70	XCR-B70
Serial Num	-	25037579
Type	CEILING	CEILING
Configuration	VERTICAL	VERTICAL

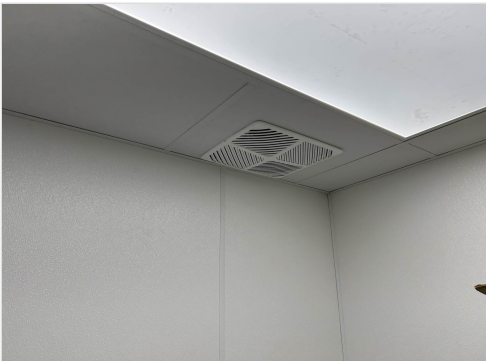
Unit Data - PHOTO LOG

Unit Data		
	Design	Actual
MFG	ACCUREX	ACCUREX
Model Num	XCR-B70	XCR-B70
Serial Num	-	25037580
Type	CEILING	CEILING
Configuration	VERTICAL	VERTICAL

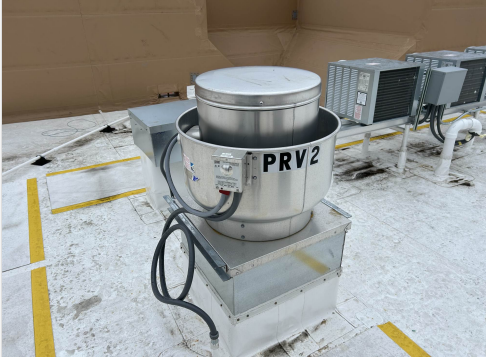
Unit Data - PHOTO LOG

Unit Data		
	Design	Actual
MFG	ACCUREX	ACCUREX
Model Num	XCUE-140VG	XCUE-140-10-VG-1-26-G
Serial Num	-	25038074
Type	-	CENTRIFUGAL
Configuration	-	UPBLAST

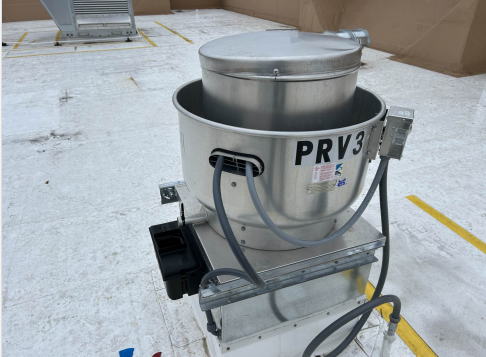
Unit Data - PHOTO LOG

Unit Data		
	Design	Actual
MFG	ACCUREX	ACCUREX
Model Num	XCUE-140VG	XCUE-140-10-VG-1-26-G
Serial Num	-	25038076
Type	-	CENTRIFUGAL
Configuration	-	UPBLAST

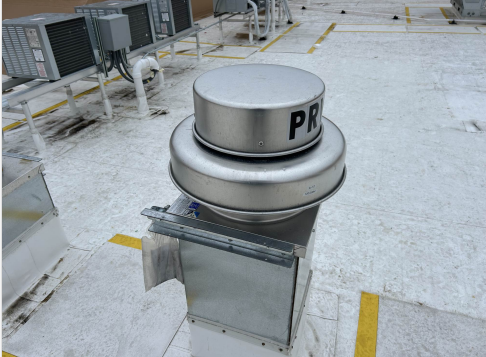
Unit Data - PHOTO LOG

Issue Name : PRV 4 - High Flow
Description : PRV 4 (dishwasher hood fan) is outputting 432 CFM (123% design). Fan is wired to the lowest speed setting (1050 RPM). May require an additional speed controller to slow the fan further.
Created By : National TAB **Assigned To :** National TAB - Will Turnbough
Status : Open
Priority : [Medium](#) **Asset Tag :** PRV4
Originated Date : 01/24/2025 - Mark Johnson - National TAB
