Report: TAB Report
Function: Test, Adjust, & Balance
Date: 01/29/2025
Completed By: National TAB

PROJECT
01-20-25 CULVERS AVON PARK, FL

Project: 01-20-25 CULVERS AVON PARK, FL

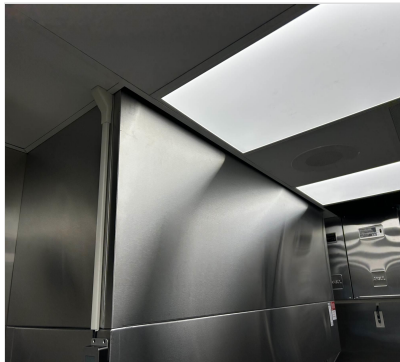
HD-1

Top of enclosure not sealed against ceiling

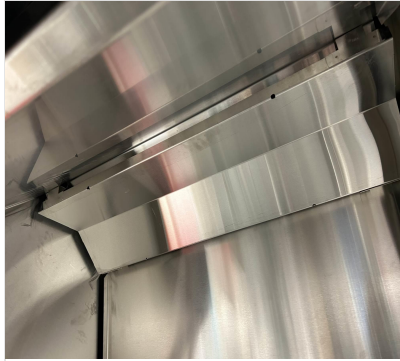
HD-3

Are the correct number and size of filters installed, and are they installed correctly? Fail

Baffles not installed correctly (hooks at top of hood are defective from manufacturer)

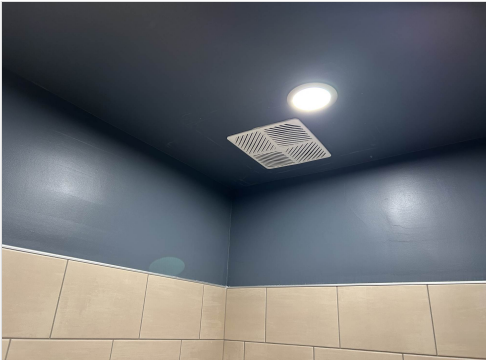
Asset: EF1

Unit Data		
	Design	Actual
MFG	ACCUREX	ACCUREX
Model Num	XCR-A200	XCR-A200
Serial Num	-	25037577
Type	CEILING	CEILING
Configuration	VERTICAL	VERTICAL

Test Data		
	Design	Actual
CFM	220	223
Fan RPM	831	900
Fan Rotation	-	CCW
Motor RPM	-	900
System SetPt	-	MAX
RL Voltage	-	123
RL Amperage	-	0.4

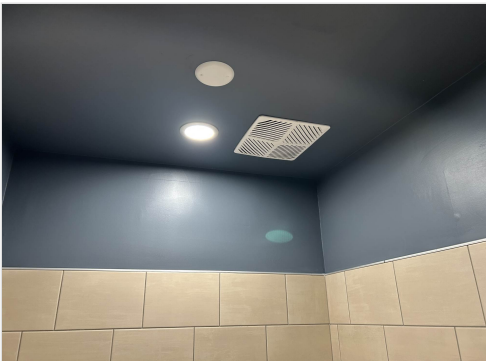
Asset: EFB3

Unit Data		
	Design	Actual
MFG	ACCUREX	ACCUREX
Model Num	XCR-B70	XCR-B70
Serial Num	-	25037581
Type	CEILING	CEILING
Configuration	VERTICAL	VERTICAL

Test Data		
	Design	Actual
CFM	70	66
Fan RPM	644	675
Fan Rotation	-	CCW
Motor RPM	-	675
System SetPt	-	MAX
RL Voltage	-	122
RL Amperage	-	0.15

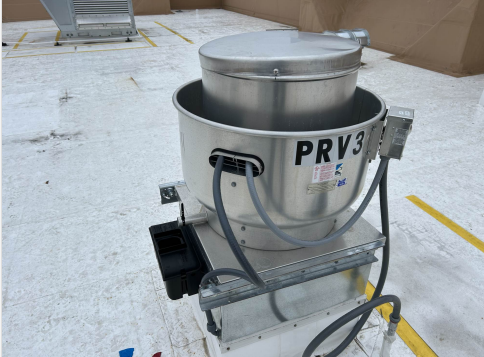
Asset: PRV3

Unit Data		
	Design	Actual
MFG	ACCUREX	ACCUREX
Model Num	XCUE-140VG	XCUE-140-10-VG-1-26-G
Serial Num	-	25038076
Type	-	CENTRIFUGAL
Configuration	-	UPBLAST

Test Data		
	Design	Actual
CFM	1500	1515
Fan RPM	-	1068
Fan Rotation	-	CW
Motor RPM	-	1068
System SetPt	-	6.1 V
RL Voltage	-	121
RL Amperage	-	3.4
Total ESP	-	0.35"
Fan Inlet SP	-	-0.35"
Fan Discharge SP	-	ATM
