Report: TAB Report CFA# 01527
Function: Test, Adjust, & Balance
Date: 10/27/2023

**10-16-23 CHICK-FIL-A #01527 - EXTON, PA
(LIONSVILLE, FSU) REINVEST**

Project: 10-16-23 CHICK-FIL-A #01527 - EXTON, PA (LIONSVILLE, FSU) REINVEST

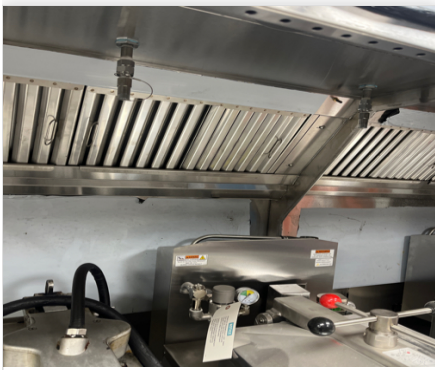
H1Lmissinggreasecup.j..
10/19/2023

Issue Name : NON-CRITICAL: HD 1L grease cup
Description : Hd1L is missing it's grease cup. If not found on-site contact Halton to order replacement.
Created By : National TAB **Assigned To :** National TAB - Tyler Youells
Status : Open
Originated Date : 10/19/2023 - Tyler Youells - National TAB

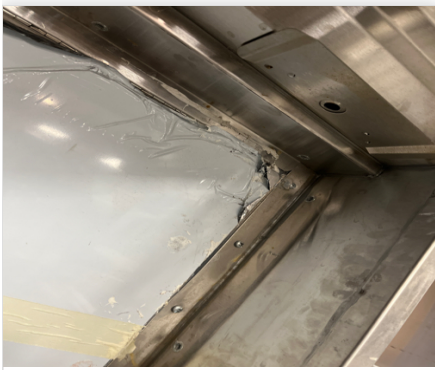
Gussetbolts
10/19/2023

Issue Name : NON-CRITICAL: HD 3 Gusset bolts
Description : Hood 3 missing the gusset bracket bolts. These were to be replaced when the gusset bracket was removed.
Created By : National TAB **Assigned To :** National TAB - Tyler Youells
Status : Open
Originated Date : 10/19/2023 - Tyler Youells - National TAB

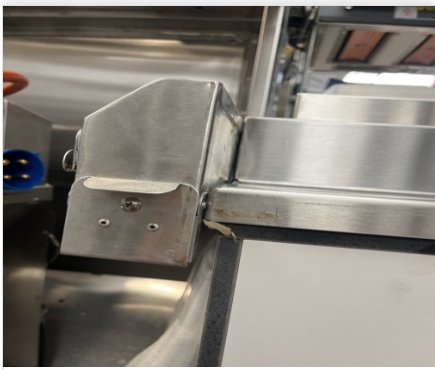
Hd3sidearm
10/27/2023

Issue Name : NON-CRITICAL: HD-3 Side arm Bracket
Description : HD-3 Sidearm bracket is not installed, does not appear to be on-site. See MH1.1 Integral Side arm Jet detail.
Created By : National TAB **Assigned To :** National TAB - Tyler Youells
Status : Open
Originated Date : 10/27/2023 - Tyler Youells - National TAB

Hd-3 is missing sidearm bracket

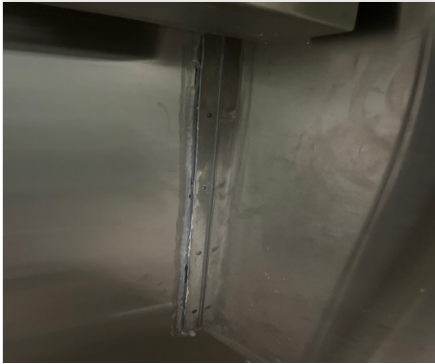
**Hood2prepunch
10/21/2023**

Issue Name : NON-CRITICAL: HD2 Prepunch
Description : Hood 2 is not secured at the prepunch locations.
Created By : National TAB **Assigned To :** National TAB - Tyler Youells
Status : Open
Originated Date : 10/21/2023 - Tyler Youells - National TAB

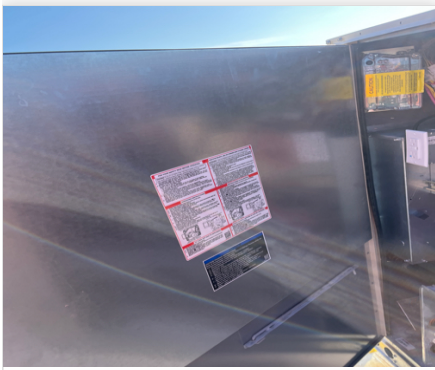
**Nodiagram
10/19/2023**

Issue Name : NON-CRITICAL: Laminated control diagram
Description : Each RTU to have a copy of the laminated control wire diagram found on: M4.1 Detail 2 See: Note
Created By : National TAB **Assigned To :** National TAB - Tyler Youells
Status : Open
Originated Date : 10/19/2023 - Tyler Youells - National TAB

No

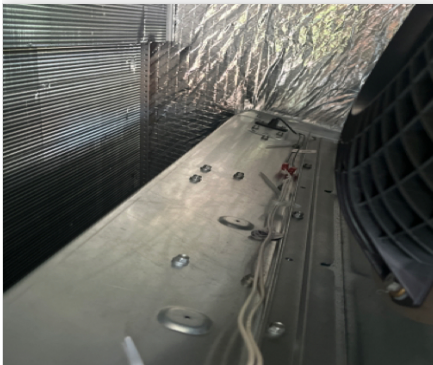
**Dischargesensor
10/21/2023**

Issue Name : REVIEW+RECTIFY: FAH sensors
Description : Lennox units spec'd with FAH need to have the factory discharge sensors relocated to the supply duct after the first elbow. See: M3.1 Lennox FAT Setup detail.
Created By : National TAB **Assigned To :** National TAB - Tyler Youells
Status : Open
Originated Date : 10/21/2023 - Tyler Youells - National TAB

- **10/31/2023 National TAB - Tyler Youells**
 - Spec applies to Lennox prodigy 2.0 units and not new core system. core Rtus do not ship with a separate discharge air sensor.

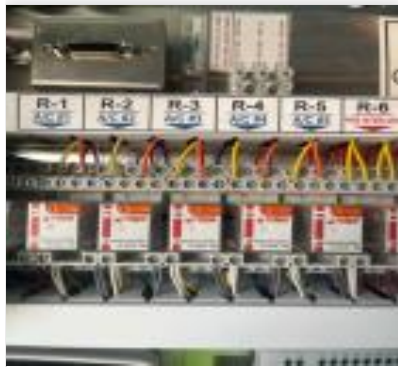
Acrelays
10/21/2023

-Are R-1, R-2, and R-3 (R-4 and R-5 if applicable) ice cube relays factory wired properly from SEC inside the panel. Take photo and include in TAB report

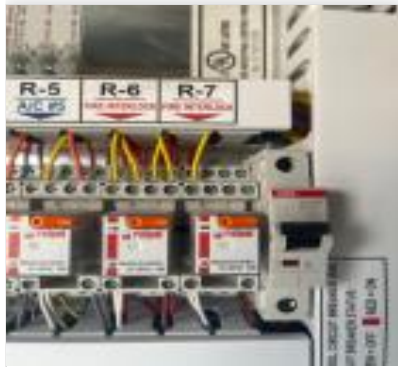
Firerelay
10/21/2023

-Is R-6 (fire interlock) relay factory wired properly from SEC inside the panel. Take photo and include in TAB report.
