Report: TAB Report
Function: Test, Adjust, & Balance
Date: 03/02/2026
Completed By: National TAB

**02-23-26 WHATABURGER #1572 GLENDALE,
AZ**

System/Unit: AHU/RTU

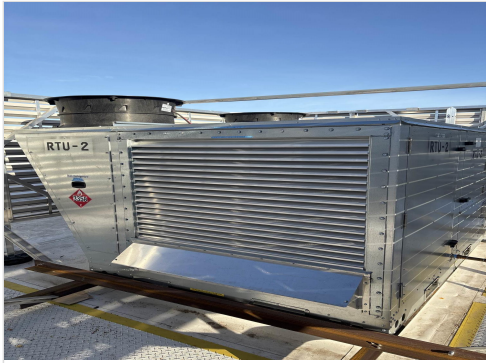
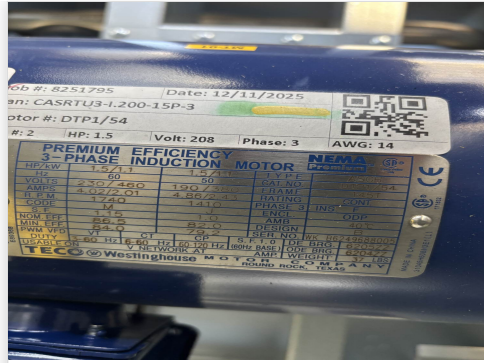
Unit Data - PHOTO LOG

Unit Data	
	Actual
MFG	CAPTIVEAIRE
Serial Num	8251795
Model Num	CAS-HVAC3-I.200-15-15T
Num OA Filters 1	4
OA Filter Size 1	16X25X2
Num Final Filter 1	4
Final Filter Size 1	20X25X2

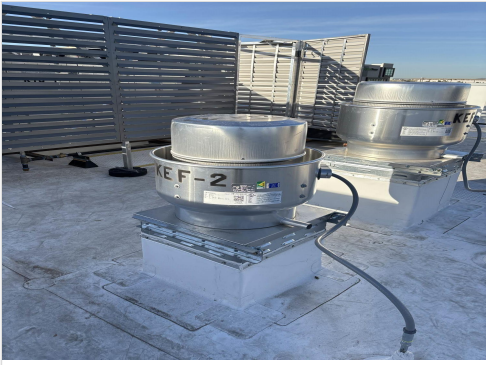
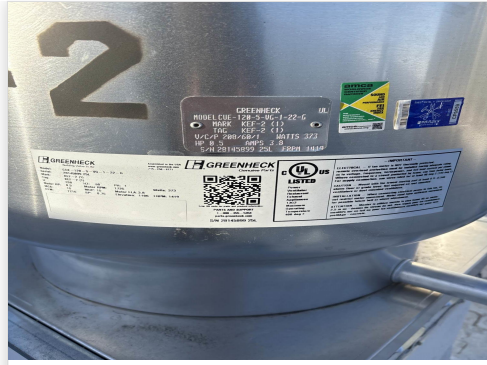
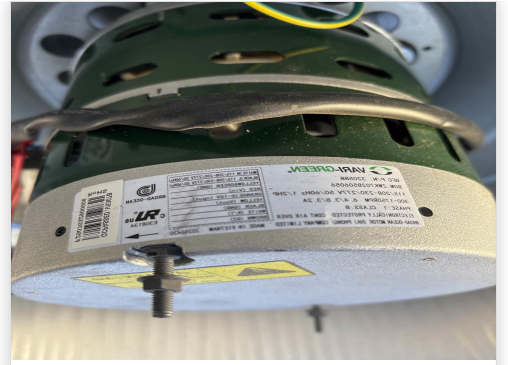
Unit Data - PHOTO LOG

Unit Data		
	Design	Actual
MFG	GREENHECK	GREENHECK
Model Num	CUE-120-VG	CUE-120-5--VG-1-22-G
Serial Num	-	28145899 25L
Type	UPBLAST	UPBLAST
Configuration	VERTICAL	VERTICAL
