**National TAB
1329 E. KEMPER ROAD
SUITE 4210
CINCINNATI, OH 45246**

**Report: TAB REPORT
Function: Test, Adjust, & Balance
Date: 04/18/2023**

**PROJECT
04-17-23 NIKE CLEARANCE -
SACRAMENTO, CA**

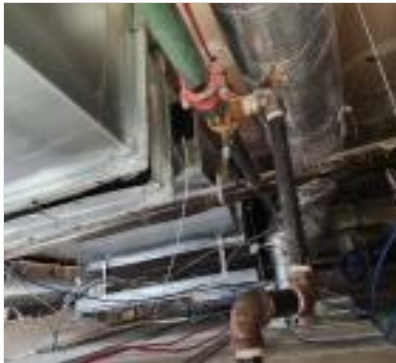
VRF-1

Test Data		
	Design	Actual
SF CFM	1200	1168
SF RPM	-	NA
RA CFM	1030	991
OA CFM	170	177-431
RL Voltage	-	210
RL Amperage	-	5.3
SF Rotation	-	CCW
RA Damper Position	-	60%-80%
Min OA Damper Position	-	40%-20%
Min OA Damper Type	-	MOTORIZED

Performance Data		
	Design	Actual
MA Plenum SP	-	-0.17"
Fan Suction SP	-	-0.38"
Fan Discharge SP	-	0.31"
Total ESP	0.50"	0.48"
OA Temp (db/wb)	-	69.4/58.1
RA Temp (db/wb)	-	74.9/61.8

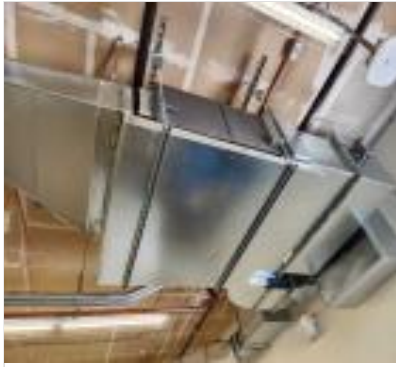
VRF-12

Test Data		
	Design	Actual
SF CFM	750	812
SF RPM	-	NA
RA CFM	120	171
OA CFM	630	641-812
RL Voltage	-	210
RL Amperage	-	2.2
SF Rotation	-	CCW
RA Damper Position	-	15%-0%
Min OA Damper Position	-	85%-100%
Min OA Damper Type	-	MOTORIZED

Performance Data		
	Design	Actual
MA Plenum SP	-	-0.12"
Fan Suction SP	-	-0.33"
Fan Discharge SP	-	0.27"
Total ESP	0.55"	0.39"
OA Temp (db/wb)	-	69.4/58.1
RA Temp (db/wb)	-	74.9/61.8

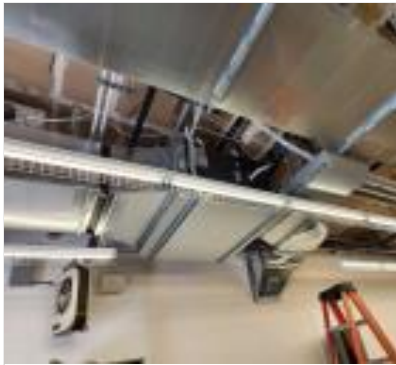
VRF-13

Test Data		
	Design	Actual
SF CFM	1300	1401
SF RPM	-	NA
RA CFM	300	419
OA CFM	1000	982-1401
RL Voltage	-	209
RL Amperage	-	2.9
SF Rotation	-	CCW
RA Damper Position	-	20%-0%
Min OA Damper Position	-	80%-100%
Min OA Damper Type	-	MOTORIZED

Performance Data		
	Design	Actual
MA Plenum SP	-	-0.12"
Fan Suction SP	-	-0.34"
Fan Discharge SP	-	0.23"
Total ESP	0.6"	0.35"
OA Temp (db/wb)	-	69.4/58.6
RA Temp (db/wb)	-	74.9/61.8

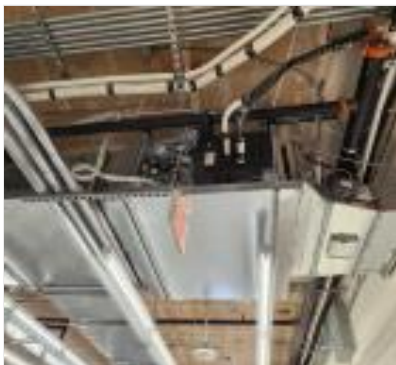
VRF-14

Test Data		
	Design	Actual
SF CFM	1300	1425
SF RPM	-	NA
RA CFM	300	402
OA CFM	1000	1023-1425
RL Voltage	-	210
RL Amperage	-	3.1
SF Rotation	-	CCW
RA Damper Position	-	20%-0%
Min OA Damper Position	-	80%-100%
Min OA Damper Type	-	MOTORIZED

Performance Data		
	Design	Actual
MA Plenum SP	-	-0.085"
Fan Suction SP	-	-0.24"
Fan Discharge SP	-	0.31"
Total ESP	0.6"	0.395"
OA Temp (db/wb)	-	69.4/58.6
RA Temp (db/wb)	-	74.9/61.8

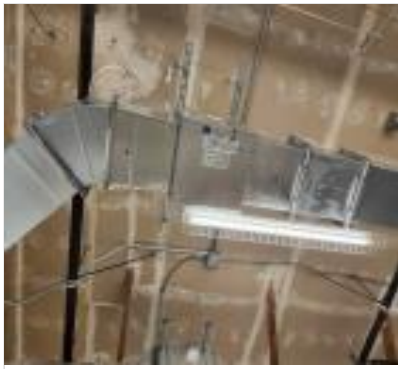
EF-1

Test Data		
	Design	Actual
CFM	275	254
Fan RPM	1684	NA
Fan Rotation	-	CCW
Motor RPM	-	NA
System SetPt	-	ON
RL Voltage	-	NA
RL Amperage	-	NA
Total ESP	0.5"	0.29"
Fan Inlet SP	-	-0.13"
Fan Discharge SP	-	0.16"

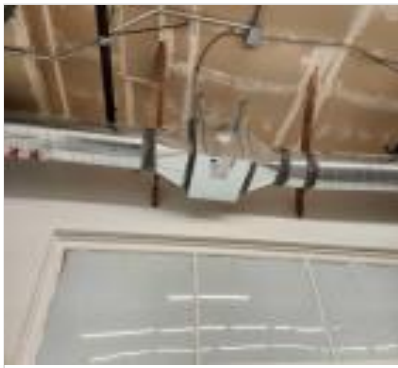
SF-1

Test Data		
	Design	Actual
CFM	435	431-177
SF RPM	1668	NA
Motor RPM	-	NA
SF System SetPt	-	ON
RL Voltage	-	NA
RL Amperage	-	NA
Total ESP	-	0.12"
Fan Discharge SP	-	0.12"
