Pre-Evaluation Report Prior to ReDesign Phase

DILLONS 615-065

3211 S SENECA ST

This test completed on 8/27/2015

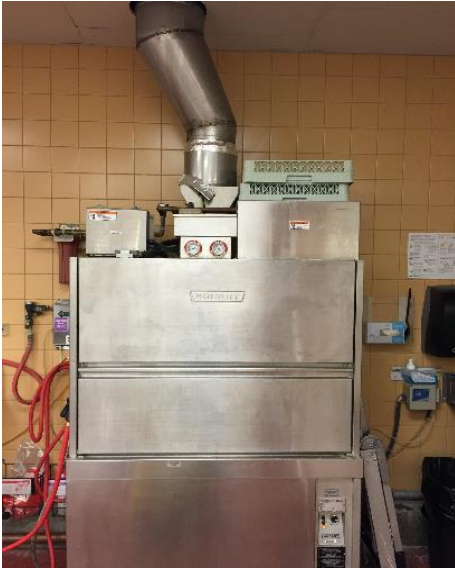
DISH MACHINE

NO ROOF TOP EXHAUST FAN - GOOSE NECK.

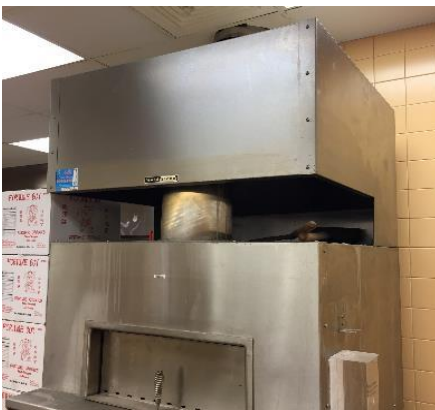
PIZZA OVEN - WITH EXHAUSTO FAN
 HAS NOT BEEN IN OPERATION
 4-5 YEARS. EXHAUSTO IS ROTATING SLOWLY,
 NO MEASUREABLE CFM

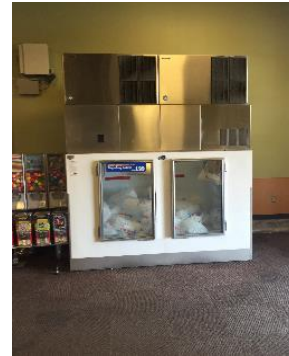
ICE MACHINE IN VESTIBULE

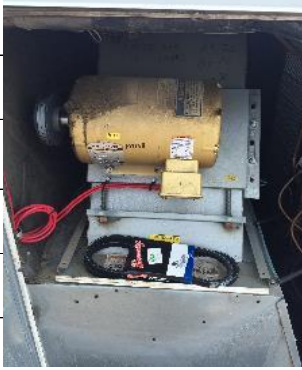
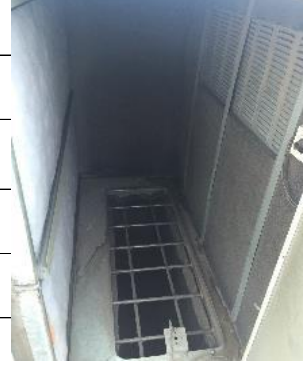
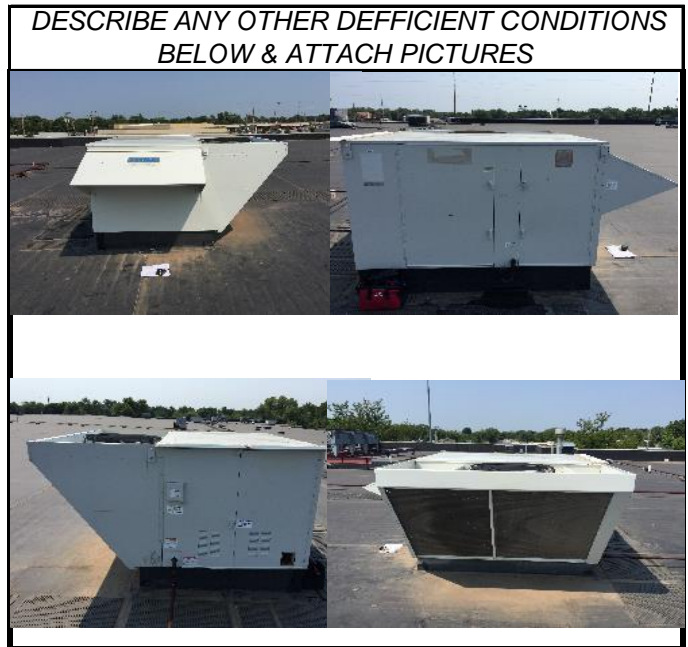
UNIT & MOTOR DATA:	
UNIT MANF.	AAON
MODEL #	RM-010-8-0
SERIAL #	200801-AMGJ37519
DISCHARGE	VERTICAL
MOTOR HP	3
MOTOR RATED VOLTS	200-230/460
MOTOR RATED AMPS	8.9-9 / 4
UNIT TAG (BarCode on Unit Housing if found)	KR#: 4011529

UNIT CONDITION:	
PHYSICAL DAMAGE	NONE
PULLEY/BELT WEAR	NONE
WIRING	GOOD
FILTERS	2 - 47"X19.5"
OUTSIDE AIR DAMPER TYPE	MANUAL SLIDE DAMPER
SIZE OF OUTSIDE AIR DAMPER	29.5"X13.75"
DX FILTER CONDITION	GOOD

TEST DATA	
TOTAL OUTSIDE AIR	0 CFM
R.L. VOLTAGE	205-206-207
R.L. AMPERAGE	6.5-6.6-6.6

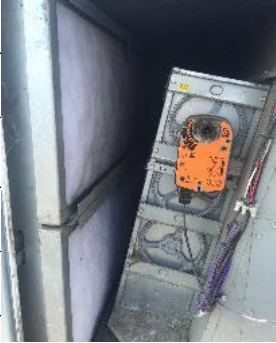
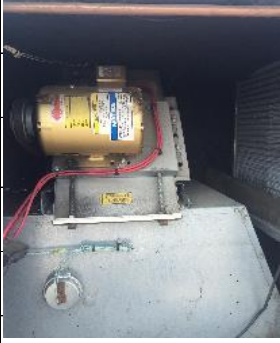
PROJECT: DILLONS 615-065 WICHITA, KS
SYSTEM/UNIT: RTU-3

UNIT CONDITION:	
PHYSICAL DAMAGE	NONE
PULLEY/BELT WEAR	BELTS IS LOOSE
WIRING	GOOD
FILTERS	2 - 39"X15.5"
OUTSIDE AIR DAMPER TYPE	ECONOMIZER
SIZE OF OUTSIDE AIR DAMPER	35"X12"
DX FILTER CONDITION	GOOD
DX COIL	MINOR CLEANING NEEDED

REMARKS:
OA SCREEN NEEDS TO BE FASTENED TO UNIT BETTER.

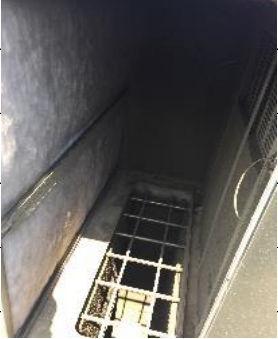
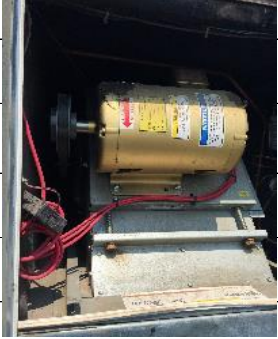
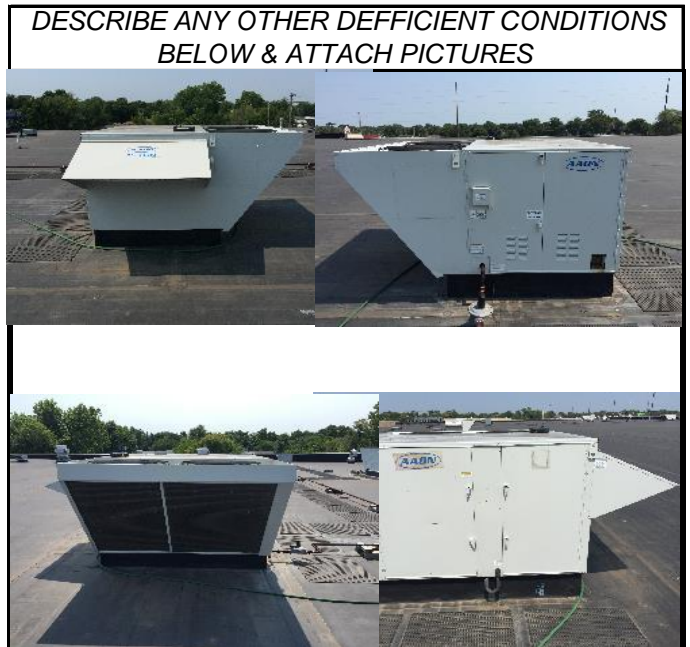
UNIT & MOTOR DATA:	
UNIT MANF.	AAON
MODEL #	RM-015-8-0-BA02
SERIAL #	200801-AMGL37517
DISCHARGE	VERTICAL
MOTOR HP	5
MOTOR RATED VOLTS	200
MOTOR RATED AMPS	15
UNIT TAG (BarCode on Unit Housing if found)	KR#4011550

UNIT CONDITION:	
PHYSICAL DAMAGE	NONE
PULLEY/BELT WEAR	NONE
WIRING	GOOD
FILTERS	2 - 47"X19.5"
OUTSIDE AIR DAMPER TYPE	SLIDE MANUAL DAMPER
SIZE OF OUTSIDE AIR DAMPER	29.5"X13.5"
DX FILTER CONDITION	GOOD

TEST DATA	
TOTAL OUTSIDE AIR	0 CFM
R.L. VOLTAGE	202-202-202
R.L. AMPERAGE	11.5-12-11.7

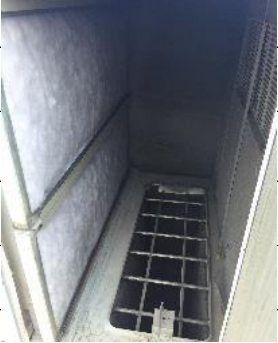
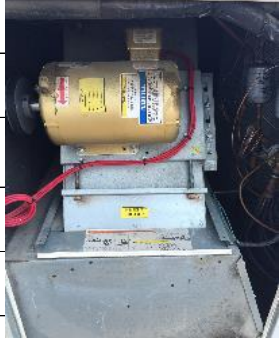
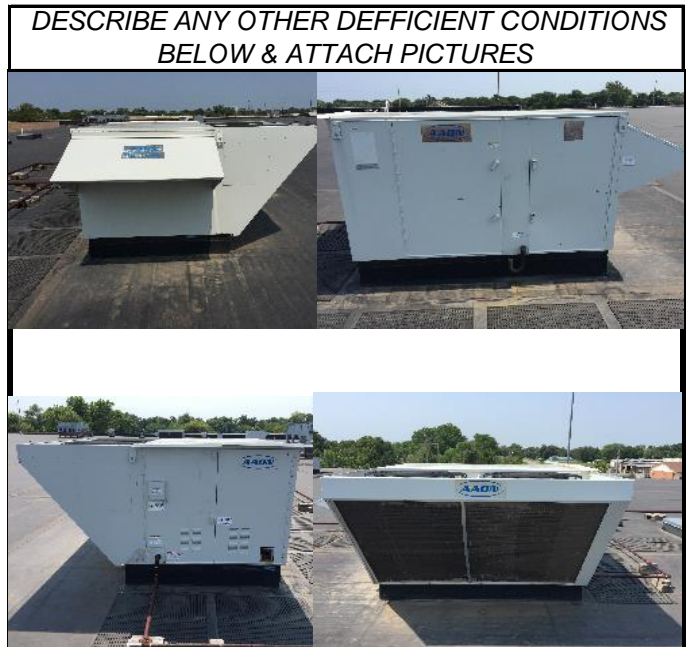
UNIT & MOTOR DATA:	
UNIT MANF.	AAON
MODEL #	RM-015-8-0-BA02
SERIAL #	200801-AMGL37518
DISCHARGE	VERTICAL
MOTOR HP	5
MOTOR RATED VOLTS	200
MOTOR RATED AMPS	15
UNIT TAG (BarCode on Unit Housing if found)	KR#: 4011551

UNIT CONDITION:	
PHYSICAL DAMAGE	NONE
PULLEY/BELT WEAR	NONE
WIRING	GOOD
FILTERS	2 - 47"X19.5"
OUTSIDE AIR DAMPER TYPE	SLIDE MANUAL DAMPER
SIZE OF OUTSIDE AIR DAMPER	29.5"X13.5"
DX FILTER CONDITION	GOOD

TEST DATA	
TOTAL OUTSIDE AIR	0 CFM
R.L. VOLTAGE	204-204-204
R.L. AMPERAGE	11.6-13.7-13

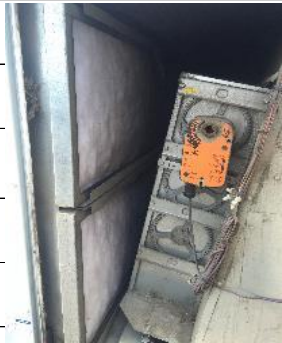
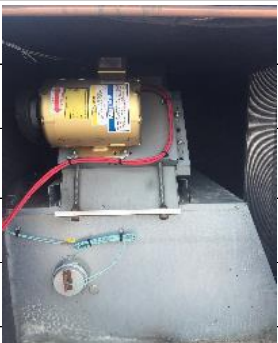
UNIT & MOTOR DATA:	
UNIT MANF.	AAON
MODEL #	RM-006-8-0-BA01
SERIAL #	200801-AMGF37523
DISCHARGE	VERTICAL
MOTOR HP	1
MOTOR RATED VOLTS	200
MOTOR RATED AMPS	3.2
UNIT TAG (BarCode on Unit Housing if found)	KR#: 4011532

UNIT CONDITION:	
PHYSICAL DAMAGE	NONE
PULLEY/BELT WEAR	NONE
WIRING	GOOD
FILTERS	2 - 39"X15.5"
OUTSIDE AIR DAMPER TYPE	ECONOMIZER
SIZE OF OUTSIDE AIR DAMPER	35"X12"
DX FILTER CONDITION	GOOD

TEST DATA	
TOTAL OUTSIDE AIR	0 CFM
R.L. VOLTAGE	203-203-204
R.L. AMPERAGE	2.8-2.8-2.9

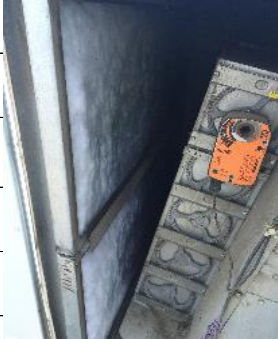
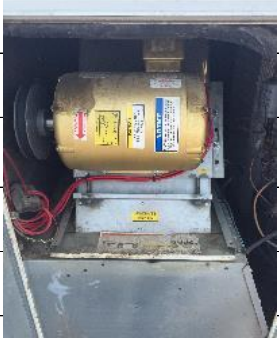
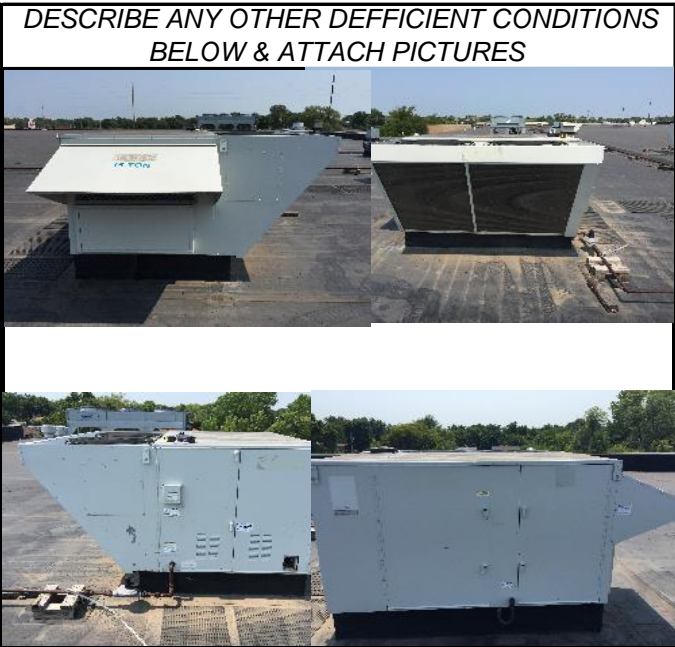
UNIT & MOTOR DATA:	
UNIT MANF.	AAON
MODEL #	RM-015-8-0-BA02
SERIAL #	200801-AMGL37516
DISCHARGE	VERTICAL
MOTOR HP	7 1/2
MOTOR RATED VOLTS	200
MOTOR RATED AMPS	22.4
UNIT TAG (BarCode on Unit Housing if found)	KR#4011543

UNIT CONDITION:	
PHYSICAL DAMAGE	NONE
PULLEY/BELT WEAR	NONE
WIRING	GOOD
FILTERS	2 - 47"X19.5"
OUTSIDE AIR DAMPER TYPE	ECONOMIZER
SIZE OF OUTSIDE AIR DAMPER	39.25"X19.5"
DX FILTER CONDITION	GOOD

TEST DATA	
TOTAL OUTSIDE AIR	393
R.L. VOLTAGE	200-200-200
R.L. AMPERAGE	15.3-14.9-15

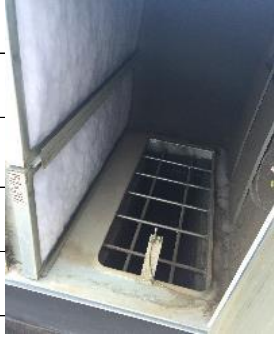
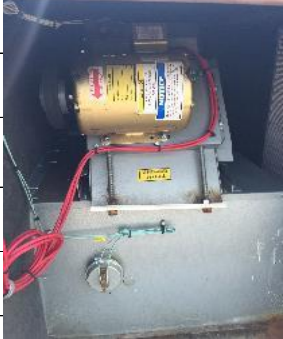
UNIT & MOTOR DATA:	
UNIT MANF.	AAON
MODEL #	RM-006-8-0-BA01-232
SERIAL #	200801-AMGF37524
DISCHARGE	VERTICAL
MOTOR HP	1
MOTOR RATED VOLTS	200
MOTOR RATED AMPS	3.2
UNIT TAG (BarCode on Unit Housing if found)	KR#4011547

UNIT CONDITION:	
PHYSICAL DAMAGE	NONE
PULLEY/BELT WEAR	NONE
WIRING	GOOD
FILTERS	2 - 15.5"X39.5"
OUTSIDE AIR DAMPER TYPE	MANUAL SLIDE DAMPER
SIZE OF OUTSIDE AIR DAMPER	29.5"X13.5"
DX FILTER CONDITION	GOOD

TEST DATA	
TOTAL OUTSIDE AIR	0
R.L. VOLTAGE	203-203-203
R.L. AMPERAGE	2.8-2.7-3.1

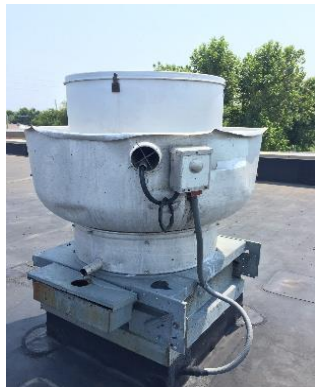
FAN SERVES:	CHINESE WOK HOOD
FAN TAG:	FADED / EF-2
MFG	FADED
MODEL	FADED
HP	MOTOR CAKED IN DEBRIS - LABEL NOT VISIBLE
NAMEPLATE VOLT	MOTOR CAKED IN DEBRIS - LABEL NOT VISIBLE
NAMEPLATE AMP	MOTOR CAKED IN DEBRIS - LABEL NOT VISIBLE
BELT SIZE & CONDITION	1- AX23 (GOOD WITH SPARE)
EXHAUST (ACTUAL AIRFLOW MEASURED)	2507 CFM
ADDITIONAL NOTES (OVERALL DEFFICIENCY OR CONDITION OF FAN-DESCRIBE & INDICATE HOW YOU MEASURED AIRFLOW:

VARIABLE SHEAVE **MINIMIZED - MOTOR HOUSING NEEDS COMPLETE CLEANING**

NEEDS THOROUGH CLEANING **NEEDS TO BE RE-INVENTORIED / NO VISIBLE TAGS OR MFG DATA**

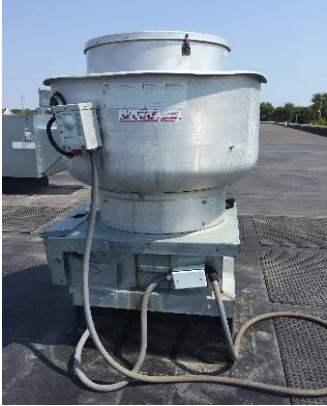
FAN SERVES:	DELI - CHICKEN DEEP FAT FRYER HOOD LEFT
FAN TAG:	NO KR TAG (CAS JOB #686529) / EF-3
MFG	CAPTIVE-AIRE
MODEL	NCA14FA
HP	1/2
NAMEPLATE VOLT	115/208-230
NAMEPLATE AMP	7.7/4.3-3.9
BELT SIZE & CONDITION	1 - AX23 / GOOD
EXHAUST (ACTUAL AIRFLOW MEASURED)	1136 CFM
EXCESSIVE WHIP - NOT SEALED AT FAN BASE WILL ALLOW SNOW PACK AND RAIN WATER TO ENTER TO BUILDING

NO **GREASE CUP DOES INTERFERE WITH HINGING**

CLEANING **MOTOR HOUSING NEEDS CLEANING**

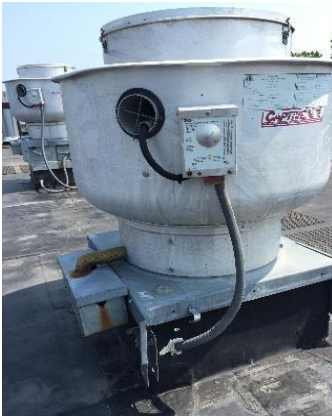
FAN SERVES:	DELI - CHICKEN OVEN HOOD RIGHT
FAN TAG:	NO KR TAG (CAS JOB #686529) / EF-4
MFG	CAPTIVE-AIRE
MODEL	NCA14FA
HP	1/2
NAMEPLATE VOLT	115/208-230
NAMEPLATE AMP	7.7/4.3-3.9
BELT SIZE & CONDITION	1 - AX23 / GOOD
EXHAUST (ACTUAL AIRFLOW MEASURED)	1292 CFM
<u>ADDITIONAL NOTES (OVERALL DEFFICIENCY OR CONDITION OF FAN-DESCRIBE & INDICATE HOW YOU MEASURED AIRFLOW:</u>

NO **HOLE AT BASE IN CURB IS STARTING TO BECOME COMPROMISED**

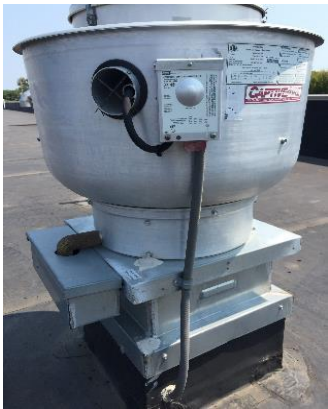
FAN SERVES:	BAKERY HOOD
FAN TAG:	KR TAG 4011545 / EF-5
MFG	CAPTIVE-AIRE
MODEL	NCA10FA
HP	1/2
NAMEPLATE VOLT	115/208-230
NAMEPLATE AMP	7.7/4.3-3.9
BELT SIZE & CONDITION	1 - AX20
EXHAUST (ACTUAL AIRFLOW MEASURED)	751 CFM
ADDITIONAL NOTES (OVERALL DEFFICIENCY OR CONDITION OF FAN-DESCRIBE & INDICATE HOW YOU MEASURED AIRFLOW:

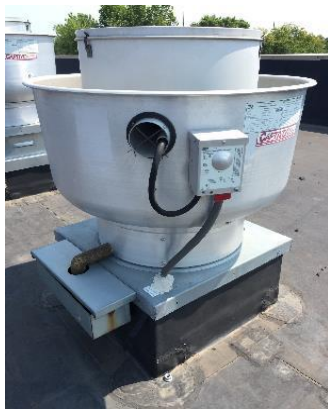
FAN SERVES:	HOBART BREAD OVEN HOOD
FAN TAG:	KR#: 4011546 / EF-6
MFG	CAPTIVE-AIRE
MODEL	NCA14HPFA
HP	1/3
NAMEPLATE VOLT	115
NAMEPLATE AMP	6.4
BELT SIZE & CONDITION	1 - AX20
EXHAUST (ACTUAL AIRFLOW MEASURED)	982 CFM
ADDITIONAL NOTES (OVERALL DEFFICIENCY OR CONDITION OF FAN-DESCRIBE & INDICATE HOW YOU MEASURED AIRFLOW:

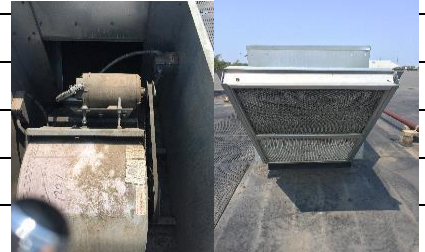
MUA Unit Heated OR Non-Heated? **NON 0 CFM (DELI - CHICKEN OVEN HOOD RIGHT)**

Size & # of filters in Unit? **2 15.5"x19.25"**
Are the filters clean? **NO DIRTY ON THE INSIDE/SIDE OF THE UNIT**
Is the electrical Whip frayed? **NO**
Any excessive noise? **NO UNIT DOES NOT RUN**
Total airflow measured (actual): **0 CFM**

UNIT IS NOT FUNCTIONAL / DISCONNECT ON OR OFF / DISCONNECT WAS FOUND OFF

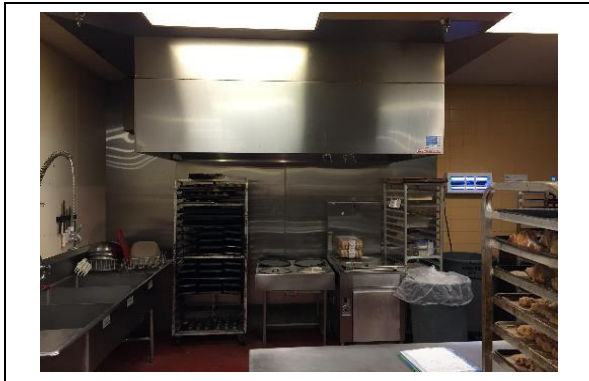
MFG CAPTIVE-AIRE
MODEL 6024ND-2 / KR#4011625

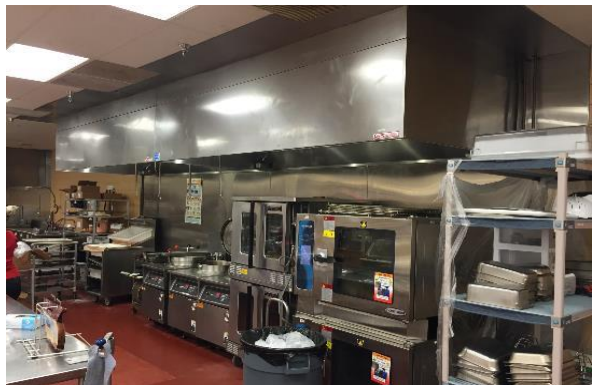
HOOD # 1	FIELD NOTES
SIZE OF HOOD (L x W)	120"X60"
LOCATION OF HOOD (IE- FRONT CHARBROILER DISPLAY HD)	HOOD RIGHT - DELI/CHICKEN OVENS
IS HOOD EXHAUST ONLY OR EXHAUST WITH MU-AIR?	EXHAUST ONLY
IF HOOD HAS MUA AIR - IS AIR COMING OUT OF PLENUM OR IS IT CLOGGED WITH DIRT?	N/A
ANY MISSING FILTERS (QTY/SIZE):	NO-ALUMINUM BAFFLE
ANY EVIDENCE OF GREASE ACCUMILATION IN OR AROUND HOOD?	YES-OVEN DOORS ARE PAST HOODS AND STEAM ROLLS OUT

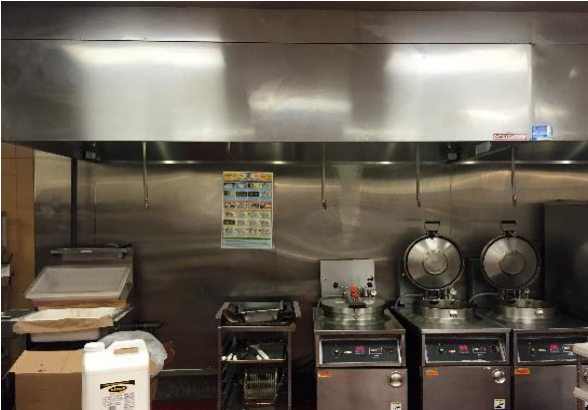
MFG CAPTIVE-AIRE / KR#4011646
MODEL 6024ND2

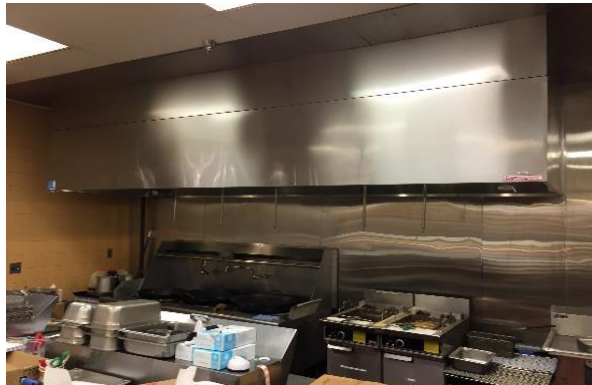
HOOD # 1	FIELD NOTES
SIZE OF HOOD (L x W)	168X60
LOCATION OF HOOD (IE- FRONT CHARBROILER DISPLAY HD)	CHINESE WOK
IS HOOD EXHAUST ONLY OR EXHAUST WITH MU-AIR?	EXHAUST ONLY
IF HOOD HAS MUA AIR - IS AIR COMING OUT OF PLENUM OR IS IT CLOGGED WITH DIRT?	NA
ANY MISSING FILTERS (QTY/SIZE):	NO - ALUMINUM
ANY EVIDENCE OF GREASE ACCUMILATION IN OR AROUND HOOD?	SOME AFFLUENT NOT BEING CAPTURED

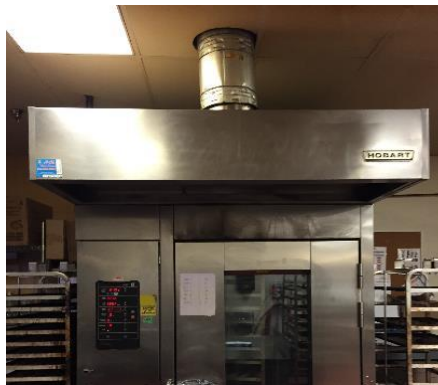
MFG HOBART
 MODEL NG
