Report: TAB REPORT
Function: Test, Adjust, & Balance
Date: 12/23/2025
Completed By: National TAB

PROJECT
Chipotle #5692

520 E CLOUD AVE

ANDOVER, KS 67002

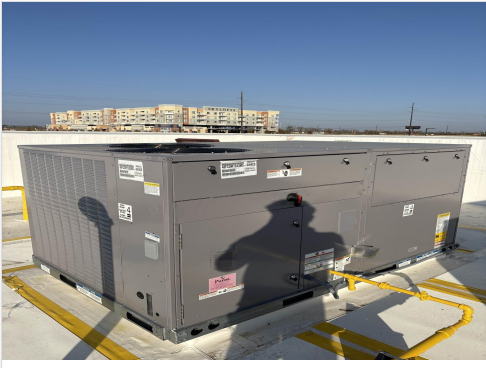
Unit Data - PHOTO LOG

Unit Data		
	Design	Actual
MFG	CARRIER	CARRIER
Serial Num	-	1123P75317
Model Num	48FDCM12	48FDCM12A3M5A6W4C0
Type	RTU	RTU
Configuration	VERTICAL	VERTICAL
Num OA Filters 1	-	1
OA Filter Size 1	-	36X20
Num Final Filter 1	-	4
Final Filter Size 1	-	20X20X2

Test Data		
	Design	Actual
SF CFM	4000	3946
RA CFM	3250	3136
OA CFM	750	810
RL Voltage	208	210/211/212
RL Amperage	12.6	5.9/5.9/6.1
SF Rotation	-	CCW
SF System SetPt	-	SWITCH C DIAL 30
RA Damper Position	-	83%
Min OA Damper Position	-	3.65 VOLTS
Min OA Damper Type	-	OPPOSED BLADE
OA Enthalpy Setpt	-	ESP5

[1] THERE IS NO DAMPER TO ADJUST DIFFUSER 1-11

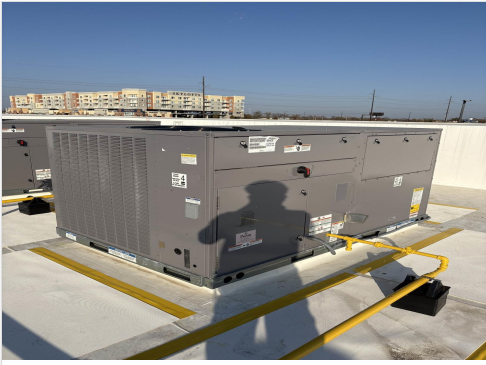
Unit Data - PHOTO LOG

Unit Data		
	Design	Actual
MFG	CARRIER	CARRIER
Serial Num	-	3123P66706
Model Num	48FDCM12	48FDCM12A3M5A6W4C0
Type	RTU	RTU
Configuration	VERTICAL	VERTICAL
Num OA Filters 1	-	1
OA Filter Size 1	-	36X20
Num Final Filter 1	-	4
Final Filter Size 1	-	20X20X2

Test Data		
	Design	Actual
SF CFM	4000	4090
SF RPM	-	DIRECT DRIVE
RA CFM	3250	3290
OA CFM	750	800
RL Voltage	208	211/211/212
RL Amperage	12.6	6.0/5.9/5.8
SF Rotation	-	CCW
SF System SetPt	-	SWITCH C DIAL 40
RA Damper Position	-	80%
Min OA Damper Position	-	3.50 VOLTS
Min OA Damper Type	-	OPPOSED BLADE
OA Enthalpy Setpt	-	ESP5

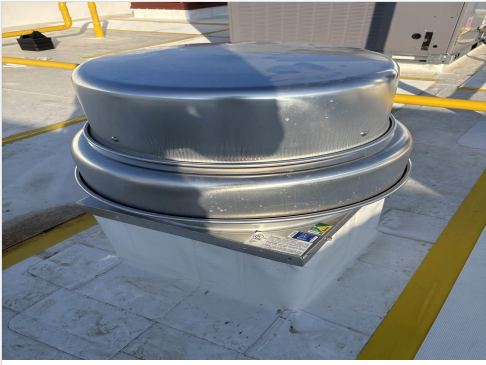
Unit Data - PHOTO LOG

Unit Data		
	Design	Actual
MFG	ACCUREX	ACCUREX
Model Num	XRED-097-VG	XRED-097-VG
Serial Num	-	27415743
Type	DOWNBLAST	DOWNBLAST
Configuration	VERTICAL	VERTICAL

Test Data		
	Design	Actual
CFM	150	146
Fan RPM	1330	NA
Fan Rotation	-	CW
Motor RPM	-	NA
System SetPt	-	5
RL Voltage	-	110
RL Amperage	-	0.9
Total ESP	0.6"	0.08
Fan Inlet SP	-	-0.08
Fan Discharge SP	-	ATM

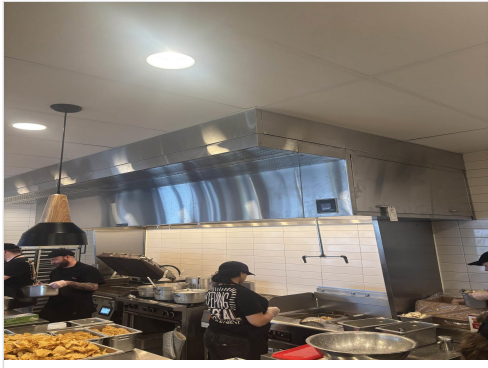
Unit Data - PHOTO LOG

Unit Data		
	Design	Actual
MFG	ACCUREX	ACCUREX
Model Num	XXEW-153-S	XXEW-153-S
Job / Serial Num	-	27427179
Type	TYPE 1 CANOPY	TYPE 1 CANOPY
Hood length	153"	153"
Hood Width	54"	54"
Supply Plenum Type	-	PSP
Supply Plenum Width	14"	14"
Supply Plenum Length	82.5"	165"

Test Data Exhaust		
	Design	Actual
Filter Type	X-TRACTOR	X-TRACTOR
Filter Size 1	16X20	16X20
Filter Size 2	20X20	20X20
Filter Qty 1	2	2
Filter Qty 2	6	6
Filter AK factor size 1	2.26	2.26
Filters AK factor size 2	3.0	3.0
Filter Total AK Area	22.52	22.52
Filter1 FPM	-	99
Filter2 FPM	-	106
Filter3 FPM	-	123
Filter4 FPM	-	132
Filter5 FPM	-	133
Filter6 FPM	-	116
Filter7 FPM	-	108
Filter8 FPM	-	95
Filter Ave FPM(corr)	-	114
CFM	2550	2567

Test Data Supply		
	Design	Actual
Total Area	8.02	16.04
Kv factor (Vel)	0.89	0.89
Num of Readings	-	14
Reading1 FPM	-	67
Reading2 FPM	-	81
Reading3 FPM	-	68
Reading4 FPM	-	81
Reading5 FPM	-	83
Reading6 FPM	-	85
Reading7 FPM	-	66
Reading8 FPM	-	85
Reading9 FPM	-	71
Reading10 FPM	-	87
Reading11 FPM	-	88
Reading12 FPM	-	155
Reading13 FPM	-	156
Reading14 FPM	-	123
Ave FPM(corr)	-	93
CFM	1300	1328

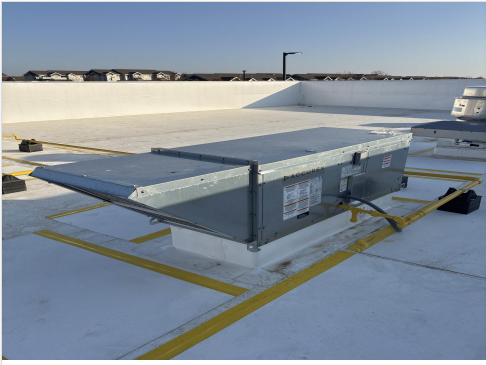
Unit Data - PHOTO LOG

Unit Data		
	Design	Actual
MFG	ACCUREX	ACCUREX
Model Num	XDGX-P115-H05-VG	XDGX-P115-H05-VG
Serial Num	-	27419000
Type	MAU	MAU
Configuration	VERTICAL	VERTICAL

Test Data		
	Design	Actual
CFM	1300	1328
SF RPM	-	NA
Motor RPM	-	DIRECT DRIVE
SF System SetPt	-	6.5 VDC
RL Voltage	-	122
RL Amperage	-	5.56
Total ESP	-	0.25"
Fan Discharge SP	-	0.25"

-FAN SPEED SET USING SPEED DIAL INSIDE UNIT.
