Report: TAB Report
Function: Test, Adjust, & Balance
Date: 11/17/2025
Completed By: National TAB

**11-17-25 WHATABURGER #1665 PEARLAND,
TX**

E BROADWAY ST & DIXIE FARM RD

PEARLAND, TX

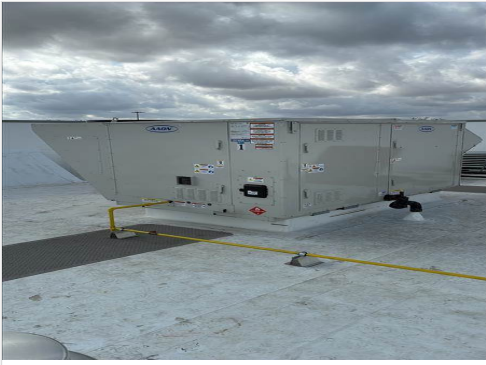
Unit Data - PHOTO LOG

Unit Data	
	Actual
MFG	AAON
Serial Num	202509-BNGP125762
Model Num	RNA-020-C-A-8-FAB04-CBK10
Num OA Filters 1	3
OA Filter Size 1	19.5X25
Num Final Filter 1	6
Final Filter Size 1	20X25X2

General	
	Actual
Unit free of Damage	YES
Fan Rotation Correct	YES
Unit Filters Clean	YES
Condensate Drain Installed	YES

[1] NO SUITABLE LOCATION FOR RETURN OR SUPPLY TRAVERSE. ONLY POSSIBLE AREAS ARE EITHER INACCESSIBLE AND/OR WOULD BE TOO TURBULENT FOR A RELIABLE READING.

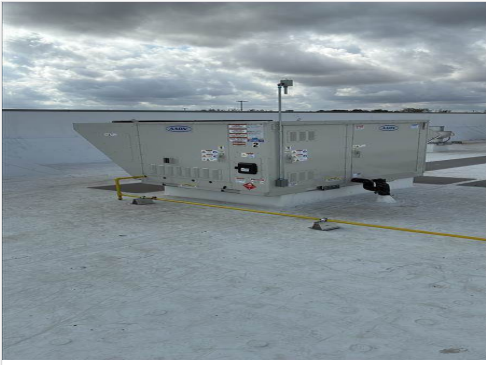
Unit Data - PHOTO LOG

Unit Data	
	Actual
MFG	AAON
Serial Num	202509-ANGK125743
Model Num	RNA-013-B-A-8-FAB04-CB1K0
Num OA Filters 1	2
OA Filter Size 1	24.5X19.5
Num Final Filter 1	4
Final Filter Size 1	20X25X2

General	
	Actual
Unit free of Damage	YES
Fan Rotation Correct	YES
Unit Filters Clean	YES
Condensate Drain Installed	YES

Notes:
[1] NO SUITABLE LOCATION FOR RETURN TRAVERSE

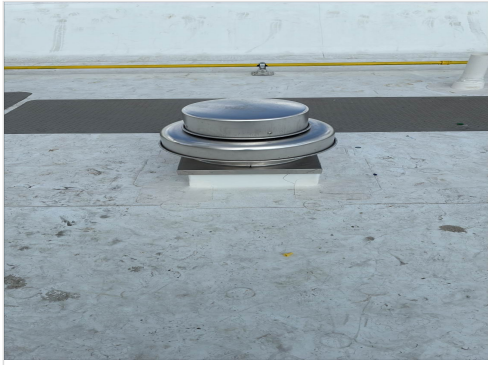
Unit Data - PHOTO LOG

Unit Data		
	Design	Actual
MFG	GREENHECK	GREENHECK
Model Num	G-080-VG	G-080-VG-1-17-X
Serial Num	-	27442922
Type	DOWNBLAST	DOWNBLAST
Configuration	VERTICAL	VERTICAL

Test Data		
	Design	Actual
CFM	300	231
Fan RPM	1680	DIRECT DRIVE
Fan Rotation	-	CCW
Motor RPM	-	DIRECT DRIVE
System SetPt	-	7.25
RL Voltage	-	122.2
RL Amperage	-	1.38
Total ESP	0.50"	0.20"
Fan Inlet SP	-	0.20"
Fan Discharge SP	-	ATM

FAN SET TO HIGHEST POSSIBLE SPEED FOR GIVEN MAX AMPERAGE. NEITHER BATHROOM COULD BE BROUGHT WITHIN 10% OF DESIGN. DAMPERS ARE OPEN AND NO KINKING IN DUCT WAS SEEN.

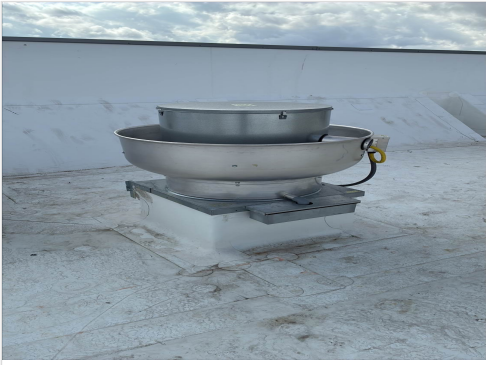
Unit Data - PHOTO LOG

Unit Data		
	Design	Actual
MFG	GREENHECK	GREENHECK
Model Num	CUE-140-VG	DU180HFA
Serial Num	-	7418675
Type	UPBLAST	UPBLAST
Configuration	VERTICAL	VERTICAL

Test Data		
	Design	Actual
CFM	1995	2016
Fan RPM	1517	810
Fan Rotation	-	CCW
Motor RPM	-	DIRECT DRIVE
System SetPt	-	67%
RL Voltage	-	212.3
RL Amperage	-	3.70
Total ESP	1.00"	0.52"
Fan Inlet SP	-	-0.52"
Fan Discharge SP	-	ATM

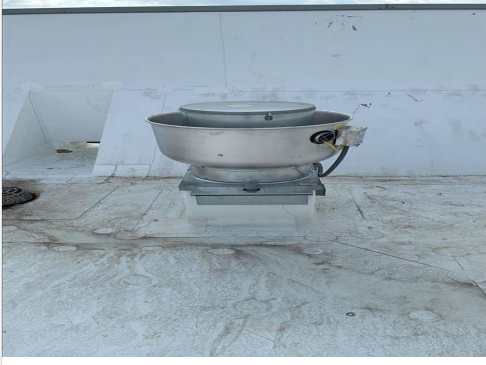
Unit Data - PHOTO LOG

Unit Data		
	Design	Actual
MFG	GREENHECK	GREENHECK
Model Num	CUE-120-VG	DU50HFA
Serial Num	-	7418675
Type	UPBLAST	UPBLAST
Configuration	VERTICAL	VERTICAL

Test Data		
	Design	Actual
CFM	1216	1240
Fan RPM	1415	1290
Fan Rotation	-	CCW
Motor RPM	-	DIRECT DRIVE
System SetPt	-	67%
RL Voltage	-	211.1
RL Amperage	-	2.60
Total ESP	0.75"	0.70"
Fan Inlet SP	-	-0.70"
Fan Discharge SP	-	ATM
