**Report: TAB REPORT**  
**Function: Test, Adjust, & Balance**  
**Date: 11/01/2023**

**PROJECT**  
**10-30-23 CULVERS - TITUSVILLE, FL (FAN**  
**CERT)**

2855 CHENEY HWY

TITUSVILLE, FL 32780

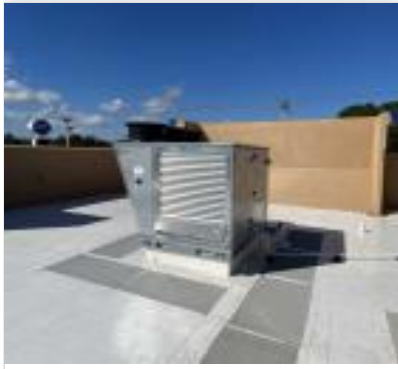
**RTU\_1**  
**11/01/2023**

Test Data		
	Design	Actual
SF CFM	5200	5091
SF RPM	-	56HZ
RA CFM	3200	3079
OA CFM	2000	2012
RL Voltage	-	211/212/213
RL Amperage	-	20.8 VFD
SF Rotation	-	CCW
RA Damper Position	-	5.0V
Min OA Damper Position	-	5.0V
Min OA Damper Type	-	ECONOMIZER

Motor Data		
	Design	Actual
Motor MFG	-	TECO WESTINGHOUSE
Frame	-	213T
Horsepower	-	7.5
Motor Rpm	-	1755
Phase	3	3
Rated Voltage	208	208
Rated Amperage	-	21.1

Performance Data		
	Design	Actual
Fan Suction SP	-	-1.96"
Fan Discharge SP	-	0.77"
Fan Total SP	-	2.73"

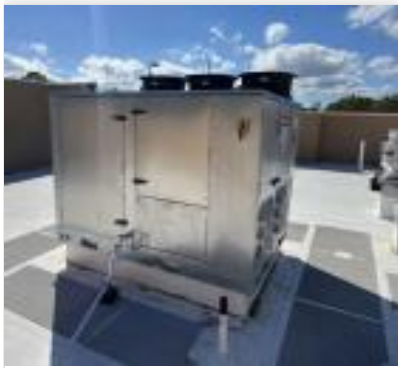
**RTU\_2**  
**11/01/2023**

Test Data		
	Design	Actual
SF CFM	5000	4886
SF RPM	-	56HZ
RA CFM	3000	2999
OA CFM	2000	1887
RL Voltage	-	211/212/213
RL Amperage	-	20.5 VFD
SF Rotation	-	CCW
RA Damper Position	-	5.1V
Min OA Damper Position	-	4.9V
Min OA Damper Type	-	ECONOMIZER

Performance Data		
	Design	Actual
Fan Suction SP	-	-2.30"
Fan Discharge SP	-	0.70"
Fan Total SP	-	3.00"

56HZ

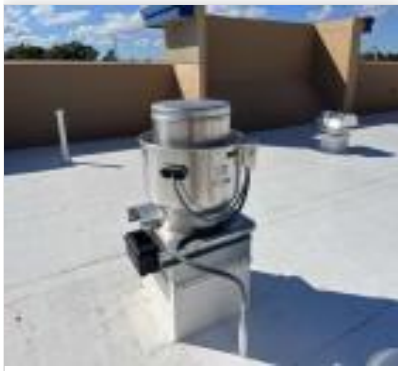
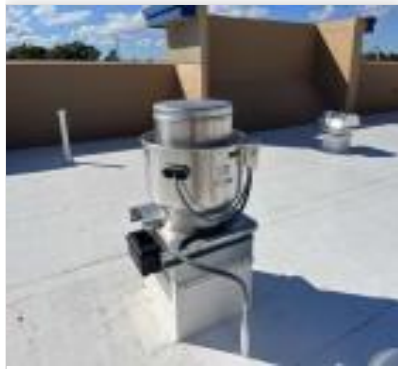
**PRV\_2**  
**11/01/2023**

Unit Data		
	Design	Actual
MFG	ACCUREX	ACCUREX
Model Num	XCUE-140-VG	XCUE-140-10-VG-1-26-G
Serial Num	-	22025565 23C
Type	UPBLAST	CENTRIFUGAL
Configuration	VERTICAL	UPBLAST

Test Data		
	Design	Actual
CFM	1500	1487
Fan RPM	1705	1260
Fan Rotation	-	CORRECT
Motor RPM	-	1260
RL Voltage	-	122
Suction ESP	-	-1.08"
Discharge ESP	-	ATM
Total ESP	1.8"	1.08"

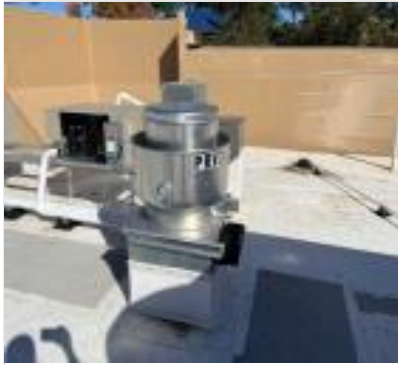
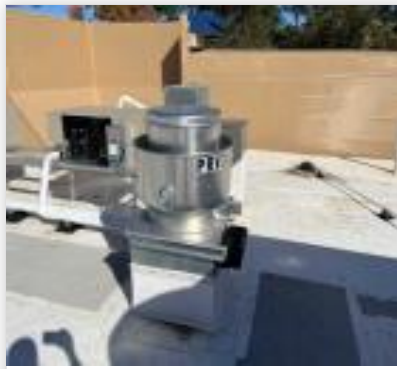
**PRV\_3**  
**11/01/2023**

Unit Data		
	Design	Actual
MFG	ACCUREX	ACCUREX
Model Num	XCUE-140-VG	XCUE-140-10-VG-1-26-G
Serial Num	-	2202566 23C
Type	UPBLAST	CENTRIFUGAL
Configuration	VERTICAL	UPBLAST

Test Data		
	Design	Actual
CFM	1500	1507
Fan RPM	1351	945
Fan Rotation	-	CORRECT
Motor RPM	-	945
RL Voltage	-	122
Suction ESP	-	-0.40"
Discharge ESP	-	ATM
Total ESP	1.0"	0.40"

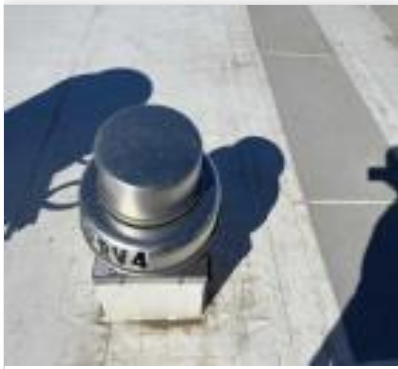
**PRV\_4**  
**11/01/2023**

Unit Data		
	Design	Actual
MFG	ACCUREX	ACCUREX
Model Num	XRED-095-D	XRED-095-D-8-1-17-X
Serial Num	-	22025985 23C
Type	CENTRIFUGAL -ROOF	CENTRIFUGAL
Configuration	VERTICAL	DOWNBLAST

Test Data		
	Design	Actual
CFM	350	321
Fan RPM	1468	DD
Fan Rotation	-	CORRECT
Motor RPM	-	DD
System SetPt	-	SPEED CONTROLLER
RL Voltage	-	122
RL Amperage	-	1.98
Total ESP	0.6"	0.16"
Fan Inlet SP	-	-0.16"
Fan Discharge SP	-	ATM

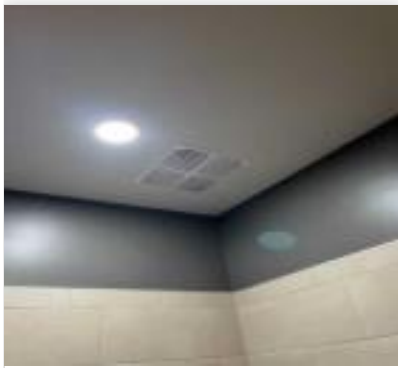
**EF\_1**  
**11/01/2023**

Unit Data		
	Design	Actual
MFG	ACCUREX	ACCUREX
Model Num	XCR-A200	XCR-A200
Serial Num	-	2206704
Type	CEILING	CEILING
Configuration	VERTICAL	VERTICAL

Test Data		
	Design	Actual
CFM	220	228
Fan RPM	-	DD
Fan Rotation	-	CORRECT
Motor RPM	-	DD
System SetPt	-	SPEED CONTROLLER
RL Voltage	-	122
RL Amperage	-	0.44

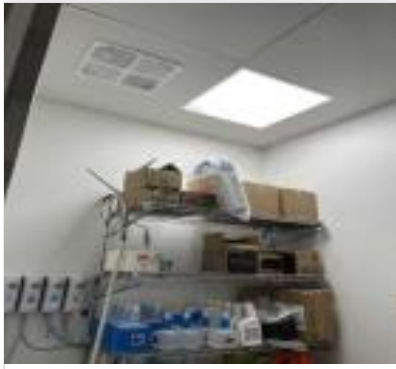
**EF\_2**  
**11/01/2023**

Unit Data		
	Design	Actual
MFG	ACCUREX	ACCUREX
Model Num	XCR-B50	XCR-B50
Serial Num	-	22026717
Type	CEILING	CEILING
Configuration	VERTICAL	VERTICAL

Test Data		
	Design	Actual
CFM	50	47
Fan RPM	-	DD
Fan Rotation	-	CORRECT
Motor RPM	-	DD
System SetPt	-	SPEED CONTROLLER
RL Voltage	-	122
RL Amperage	-	0.11

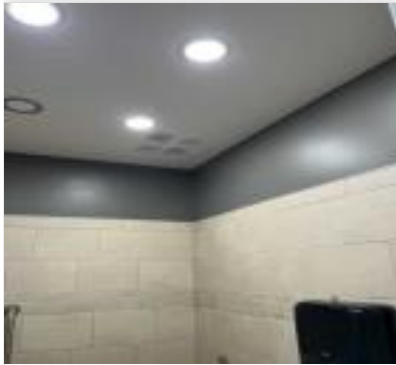
**EF\_3A**  
**11/01/2023**

Notes:  
WIRING NOT COMPLETE. UNABLE TO BALANCE.

FAN COVER TO BE INSTALLED BY MC.

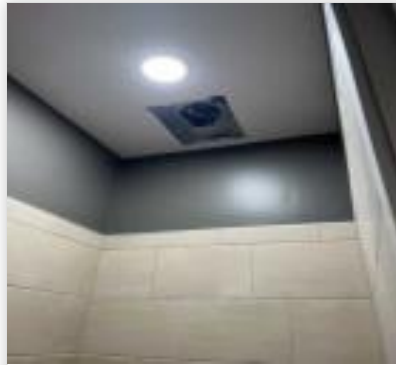
**EF\_3B**  
**11/01/2023**

Notes:  
COVER MISSING

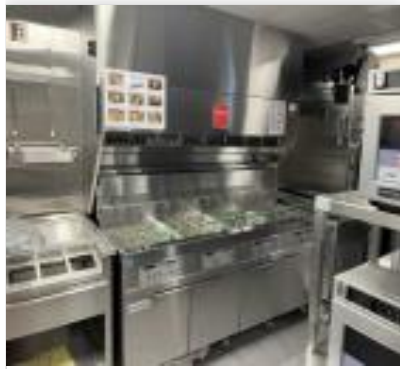
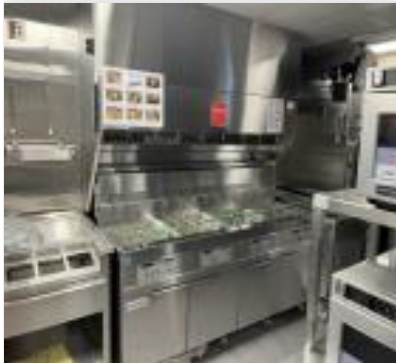
**HOOD\_1**  
**11/01/2023**

100%

Unit Data		
	Design	Actual
MFG	ACCUREX	ACCUREX
Model Num	XXEP-FB 6.92-S	XXEP-83.00-S
Job / Serial Num	-	22093911
Type	TYPE I	TYPE I CANOPY
Hood length	83"	83"
Hood Width	23"	23"

Test Data Exhaust		
	Design	Actual
Filter Type	XTRACTOR	XTRACTOR
Filter Size 1	16X16	16X16
Filter Qty 1	5	5
Filter AK factor size 1	1.53	1.53
Filter Total AK Area	7.65	7.65
Filter1 FPM	-	204
Filter2 FPM	-	193
Filter3 FPM	-	184
Filter4 FPM	-	196
Filter5 FPM	-	207
Filter Ave FPM(corr)	-	197
CFM	1500	1507

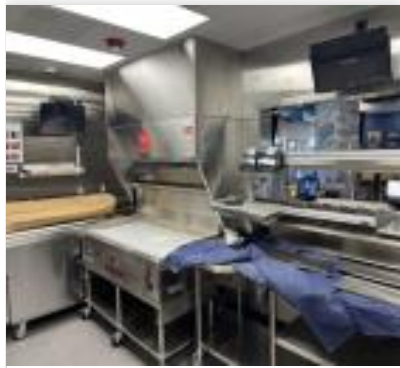
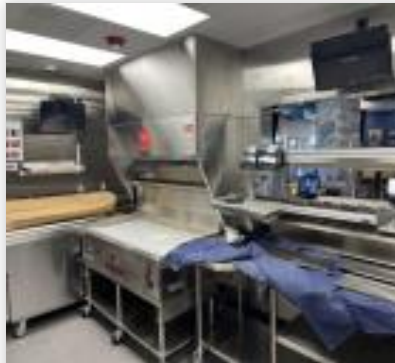
**HOOD\_2**  
**11/01/2023**

Unit Data		
	Design	Actual
MFG	ACCUREX	ACCUREX
Model Num	XGEP-64-S	XGEP-64.00-S
Job / Serial Num	-	22093929
Type	TYPE I	TYPE I CANOPY
Hood length	64"	64"
Hood Width	23"	23"
