Report: TAB

Function: Test, Adjust, & Balance

12-09-24 CHIPOTLE #42-5234 GULFGATE (HOUSTON, TX)

710 Gulfgate Center Mall, Houston, TX 77087

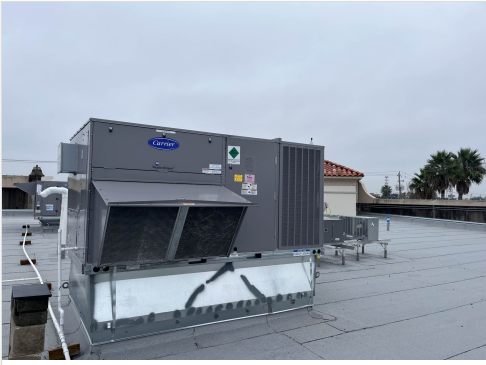
Unit Data - PHOTO LOG

Asset: RTU1

AREA: KITCHEN

Unit Data		
	Design	Actual
MFG	CARRIER	CARRIER
Serial Num	-	1824P10908
Model Num	48HCE12	48HCE12
Type	RTU	RTU
Configuration	VERTICAL	VERTICAL
Num OA Filters 1	-	2
OA Filter Size 1	-	24X26
Num Final Filter 1	-	6
Final Filter Size 1	-	18X24

Test Data		
	Design	Actual
SF CFM	4000	3386
SF RPM	-	785
RA CFM	3500	2961
OA CFM	500	425
RL Voltage	-	490/492/491
RL Amperage	-	4.6/4.5/4.6
SF Rotation	-	CCW
SF System SetPt	-	100%
RA Damper Position	-	80%
Min OA Damper Position	-	20%
Min OA Damper Type	-	OPPOSED BLADE

Notes:
(1). CONSTRUCTION FILTERS INSTALLED.

Issue Name : RTU-1 LOW AIRFLOW
Description : Pully on RTU-1 is set to 0 turns open and cannot be adjusted further. Design airflow of 4000 CFM cannot be reached current airflow is 3386 CFM.
Created By : National TAB **Assigned To :** National TAB - Will Turnbough
Status : Open
Priority : Urgent **Asset Tag :**
Originated Date : 12/16/2024 - Oscar Ventura - National TAB

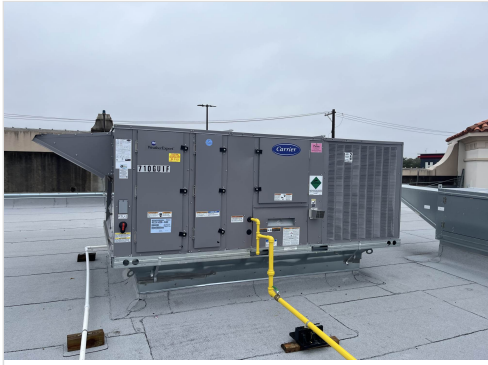
Unit Data - PHOTO LOG

Asset: RTU2

AREA: DINING

Unit Data		
	Design	Actual
MFG	CARRIER	CARRIER
Serial Num	-	4024P28449
Model Num	48HCE14	48HCE14
Type	RTU	RTU
Configuration	VERTICAL	VERTICAL
Num OA Filters 1	-	4
OA Filter Size 1	-	16X24
Num Final Filter 1	-	6
Final Filter Size 1	-	20X25X2

Test Data		
	Design	Actual
SF CFM	4375	4400
SF RPM	-	874
RA CFM	3375	3414
OA CFM	1000	986
RL Voltage	-	
RL Amperage	-	5.1/5.2/5.2
SF Rotation	-	491/492/493
SF System SetPt	-	100%
RA Damper Position	-	75%
Min OA Damper Position	-	25%
Min OA Damper Type	-	OPPOSED BLADE

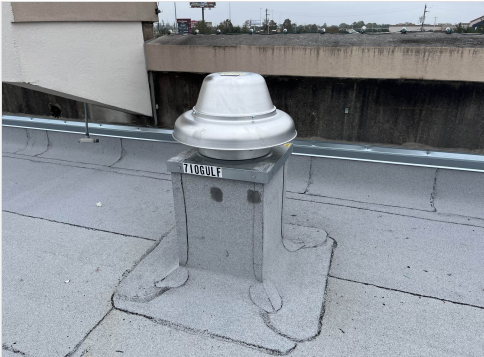
Unit Data - PHOTO LOG

Asset: EF2

AREA:bathroom

Unit Data		
	Design	Actual
MFG	CAPTIVEAIRE	CAPTIVEAIRE
Model Num	DR12HFA	DR12HFA
Serial Num	-	6777808
Type	Downblast	DOWNBLAST
Configuration	Vertical	VERTICAL

Test Data		
	Design	Actual
CFM	150	146
Fan RPM	-	1100
Fan Rotation	-	CCW
Motor RPM	-	1100
System SetPt	-	55%
RL Voltage	-	120
RL Amperage	-	1.6/1.5/1.5
Total ESP	.6	0.48"
Fan Inlet SP	-	-0.48"
Fan Discharge SP	-	ATM

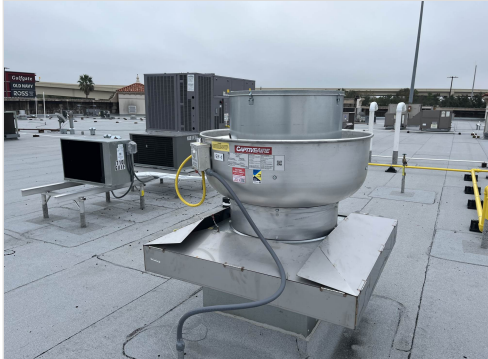
Unit Data - PHOTO LOG

Asset: KEF1

AREA:Kitchen

Unit Data		
	Design	Actual
MFG	CAPTIVEAIRE	CAPTIVEAIRE
Model Num	DU180HFA	DU180HFA
Serial Num	-	6777808
Type	upblast	UPBLAST
Configuration	Vertical	VERTICAL

Test Data		
	Design	Actual
CFM	2550	2552
Fan RPM	969	969
Fan Rotation	-	CCW
Motor RPM	-	969
System SetPt	-	49.7 HZ
RL Voltage	-	116/117/117
RL Amperage	-	4.6/4.5/4.5
Total ESP	1.2	0.59"
Fan Inlet SP	-	-0.59
Fan Discharge SP	-	ATM

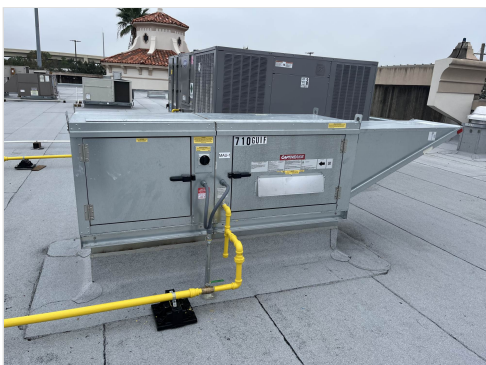
Unit Data - PHOTO LOG

Asset: MAU1

AREA:HOOD

Unit Data		
	Design	Actual
MFG	CAPTIVEAIRE	CAPTIVEAIRE
Model Num	A1-D.250-15D	A1-D.250-15D
Serial Num	-	6777808
Type	MAU	MAU
Configuration	VERTICAL	VERTICAL

Test Data		
	Design	Actual
CFM	1300	1344
SF RPM	-	1392
Motor RPM	-	1392
SF System SetPt	-	48 HZ
RL Voltage	-	120
RL Amperage	-	2.3
Total ESP	-	0.57"
Fan Discharge SP	-	0.57"

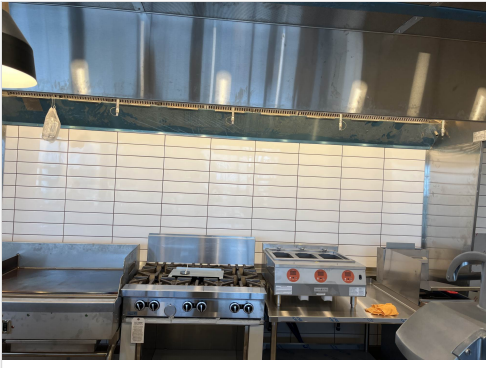
Unit Data - PHOTO LOG

Asset: HD1

AREA:COOKLINE

Unit Data		
	Design	Actual
MFG	CAPTIVEAIRE	CAPTIVEAIRE
Model Num	5424 ND-2-ACPSP-F	5424 ND-2-ACPSP-F
Job / Serial Num	-	-
Type	TYPE I CANOPY	TYPE I CANOPY
Hood length	153"	153"
Hood Width	54"	54"
Supply Plenum Type	-	PSP
Supply Plenum Width	9"	9"
Supply Plenum Length	165"	165"

Test Data Exhaust		
	Design	Actual
Filter Type	CAPTRATE SOLO	CAPTRATE SOLO
Filter Size 1	16x16	16X16
Filter Qty 1	9	9
Filter AK factor size 1	1.62	1.62
Filter Total AK Area	14.58	14.58
Filter1 FPM	-	160
Filter2 FPM	-	174
Filter3 FPM	-	192
Filter4 FPM	-	185
Filter5 FPM	-	176
Filter6 FPM	-	193
Filter7 FPM	-	176
Filter8 FPM	-	161
Filter9 FPM	-	164
Filter Ave FPM(corr)	-	175
CFM	2550	2552

Test Data Supply		
	Design	Actual
Total Area	10.31	10.31
Kv factor (Vel)	0.81	0.81
Num of Readings	-	8
Reading1 FPM	-	159
Reading2 FPM	-	151
Reading3 FPM	-	142
Reading4 FPM	-	150
Reading5 FPM	-	119
Reading6 FPM	-	189
Reading7 FPM	-	191
Reading8 FPM	-	194
Ave FPM(corr)	-	161
CFM	1300	1344
