Report: TAB Report
Function: Test, Adjust, & Balance
Date: 10/23/2025
Completed By: National TAB

PROJECT
10-27-25 QT #1126 SPARTANBURG, SC

Project: 10-27-25 QT #1126 SPARTANBURG, SC

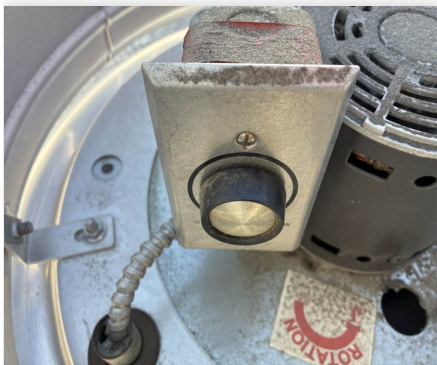
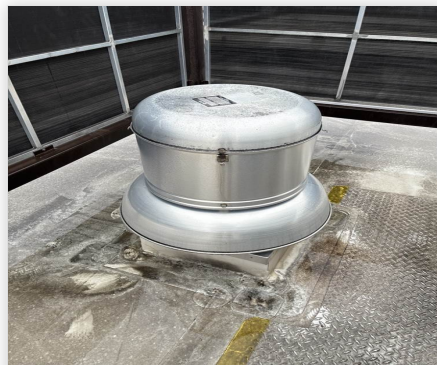
Issue Name : EF-2 Speed Controller
Description : The speed controller for EF-2 is set to maximum and there is insufficient airflow for EF2-1 and EF2-2.
Created By : National TAB **Assigned To :** National TAB - Dan Hertenstein
Status : Open
Priority : Low **Asset Tag :** EF2
Originated Date : 11/07/2025 - Alex Bauer - National TAB

[1] LOW ON AIRFLOW WITH SPEED MAXIMIZED. COMBI OVEN GRILLE ON LOW END OF DESIGN.

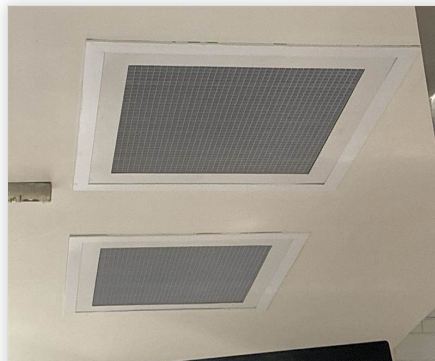
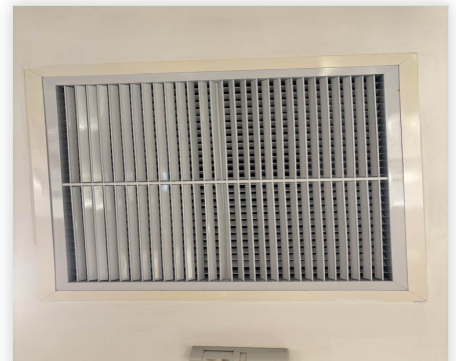
Issue Name : Incorrect Kitchen Diffusers
Description : The diffusers 3-1 through 3-4 are not the appropriate type. They should be the Titus S1 diffuser. The contractor will be replacing the incorrect diffusers with the correct type in the near future.
Created By : National TAB **Assigned To :** National TAB - Dan Hertenstein
Status : Open
Priority : InfoOnly **Asset Tag :** RT-3
Originated Date : 11/06/2025 - Alex Bauer - National TAB

Notes:
 [1] INCORRECT COOKLINE DIFFUSERS. UNABLE TO ACCESS DAMPER DUE TO CEILING.

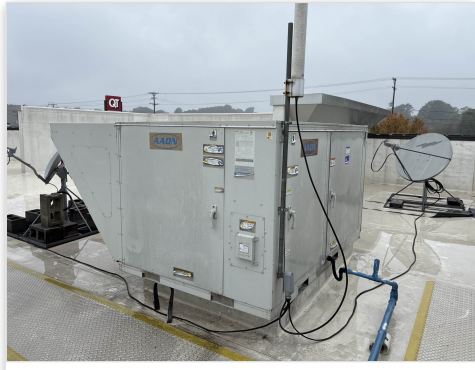
Unit Data - PHOTO LOG

Unit Data	
	Actual
MFG	AAON
Serial Num	201609-ANEK14601
Model Num	RN-013-8-0-EA0A-152
Num OA Filters 1	1
OA Filter Size 1	44.5 X 22.5

Test Data		
	Design	Actual
SF CFM	4200	4265
SF RPM	-	DD/40 Hz
OA CFM (Hoods On)	800	827
OA CFM (Hoods Off)	350	313
RL Voltage	-	123 VFD
RL Amperage	-	8.80 VFD
VFD Max SetPt	-	DD/40 Hz
OA Damper Position (Hoods On)	-	46%
OA Damper Position (Hoods Off)	-	26%
