**Report: TAB Report**  
**Function: Test, Adjust, & Balance**  
**Date: 10/23/2025**  
**Completed By: National TAB**

**PROJECT**  
**10-27-25 QT #1126 SPARTANBURG, SC**

Project: 10-27-25 QT #1126 SPARTANBURG, SC

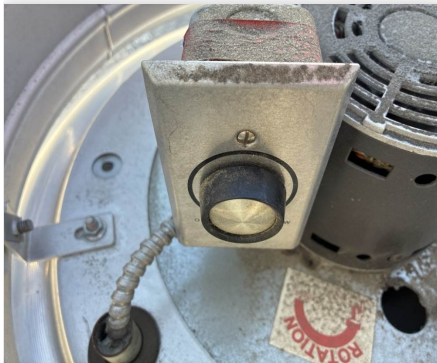
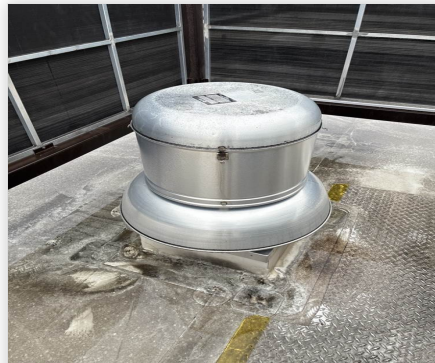
**Issue Name :** EF-2 Speed Controller  
**Description :** The speed controller for EF-2 is set to maximum and there is insufficient airflow for EF2-1 and EF2-2.  
**Created By :** National TAB                      **Assigned To :** National TAB - Dan Hertenstein  
**Status :** Open  
**Priority :** Low                                      **Asset Tag :** EF2  
**Originated Date :** 11/07/2025 - Alex Bauer - National TAB

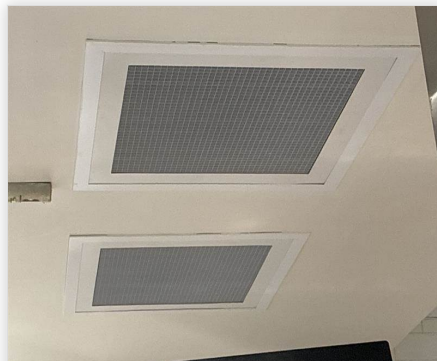
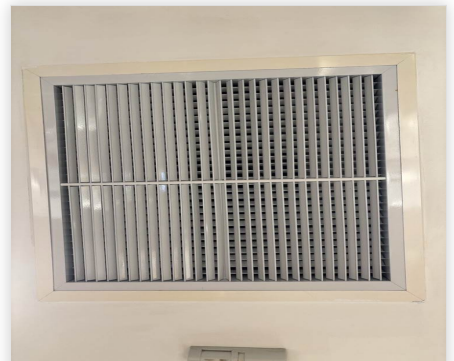
**Issue Name :** Incorrect Kitchen Diffusers  
**Description :** The diffusers 3-1 through 3-4 are not the appropriate type. They should be the Titus S1 diffuser. The contractor will be replacing the incorrect diffusers with the correct type in the near future.  
**Created By :** National TAB                      **Assigned To :** National TAB - Dan Hertenstein  
**Status :** Open  
**Priority :** InfoOnly                              **Asset Tag :** RT-3  
**Originated Date :** 11/06/2025 - Alex Bauer - National TAB

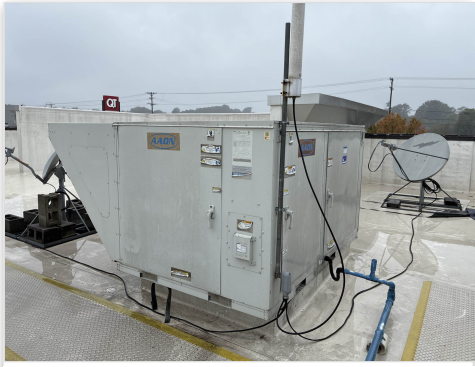
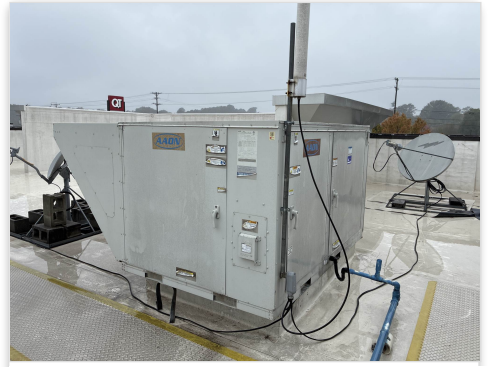
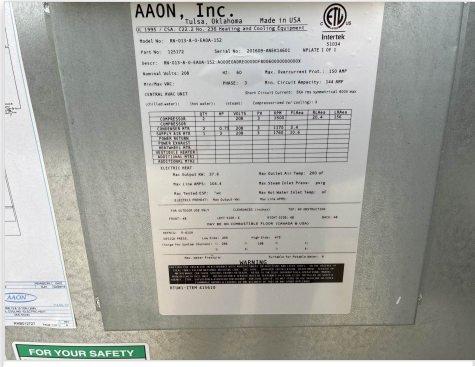
# Unit Data - PHOTO LOG

Unit Data	
	Actual
MFG	AAON
Serial Num	201609-ANEK14602
Model Num	RN-013-8-0-EA0A-152
Num OA Filters 1	1
OA Filter Size 1	44.5 X 22.5

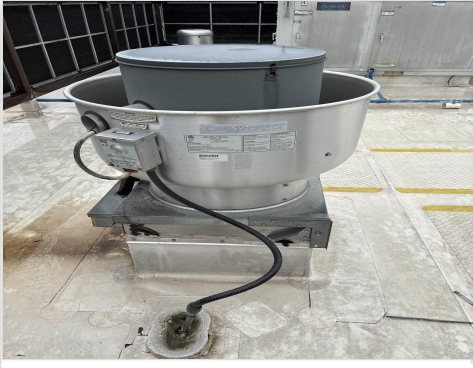
**Unit Data - PHOTO LOG**

Unit Data		
	Design	Actual
MFG	NA	CAPTIVEAIRE
Model Num	NA	DU50HFA
Serial Num	-	2771968
Type	UPBLAST	UPBLAST
Configuration	VERTICAL	VERTICAL

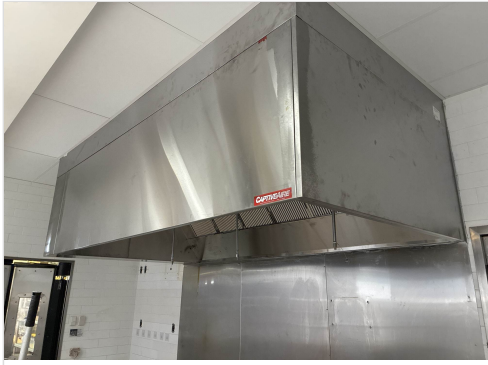
# Unit Data - PHOTO LOG

Unit Data		
	Design	Actual
MFG	CAPTIVEAIRE	CAPTIVEAIRE
Model Num	6030ND-2-F	6030ND-2
Job / Serial Num	-	7644829
Type	-	TYPE I CANOPY
Hood length	-	60"
Hood Width	-	108"

Test Data Exhaust		
	Design	Actual
Filter Type	-	BAFFLE FILTERS
Filter Size 1	-	16X20
Filter Qty 1	-	6
Filter AK factor size 1	-	2.08
Filter Total AK Area	-	12.48
Filter1 FPM	-	85
Filter2 FPM	-	104
Filter3 FPM	-	108
Filter4 FPM	-	107
Filter5 FPM	-	98
Filter6 FPM	-	106
Filter Ave FPM(corr)	-	101
CFM	1350	1260
