**Report: TAB REPORT
Function: Test, Adjust, & Balance
Date: 01/31/2023**

01-30-23 CULVERS - BATAVIA, IL

470 N RANDALL RD

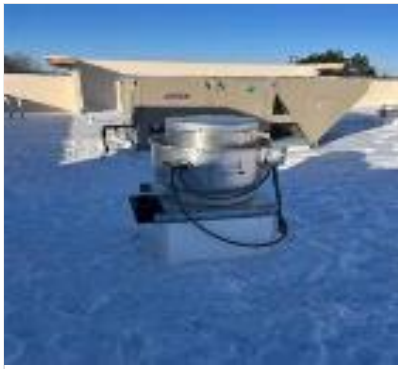
PRV-3

Unit Data		
	Design	Actual
MFG	ACCUREX	ACCUREX
Model Num	XRUB-140-7	XCUE-140-10-VG-1-26-G
Serial Num	-	21020963 22J
Type	UPBLAST	UPBLAST
Configuration	VERTICAL	VERTICAL

Test Data		
	Design	Actual
CFM	1500	1622
Fan RPM	1377	1015
Fan Rotation	-	CW
Motor RPM	-	1015
RL Voltage	-	120
RL Amperage	-	2.7
Suction ESP	-	-0.47"
Discharge ESP	-	ATM
Total ESP	1.0"	0.47"

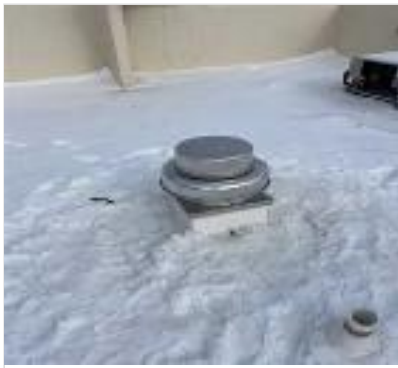
PRV-4

Unit Data		
	Design	Actual
MFG	ACCUREX	ACCUREX
Model Num	XRED-095-VG	XRED-095-VG-1-17-X
Serial Num	-	21021232
Type	DOWNBLAST	DOWNBLAST
Configuration	HORIZONTAL	VERTICAL

Test Data		
	Design	Actual
CFM	350	328
Fan RPM	1486	DD
Fan Rotation	-	CW
Motor RPM	-	DD
System SetPt	-	8 ON SPEED CONTROLLER
RL Voltage	-	120
RL Amperage	-	2.1
Total ESP	0.6"	0.92"
Fan Inlet SP	-	-0.92"
Fan Discharge SP	-	ATM

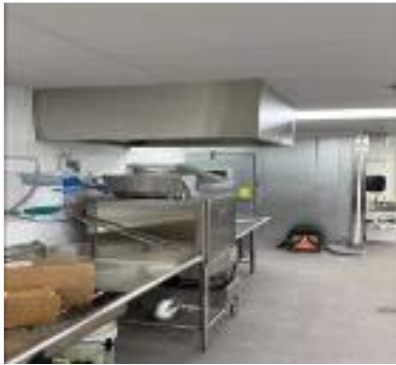
HOOD 3

Unit Data		
	Design	Actual
MFG	ACCUREX	ACCUREX
Model Num	XD3-42-S	XD3-42.00-S
Serial Num	-	21036266
Type	TYPE II CANOPY	TYPE II CANOPY
Hood length	42	42
Hood Width	42	42

Test Data		
	Design	Actual
Exhaust CFM	350	328

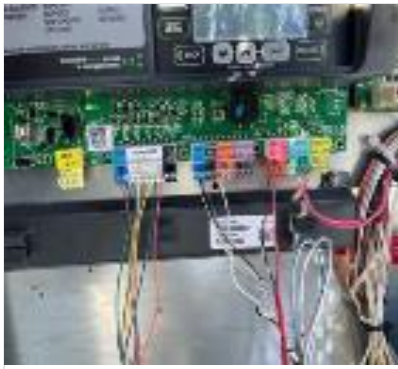
PRODIGY BOARD WIRING

PRODIGY SETTINGS FOR RTU'S

Parameter 65 set to 0	Yes
-----------------------	-----

Parameter 78 set to 0	Yes
Parameter 105 set to 6	Yes
Parameter 156 set to 70 (Dining unit only)	Yes
Parameter 156 set to 65 (Kitchen Unit Only)	Yes
Parameter 170 set to 75 (Dining Unit Only)	Yes
Parameter 170 set to 70 (Kitchen Unit Only)	Yes
Parameter 131 set to the same % as OA minimum position?	Yes
Parameter 117 set to the same % as OA minimum position?	Yes
