RTU DINING

KITCHEN UNIT

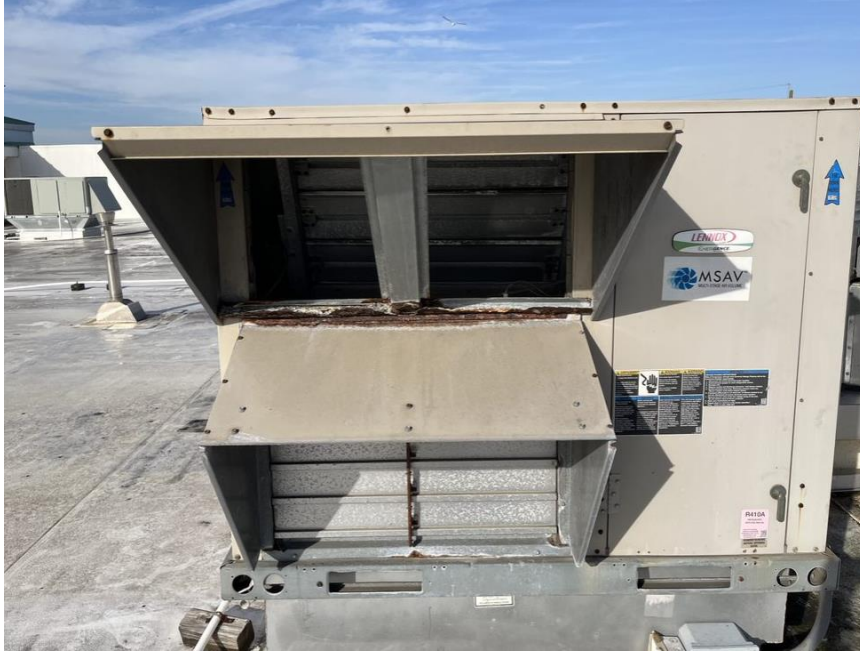
OUTSIDE FILTERS MISSING. IDEAL TO REPLACE.

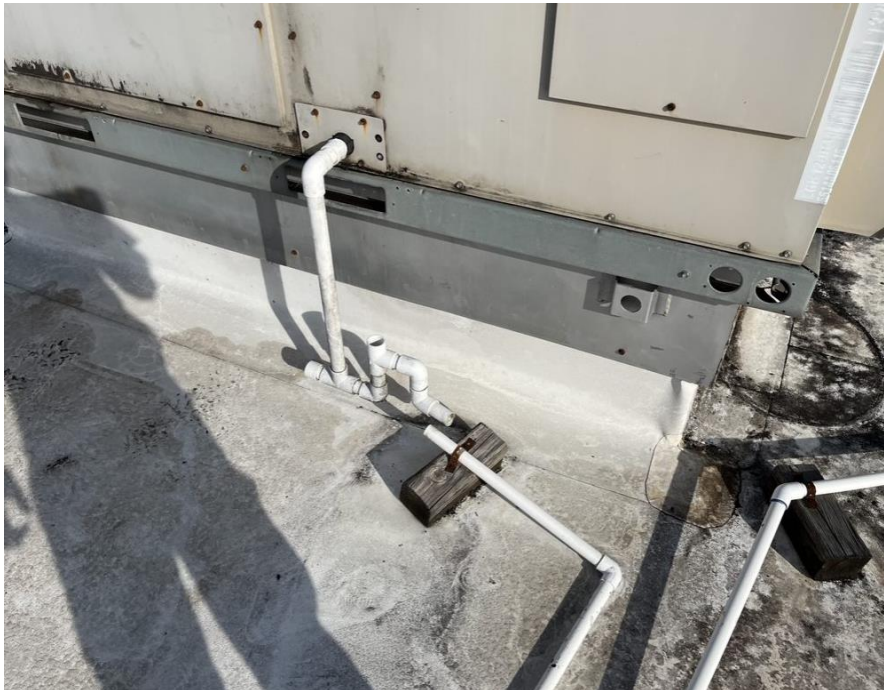
CLEAN & CONNECT PROPERLY ALL CONDENSATE TRAPS

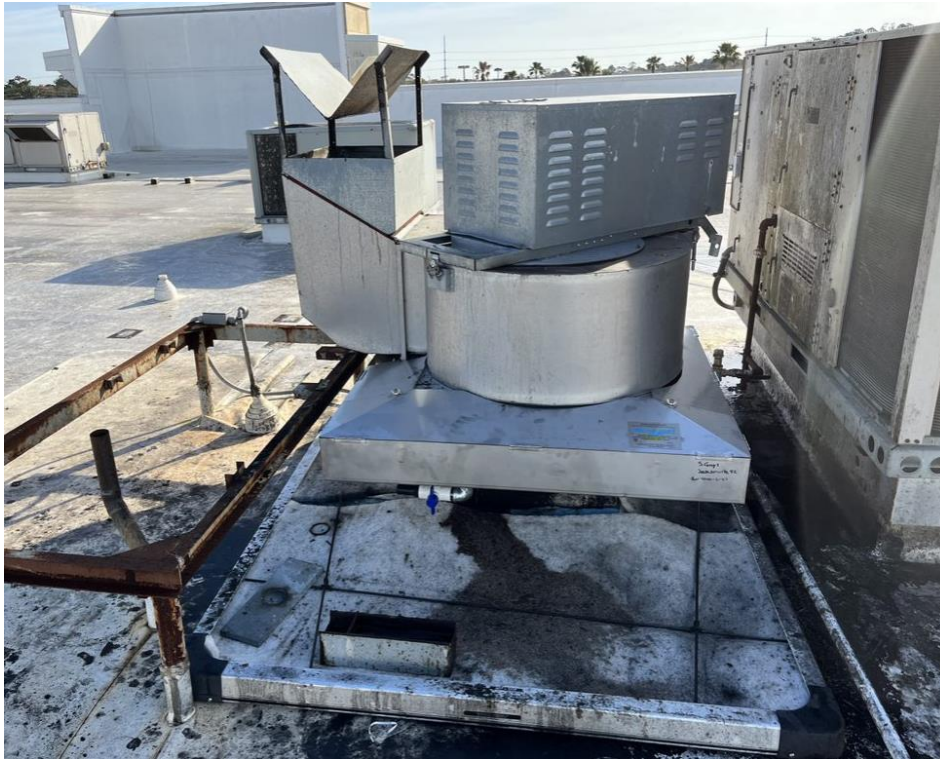
The unit is also very close to the Grill exhaust fan (KEF1) which causes a lot of grease build up on the condenser coil, fan & unit (see pictures). It is recommended to install a 45-degree discharge directed away from the RTU unit.

EXHAUST VERY CLOSE TO UNIT. SEE PICTURES & NOTES OF MINIMUM ACTION ITEM TO HELP RESOLVE ISSUE.

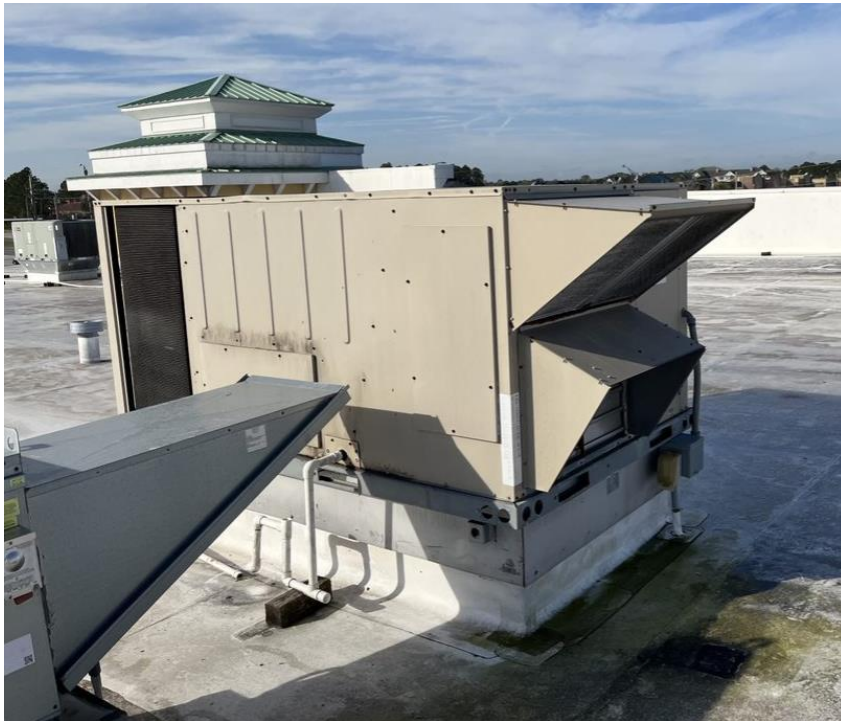
DIFFICULT TO GET FILTERS OUT OF MUA UNIT. IS IT POSSIBLE TO GET OUT? IF NOT, MAY NEED TO CREATE A SLOT ON SIDE OF INTAKE HOOD TO SLIDE FILTERS IN & OUT.

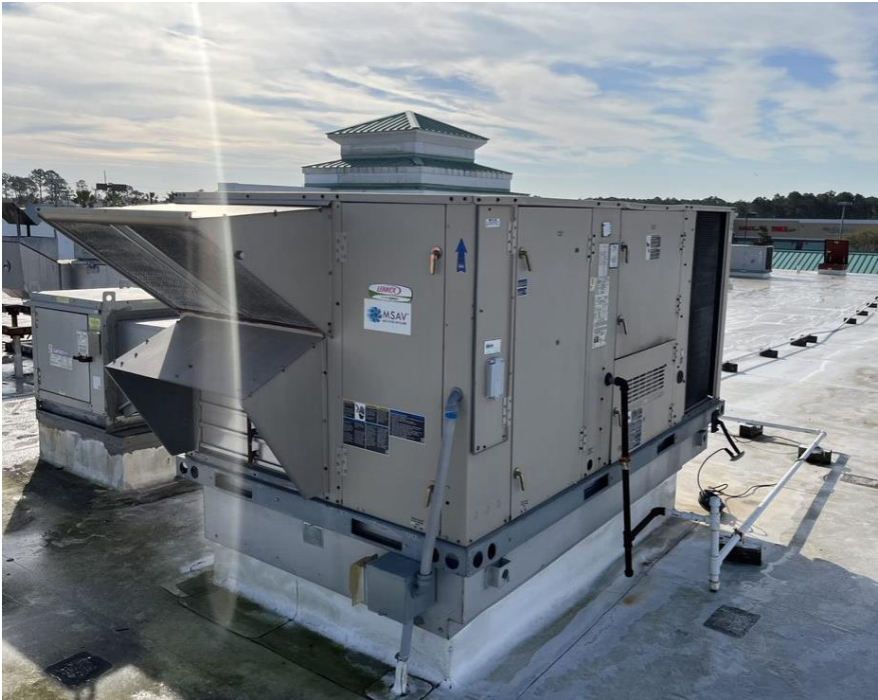
RTU-DINING WITH CURB ADAPTER. IDEAL TO SAND DOWN GAS PIPING & PAINT FOR THE PORTION THAT WAS REPLACED WITH LAST RTU REPLACEMENT.
