Report: Test Report
Function: Test, Adjust, & Balance
Date: 03/14/2025
Completed By: National TAB

PROJECT
03-10-25 WHATABURGER #1582 GASTONIA,
NC

Project: 03-10-25 WHATABURGER #1582 GASTONIA, NC

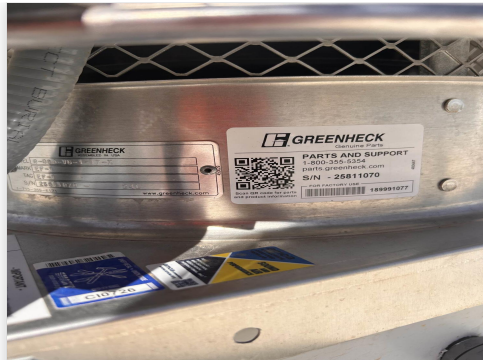
Unit Data - PHOTO LOG

Asset: EF1

AREA:RESTROOMS
