**Report: TAB**

**Function: Test, Adjust, & Balance**

**03-10-25 WHATABURGER #1582 GASTONIA,  
NC**

Whataburger Restaurants

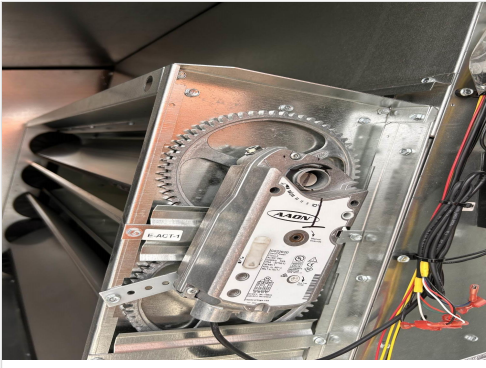
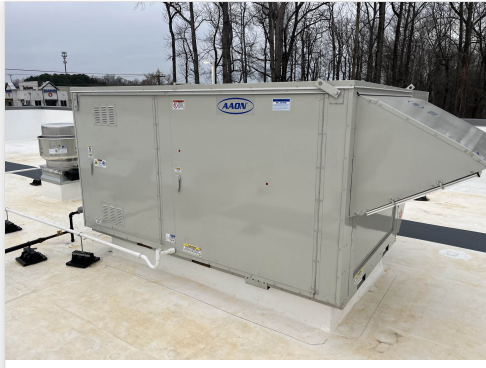
- [1] SGRD9 IS LOW OF DESIGN CFM DUE TO THE WRONG SIZED DUCTWORK BEING INSTALLED. A 6" DUCT WAS INSTALLED WHEN PLANS CALL FOR A 8". SPENT OVER AN HOUR TRYING TO PUSH AIR TO SGRD9 BUT WAS UNABLE TO INCREASE SUPPLY AIR TO DESIGN CFM.
- [2] RETURN & SUPPLY DUCT COULD NOT BE TRAVERSED DUE TO MAIN DROP / TRUCK LINE NOT HAVING A RUN OF 4FT. OR MORE OF STRAIGHT DUCTWORK. UNABLE TO TAKE AN ACCURATE TRAVERSE DUE TO THIS ISSUE.

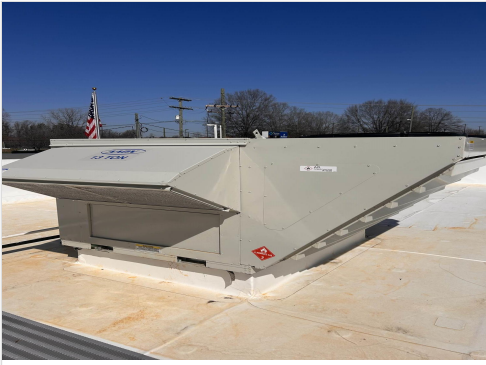
- [1] BALANCE SCHEDULE CALLS FOR UNIT TOTAL TO BE 2240. SUPPLY GRILLS ADD UP TO 2140 ON GRD. SUPPLY GRILLS SGRD1,4,6,10,14,17,18 DESIGNS WERE ENCREASED TO REACH 2240 CFM.
- [2] SRD13 WAS REMOVED AND SGRD14 DESIGN WAS INCREASED TO 200CFM PER G.C.
- [3] RETURN DUCT COULD NOT BE TRAVERSED DUE TO MAIN DROP / TRUCK LINE NOT HAVING A RUN OF 4FT. OR MORE OF STRAIGHT DUCTWORK. UNABLE TO TAKE AN ACCURATE TRAVERSE DUE TO THIS ISSUE.
