Report: TAB

Function: Test, Adjust, & Balance

Date: 03/14/2025

**03-10-25 WHATABURGER #1582 GASTONIA,
NC**

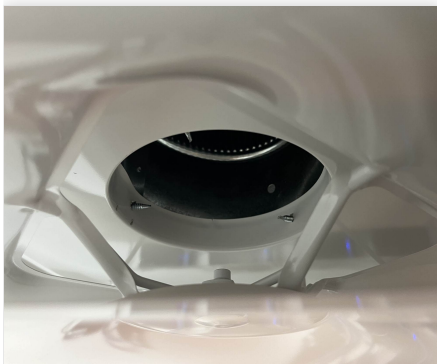
Issue Name : RTU1 / SGRD9 Duct Size
Description : SGRD9 IS LOW OF DESIGN CFM DUE TO THE WRONG SIZED DUCTWORK BEING INSTALLED. A 6" DUCT WAS INSTALLED WHEN PLANS CALL FOR A 8". SPENT OVER AN HOUR TRYING TO PUSH AIR TO SGRD9 BUT WAS UNABLE TO INCREASE SUPPLY AIR TO DESIGN CFM.
Created By : National TAB **Assigned To :** National TAB - Dan Hertenstein
Status : Open
Priority : Medium **Asset Tag :**
Originated Date : 03/14/2025 - Dale Wheeler - National TAB

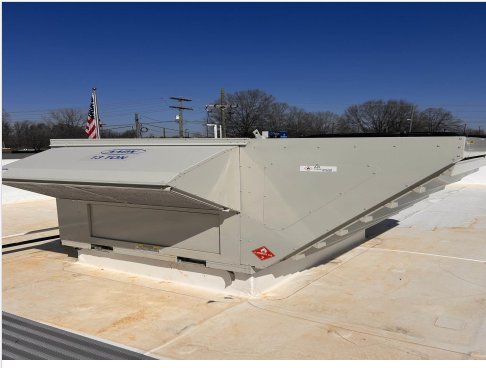
Unit Data - PHOTO LOG

- [1] BALANCE SCHEDULE CALLS FOR UNIT TOTAL TO BE 2240. SUPPLY GRILLS ADD UP TO 2140 ON GRD. SUPPLY GRILLS SGRD1,4,6,10,14,17,18 DESIGNS WERE ENCREASED TO REACH 2240 CFM.
- [2] SRD13 WAS REMOVED AND SGRD14 DESIGN WAS INCREASED TO 200CFM PER G.C.
- [3] RETURN DUCT COULD NOT BE TRAVERSED DUE TO MAIN DROP / TRUCK LINE NOT HAVING A RUN OF 4FT. OR MORE OF STRAIGHT DUCTWORK. UNABLE TO TAKE AN ACCURATE TRAVERSE DUE TO THIS ISSUE.
