**Report: TAB**

**Function: Test, Adjust, & Balance**

**03-10-25 WHATABURGER #1582 GASTONIA,  
NC**

Project: 03-10-25 WHATABURGER #1582 GASTONIA, NC

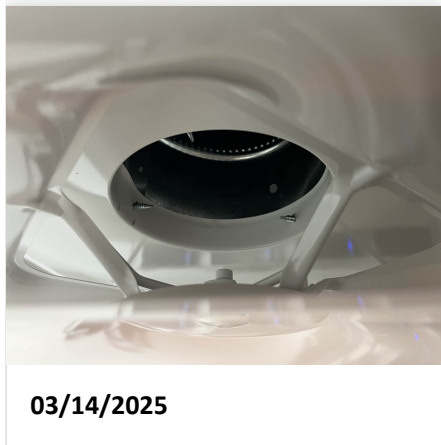
**Issue Name :** RTU1 / SGRD9 Duct Size  
**Description :** SGRD9 IS LOW OF DESIGN CFM DUE TO THE WRONG SIZED DUCTWORK BEING INSTALLED. A 6" DUCT WAS INSTALLED WHEN PLANS CALL FOR A 8". SPENT OVER AN HOUR TRYING TO PUSH AIR TO SGRD9 BUT WAS UNABLE TO INCREASE SUPPLY AIR TO DESIGN CFM.  
**Created By :** National TAB                      **Assigned To :** National TAB - Dan Hertenstein  
**Status :** Open  
**Priority :** Medium                      **Asset Tag :**  
**Originated Date :** 03/14/2025 - Dale Wheeler - National TAB

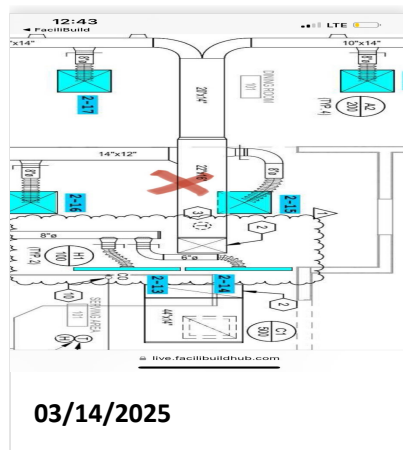
Screenshot of the GRD marked up with supply and return traverse locations for RTU-2 (Add picture here)

RETURN DUCT COULD NOT BE TRAVERSED DUE TO MAIN DROP / TRUCK LINE NOT HAVING A RUN OF 4FT. OR MORE OF STRAIGHT DUCTWORK. UNABLE TO TAKE AN ACCURATE TRAVERSE DUE TO THIS ISSUE SUPPLY DUCTWORK WAS TRAVEERSED & HOLES PLUGED AND INSULATION RETAPED. GRD MARKED WITH RED X SHOWING WHERE TRAVERSE WAS TAKEN.
