Report: TAB Report
Function: Test, Adjust, & Balance
Date: 03/30/2026
Completed By: National TAB

PROJECT
03-30-26 QT #0813 NEWNAN, GA

1060 BULLSBORO DR.

Project: 03-30-26 QT #0813 NEWNAN, GA

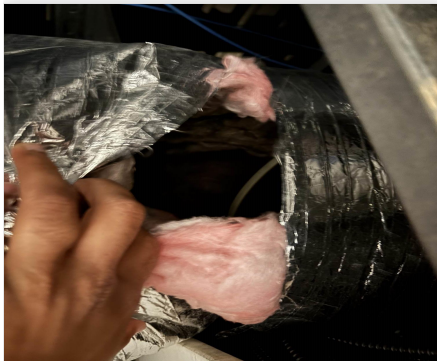
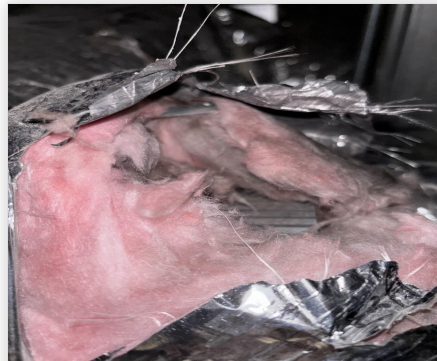
Issue Name : RTU-3: Hole in Flex Duct for Diffuser 3-4
Description : There are holes in the flex duct for diffuser 3-4, farthest diffuser from the combi-oven/ closest to the walk-in cooler. This is releasing a lot of air into the ceiling. Tech attempted to patch on hole and found a second hole wrapping around the duct to the other side of it.
Created By : National TAB **Assigned To :** National TAB - Brianna Biggs
Status : Open
Priority : Urgent **Asset Tag :**
Originated Date : 03/30/2026 - Sagar Patel - National TAB

Unable to balance RTU-3 due to hole in flex duct.
