Report: TAB Report
Function: Test, Adjust, & Balance
Date: 03/30/2026
Completed By: National TAB

PROJECT
03-30-26 QT #0813 NEWNAN, GA

Project: 03-30-26 QT #0813 NEWNAN, GA

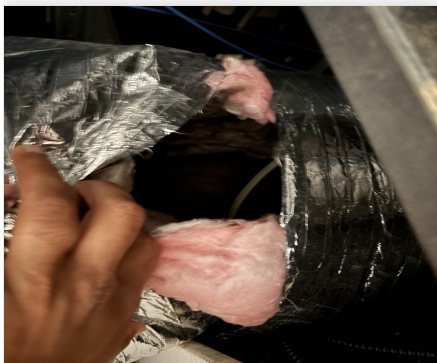
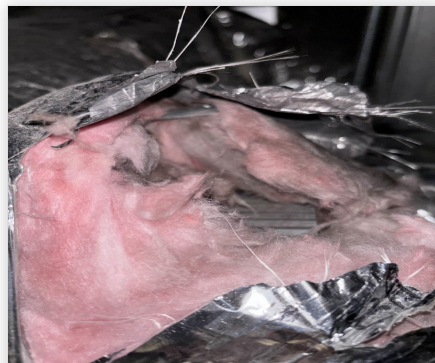
Issue Name : RTU-3: Hole in Flex Duct for Diffuser 3-4
Description : There are holes in the flex duct for diffuser 3-4, farthest diffuser from the combi-oven/ closest to the walk-in cooler. This is releasing a lot of air into the ceiling. Tech attempted to patch on hole and found a second hole wrapping around the duct to the other side of it.
Created By : National TAB **Assigned To :** National TAB - Brianna Biggs
Status : Open
Priority : Urgent **Asset Tag :**
Originated Date : 03/30/2026 - Sagar Patel - National TAB

Unable to balance RTU-3 due to hole in flex duct.

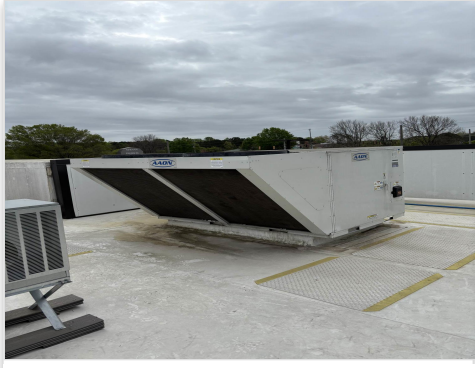
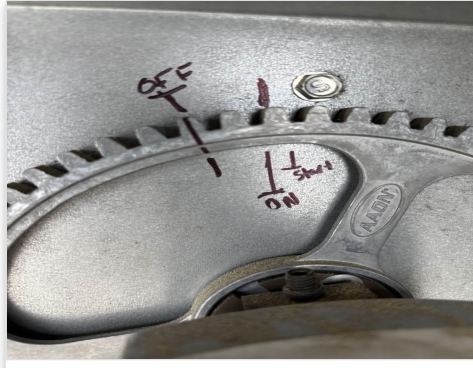
Unit Data - PHOTO LOG

Unit Data	
	Actual
MFG	AAON
Serial Num	202201-ANEK23512
Model Num	RN-013-8-0-EA0A-152
Num OA Filters 1	1
OA Filter Size 1	22X45
Num Final Filter 1	4
Final Filter Size 1	20X25X2

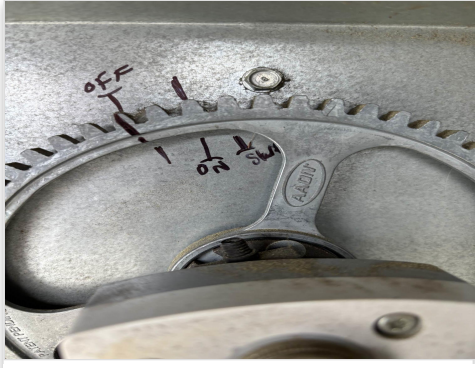
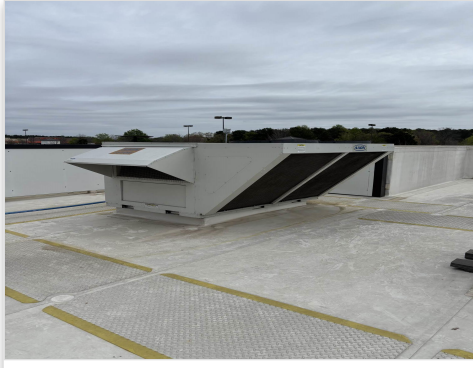
Unit Data - PHOTO LOG

Unit Data	
	Actual
MFG	AAON
Serial Num	202201-ANEK23513
Model Num	RN-013-8-0-EA0A-152
Num OA Filters 1	1
OA Filter Size 1	22X45
Num Final Filter 1	4
Final Filter Size 1	20X25X2

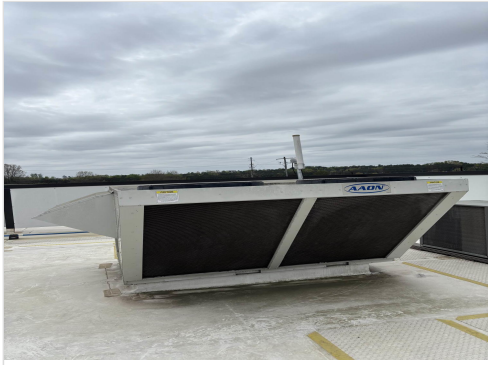
Unit Data - PHOTO LOG

Unit Data	
	Actual
MFG	AAON
Serial Num	202201-ANEK23514
Model Num	RN-013-8-0-EA0A-152
Num OA Filters 1	1
OA Filter Size 1	22X45
Num Final Filter 1	4
Final Filter Size 1	20X25X2

Test Data		
	Design	Actual
SF CFM	4200	3085
SF RPM	-	1355
RL Voltage	-	160 VFD
RL Amperage	-	8.18 VFD
VFD Max SetPt	-	46.2 Hz
VFD Min SetPt	-	24 Hz

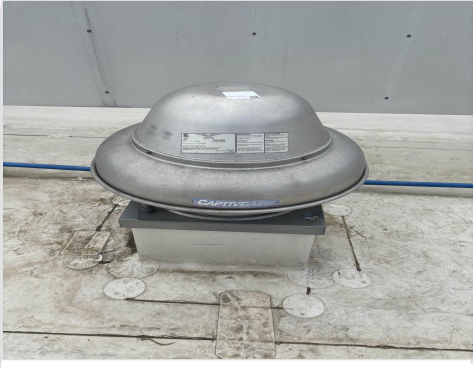
Unit Data - PHOTO LOG

Unit Data	
	Actual
MFG	CAPTIVEAIRE
Model Num	DR50HFA
Serial Num	527558
Type	DOWNBLAST
Configuration	VERTICAL

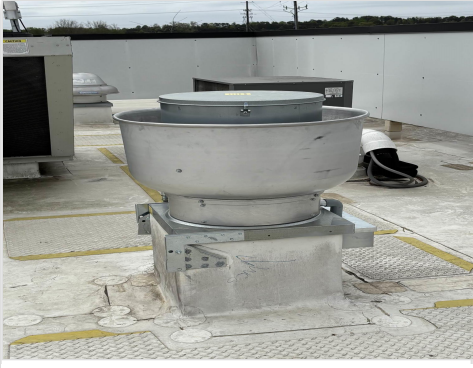
Unit Data - PHOTO LOG

Unit Data		
	Design	Actual
MFG	NA	CAPTIVEAIRE
Model Num	NA	DU50HFA
Serial Num	-	7657561
Type	UPBLAST	UPBLAST
Configuration	VERTICAL	VERTICAL

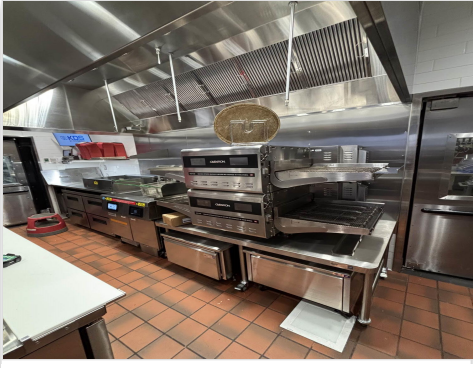
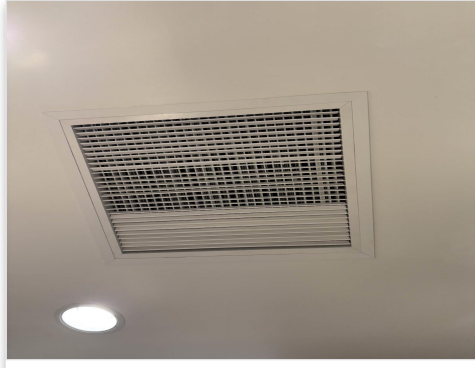
Unit Data - PHOTO LOG

Design	Actual
MFG	CAPTIVEAIRE	CAPTIVEAIRE
Model Num	6030ND-2-F	6030ND-2-F
Job / Serial Num	-	7657561
Type	TYPE I CANOPY	TYPE I CANOPY
Hood length	108"	108"
Hood Width	60"	60"

Design	Actual
Filter Type	-	CAPTRATE SOLO FILTER
Filter Size 1	-	20X16
Filter Qty 1	-	6
Filter AK factor size 1	-	2.08
Filter Total AK Area	-	12.48
Filter1 FPM	-	98
Filter2 FPM	-	103
Filter3 FPM	-	111
Filter4 FPM	-	116
Filter5 FPM	-	108
Filter6 FPM	-	97
Filter Ave FPM(corr)	-	106
CFM	1350	1322
