Report: TAB Report
Function: Test, Adjust, & Balance
Date: 01/16/2026
Completed By: National TAB

PROJECT
01-26-26 QT #1114 GREER, SC

Project: 01-26-26 QT #1114 GREER, SC

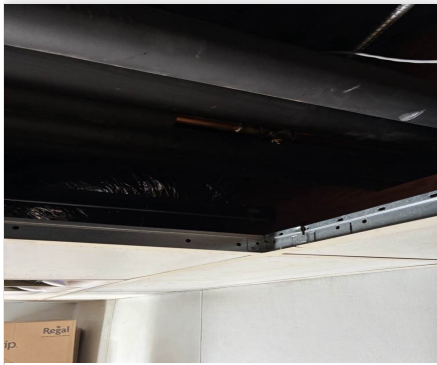
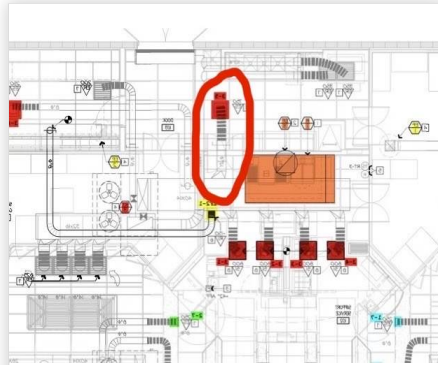
Issue Name : Damper 3-5 Not Accessible
Description : The damper for 3-5 is not accessible. It is located in an area where it cannot be reached.
Created By : National TAB **Assigned To :** National TAB - Dan Hertenstein
Status : Open
Priority : High **Asset Tag :** SGRD5
Originated Date : 01/28/2026 - Alex Bauer - National TAB

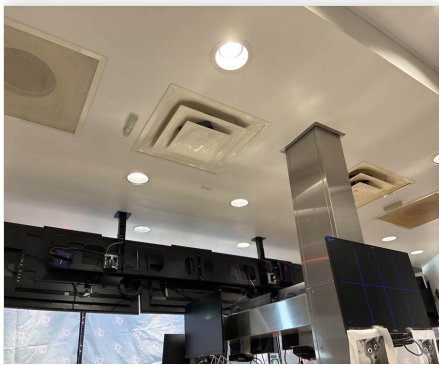
Issue Name : Dampers 3-1 Through 3-4 Not Accessible
Description : The ceiling tiles that access the mechanical dampers for 3-1 through 3-4 are not able to be moved. The panels moved approximately 3/4" but are not able to be moved out of the way to access the dampers.
Created By : National TAB **Assigned To :** National TAB - Dan Hertenstein
Status : Open
Priority : Urgent **Asset Tag :** RT-3
Originated Date : 01/28/2026 - Alex Bauer - National TAB

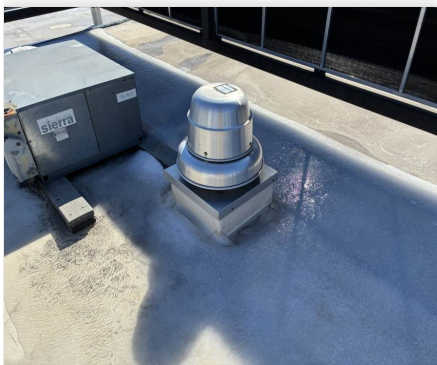
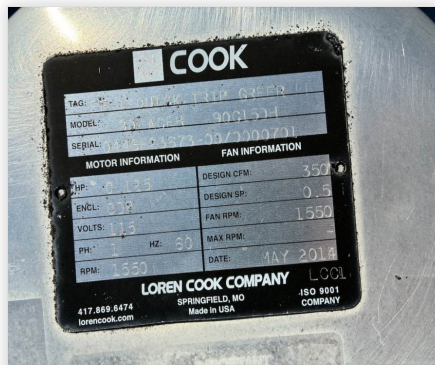
Issue Name : EF-1 Not Operational
Description : There is power being run to EF-1, the breakers are on, the switch on the fan is on, the speed dial is rotated, and the fan will not operate.
Created By : National TAB **Assigned To :** National TAB - Dan Hertenstein
Status : Open
Priority : Urgent **Asset Tag :** EF1
Originated Date : 01/28/2026 - Alex Bauer - National TAB

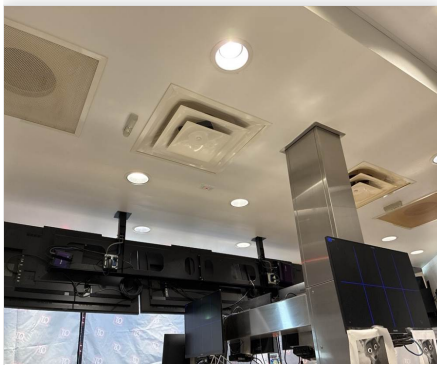
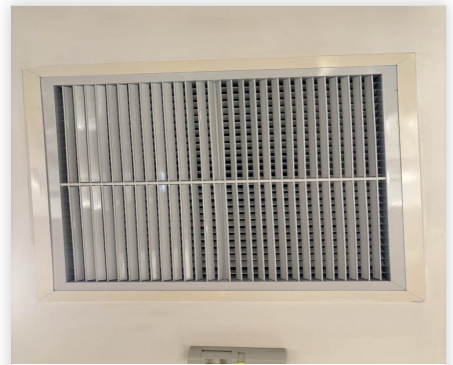
Issue Name : Incorrect Kitchen Diffusers
Description : The kitchen diffusers 3-1 through 3-4 are the incorrect type. They need to be the TITUS 300FS diffuser with the installed deflection blades.
Created By : National TAB **Assigned To :** National TAB - Dan Hertenstein
Status : Open
Priority : Medium **Asset Tag :** RT-3
Originated Date : 01/28/2026 - Alex Bauer - National TAB

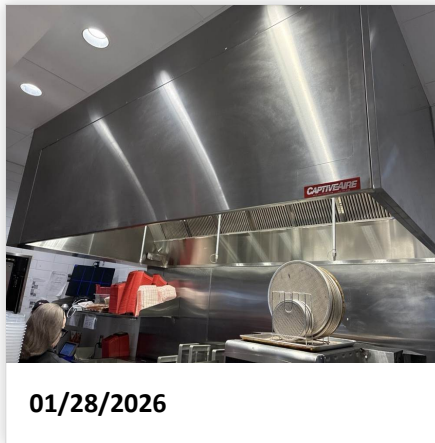
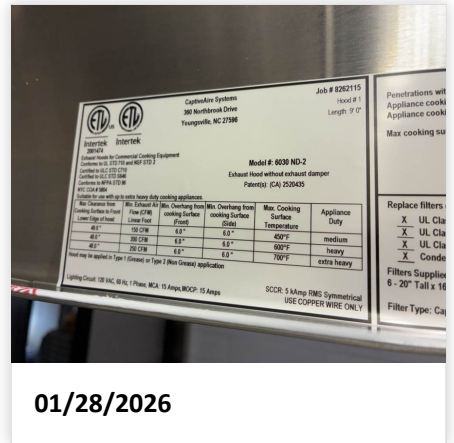
Issue Name : No Hood End Panels Installed
Description : There are no hood end panels installed as per the Hood Schedule.
Created By : National TAB **Assigned To :** National TAB - Dan Hertenstein
Status : Open
Priority : Medium **Asset Tag :** HD1
Originated Date : 01/28/2026 - Alex Bauer - National TAB

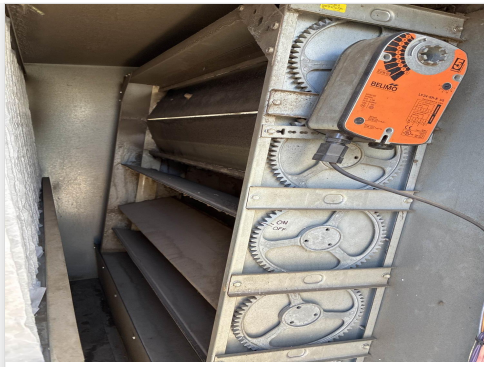
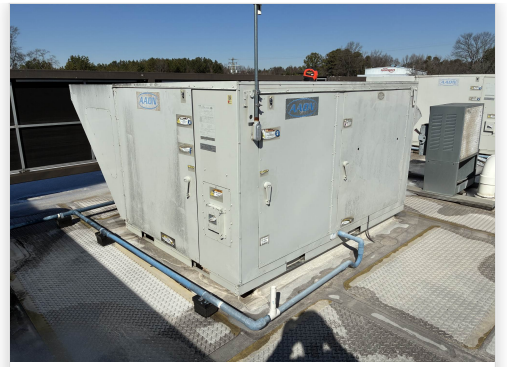
Unit Data - PHOTO LOG

Dampers 3-1 through 3-4 were not accessible. The ceiling tiles were not able to be moved. Damper 3-5 is not accessible.

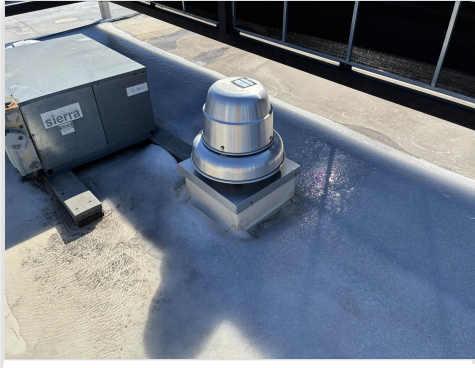
Unit Data - PHOTO LOG

Notes:
EF-1 is not operational.

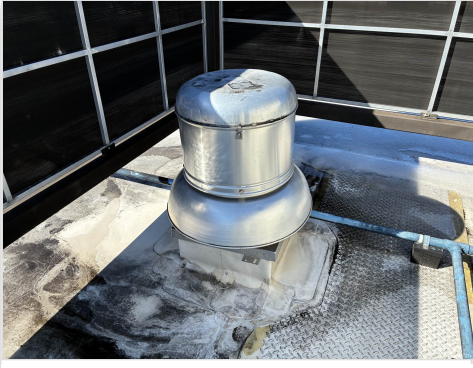
Unit Data - PHOTO LOG

EF2-1 does not have a damper.

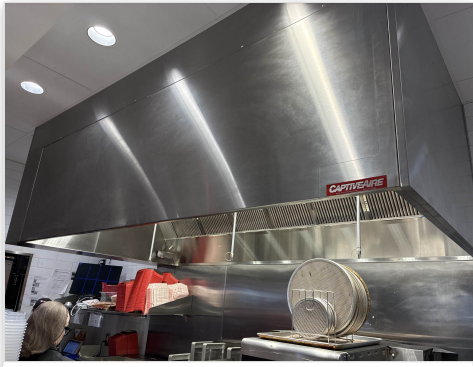
Unit Data - PHOTO LOG

Unit Data		
	Design	Actual
MFG	CAPTIVEAIRE	CAPTIVEAIRE
Model Num	6030ND-2-F	6030ND-2
Job / Serial Num	-	8262115
Type	TYPE I CANOPY	TYPE I CANOPY
Hood length	108"	108"
Hood Width	60"	60"

Test Data Exhaust		
	Design	Actual
Filter Type	-	BAFFLE FILTERS
Filter Size 1	-	16X20
Filter Qty 1	-	6
Filter AK factor size 1	-	2.08
Filter Total AK Area	-	12.48
Filter1 FPM	-	115
Filter2 FPM	-	101
Filter3 FPM	-	124
Filter4 FPM	-	99
Filter5 FPM	-	127
Filter6 FPM	-	104
Filter Ave FPM(corr)	-	111
CFM	1350	1385
