**Report: TAB**

**Function: Test, Adjust, & Balance**

**10-27-25 SWEETGREEN BURLINGAME, CA  
(TAB, IAQ)**

# National TAB

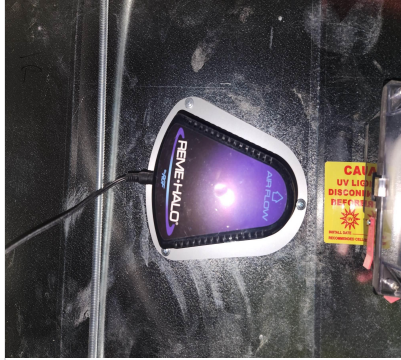
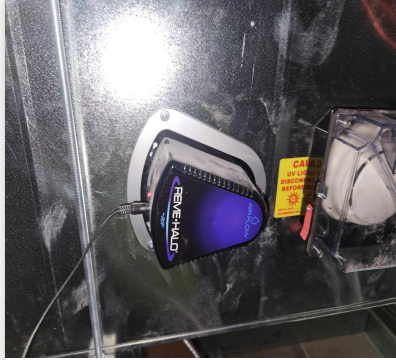
**PHI Air purifiers are installed?**

**Are they installed after the evaporator coil or in the supply duct?**

SUPPLY DUCT

**If Reme Halo, is it installed so that the air flow arrow is pointing correct direction?**

**Is a UV warning sticker installed?**

**Take picture of each air purifier and include in the report**

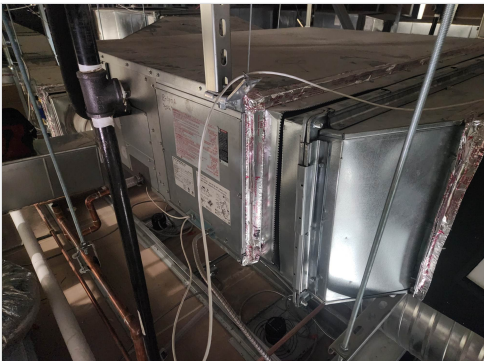
### Unit Data - PHOTO LOG

Asset: AHU2

Unit Data		
	Design	Actual
MFG	DAIKIN	DAIKIN
Serial Num	-	K000374
Model Num	FXMQ72MVJU	FXMQ72TAVJU
Type	AHU	AHU
Configuration	VERTICAL	HORIZONTAL
Num OA Filters 1	-	N/A
OA Filter Size 1	-	N/A
Num Final Filter 1	-	4
Final Filter Size 1	-	18X24X4
Num Final Filter 2	-	
Final Filter Size 2	-

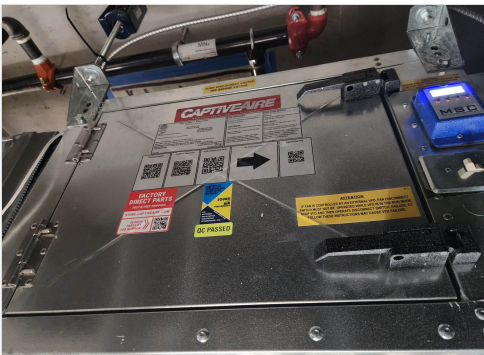
### Unit Data - PHOTO LOG

Asset: EF1

Unit Data		
	Design	Actual
MFG	CAPTIVEAIRE	CAPTIVEAIRE
Model Num	SIF11DD	SIF11DD
Serial Num	-	7285303
Type	INLINE	INLINE
Configuration	VERTICAL	VERTICAL

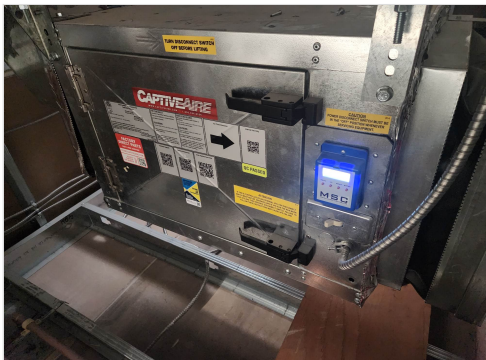
### Unit Data - PHOTO LOG

Asset: SF1

Unit Data		
	Design	Actual
MFG	NL	CAPTIVEAIRE
Model Num	NL	SIF11DD
Serial Num	-	7610984
Type	-	INLINE
Configuration	-	HORIZONTAL
