**Report: TAB Report**  
**Function: Test, Adjust, & Balance**  
**Date: 03/25/2026**  
**Completed By: National TAB**

**PROJECT**  
**03-23-26 QT #1736 MACON, GA**

519 NORTH AVE

QUIKTRIP  
4705 SOUTH 129TH EAST AVENUE  
TULSA, OK 74134

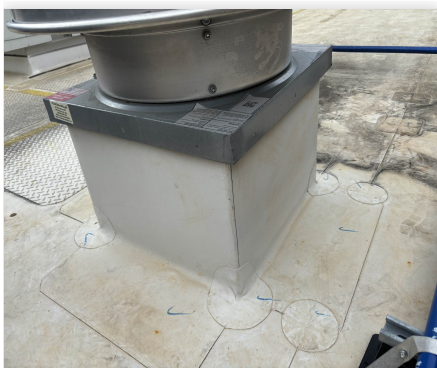
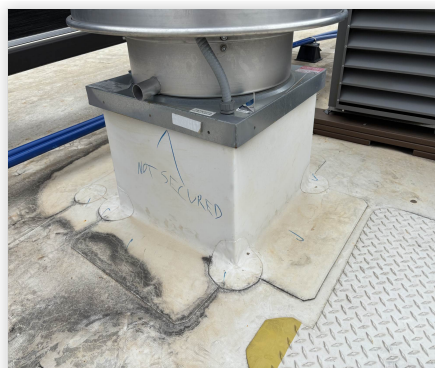
**Issue Name :** EF-1: Not Secured to Curb  
**Description :** The unit is not secured to the curb of the roof. It can be secured with some screws on opposite sides of each other to keep it held down and prevent it from moving.  
**Created By :** National TAB      **Assigned To :** National TAB - Dan Hertenstein  
**Status :** Open  
**Priority :** Low      **Asset Tag :**  
**Originated Date :** 03/25/2026 - Sagar Patel - National TAB

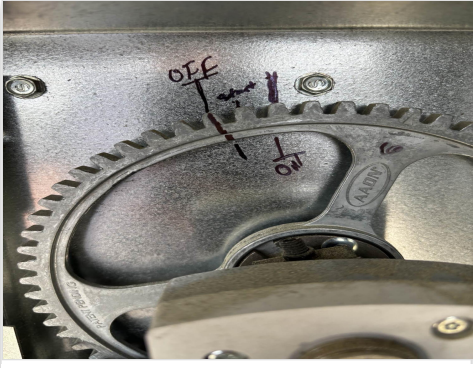
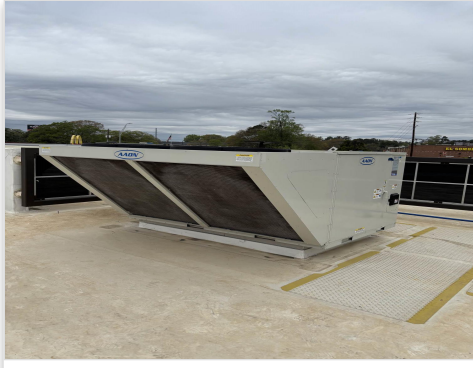
**Unit Data - PHOTO LOG**

Asset: RT-1

Test Data		
	Design	Actual
SF CFM	4200	4180
SF RPM	-	1267
OA CFM (Hoods On)	800	867
OA CFM (Hoods Off)	350	364
RL Voltage	-	141 VFD
RL Amperage	-	7.59 VFD
VFD Max SetPt	-	43.2 Hz
VFD Min SetPt	-	24 Hz
OA Damper Position (Hoods On)	-	46%
OA Damper Position (Hoods Off)	-	26%

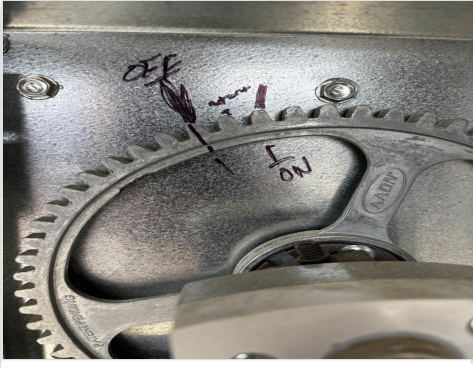
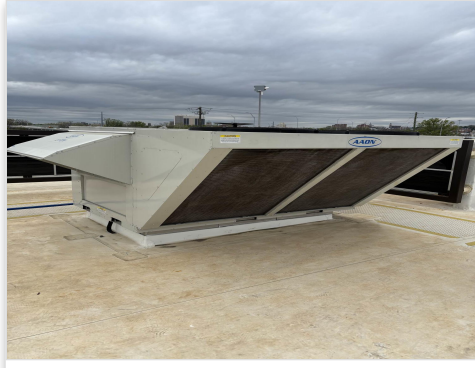
**Unit Data - PHOTO LOG**

Asset: RT-2

Test Data		
	Design	Actual
SF CFM	4200	4209
SF RPM	-	1267
OA CFM (Hoods On)	800	784
OA CFM (Hoods Off)	350	371
RL Voltage	-	140 VFD
RL Amperage	-	6.98 VFD
VFD Max SetPt	-	43.2 Hz
VFD Min SetPt	-	24 Hz
OA Damper Position (Hoods On)	-	46%
OA Damper Position (Hoods Off)	-	26%

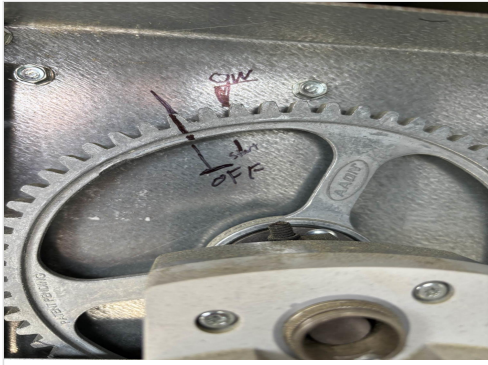
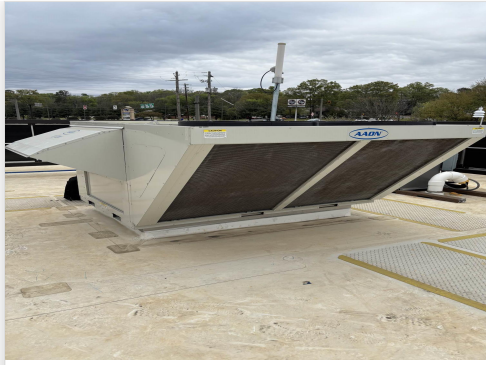
**Unit Data - PHOTO LOG**

Asset: RT-3

Test Data		
	Design	Actual
SF CFM	4200	3905
SF RPM	-	1320
OA CFM (Hoods On)	800	832
OA CFM (Hoods Off)	350	378
RL Voltage	-	152 VFD
RL Amperage	-	7.91 VFD
VFD Max SetPt	-	45 Hz
VFD Min SetPt	-	24 Hz
OA Damper Position (Hoods On)	-	46%
OA Damper Position (Hoods Off)	-	26%

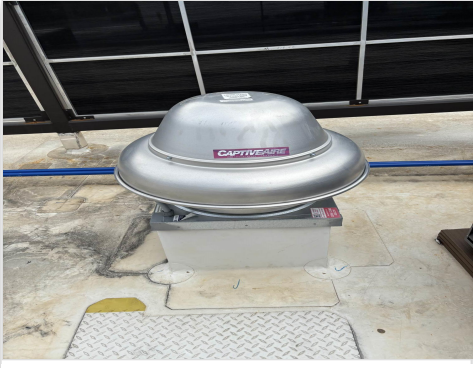
## Unit Data - PHOTO LOG

Asset: EF-1

Test Data		
	Design	Actual
CFM	750	763
Fan RPM	-	798
Fan Rotation	-	CCW
Motor RPM	-	798
System SetPt	-	42P
RL Voltage	-	[1]
RL Amperage	-	[1]
Total ESP	-	0.22"
Fan Inlet SP	-	-0.22"
Fan Discharge SP	-	ATM

Notes:  
[1] UNABLE TO READ VOLTS AND AMPS SAFELY

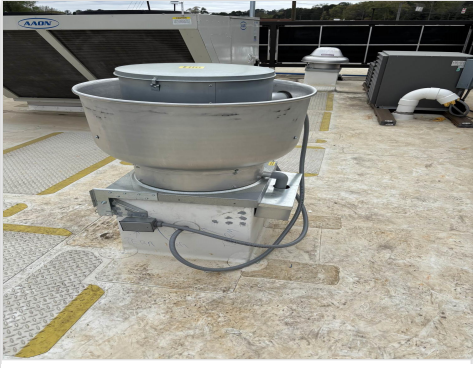
## Unit Data - PHOTO LOG

Asset: EF-3

Test Data		
	Design	Actual
CFM	1350	1335
Fan RPM	-	1195
Fan Rotation	-	CCW
Motor RPM	-	1195
System SetPt	-	52.8 Hz (66% on MSC)
RL Voltage	-	210
RL Amperage	-	1.8
Total ESP	0.75"	0.26"
Fan Inlet SP	-	-0.26"
Fan Discharge SP	-	ATM

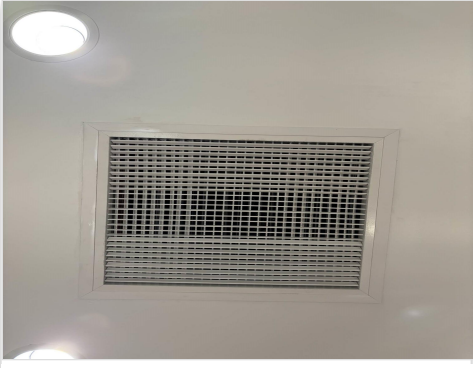
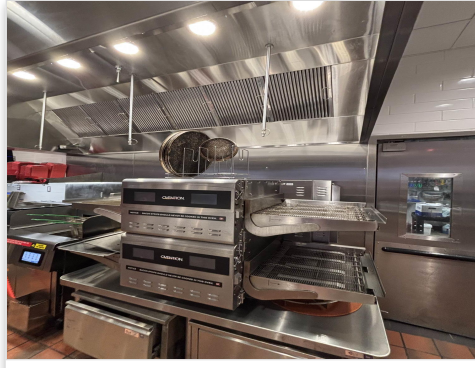
**Unit Data - PHOTO LOG**

Asset: HD-1

Design	Actual
Filter Type	CAPTRATE SOLO FILTER	CAPTRATE SOLO FILTER
Filter Size 1	20X16	20X16
Filter Qty 1	6	6
Filter AK factor size 1	2.08	2.08
Filter Total AK Area	12.48	12.48
Filter1 FPM	-	107
Filter2 FPM	-	116
Filter3 FPM	-	109
Filter4 FPM	-	107
Filter5 FPM	-	106
Filter6 FPM	-	98
Filter Ave FPM(corr)	-	107
CFM	1350	1335
